Product Support Bulletins

May 1974 to September 2000

| | PSB INDEX | | |

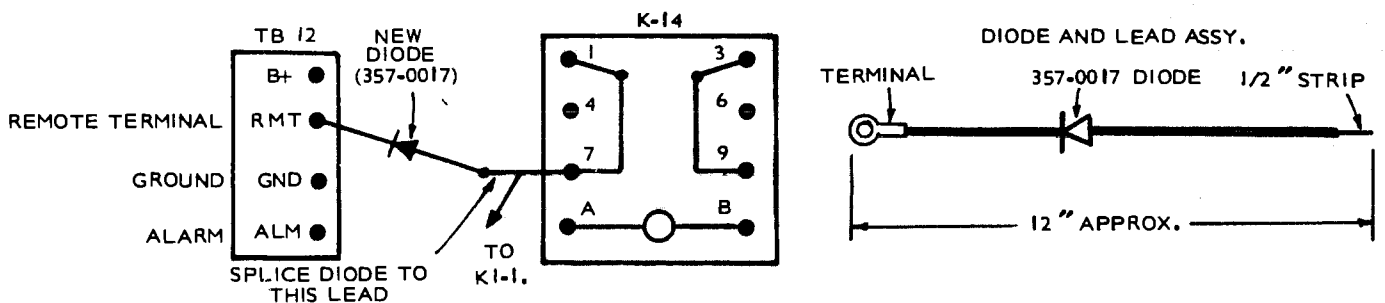
The solution to this problem is to install a diode (Part #357-0017) in the engine control between relay K14 pin 7 and terminal board TB12-remote terminal (RMT) connection point. See diagram below.

This diode and lead assembly will bypass the voltage drop of the time delay start-stop board when the starter is energized. This will provide enough voltage to the ignition relay (K-12) to keep it energized and preventing starter chatter.

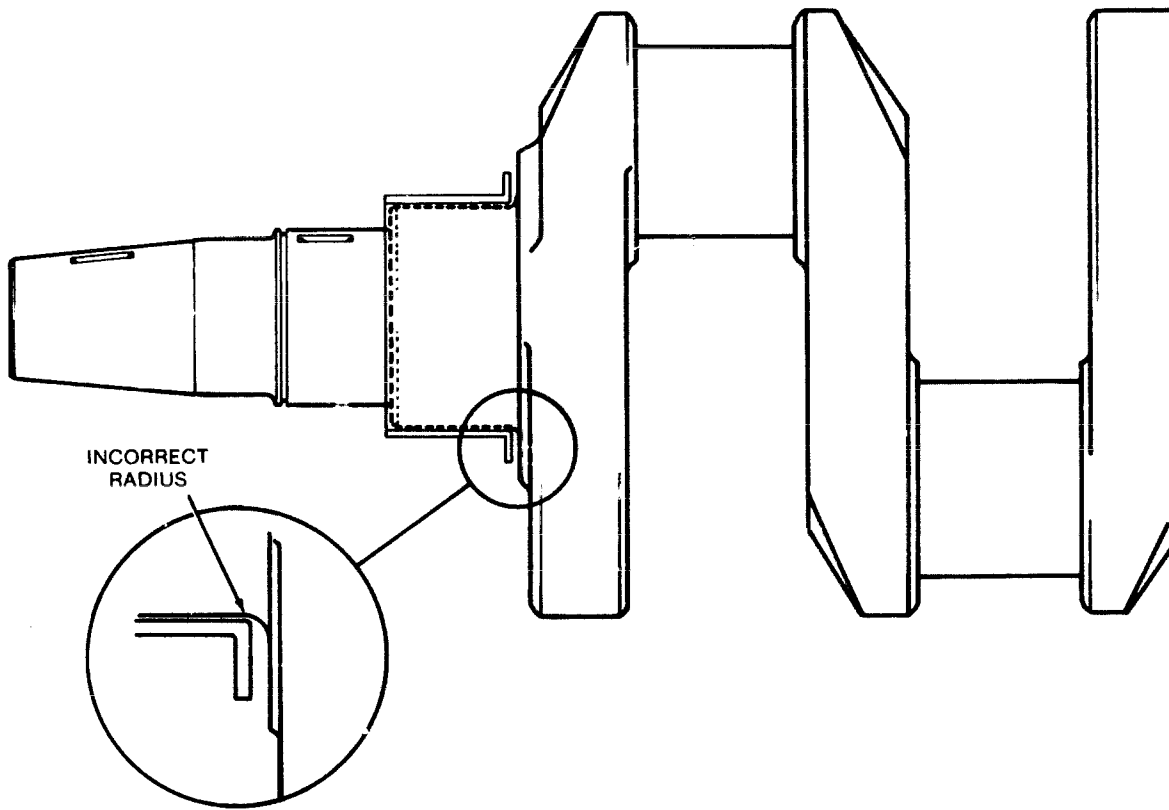
FIGURE 1. FRONT MAIN BEARING AND CRANKSHAFT RADIUS DO NOT MATCH RESULTING IN A PRE-LOAD CONDITION AND NO ENDPLAY

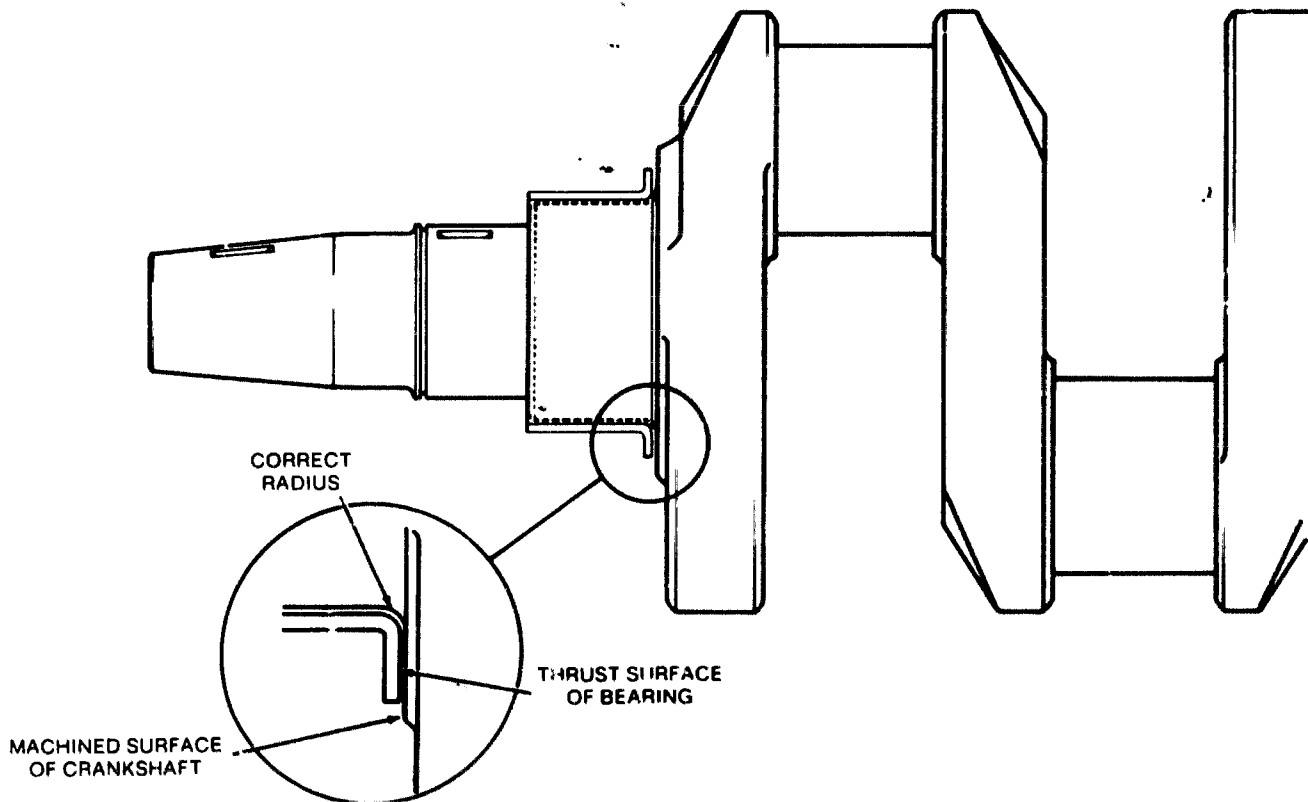
FIGURE 2. FRONT MAIN BEARING AND CRANKSHAFT RADIUS MATCH ALLOWING PROPER ENDPLAY.

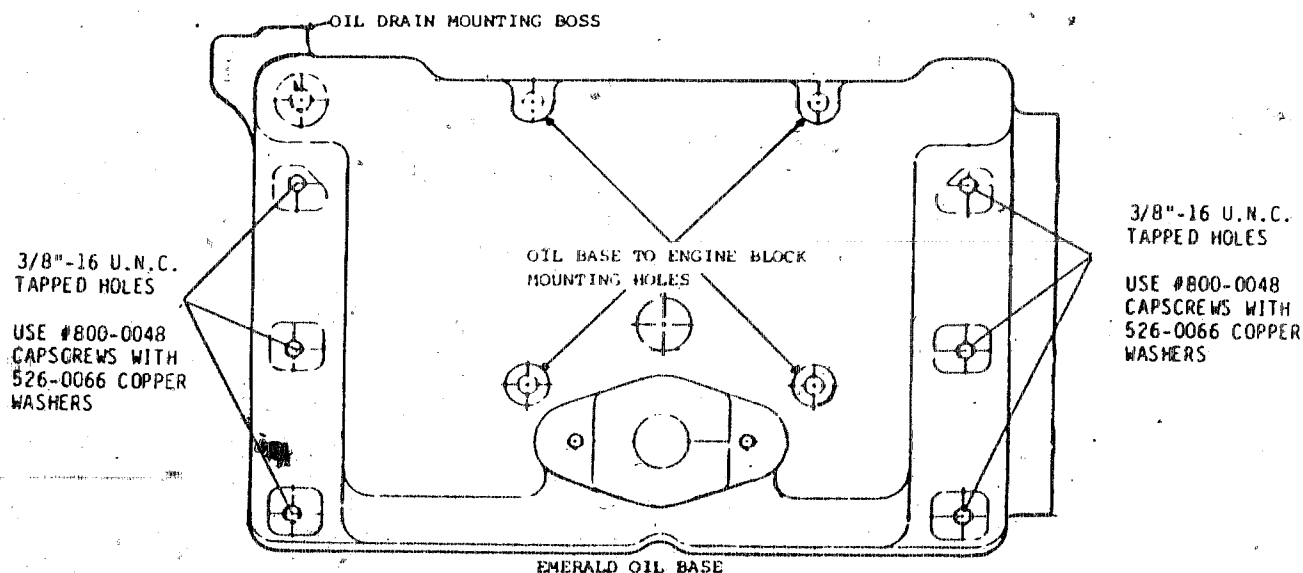
- 1) Oil leaking at (#504-0150) shutoff valve mounting boss. This valve may have been over-tightened at the factory causing oil base to crack. The only repair is to replace the (102-1242) oil base.
- 2) Oil leaking at oil base to engine block mounting holes. Check the base-to-block mounting gasket (102-1200). Replace gasket if damaged or not sealing properly. If no gasket or mounting surface damage is apparent, fill oil base with solvent and check for porosity. If oil base is porous, replace the oil base.
- 3) There are six 3/8" -16 U.N.C. tapped holes on the bottom of the oil base (3 on each side). If oil leaks occur at any one of these holes they can be repaired by installing a capscrew with copper washer, see figure. Apply Teflon pipe thread sealer to capscrew threads.

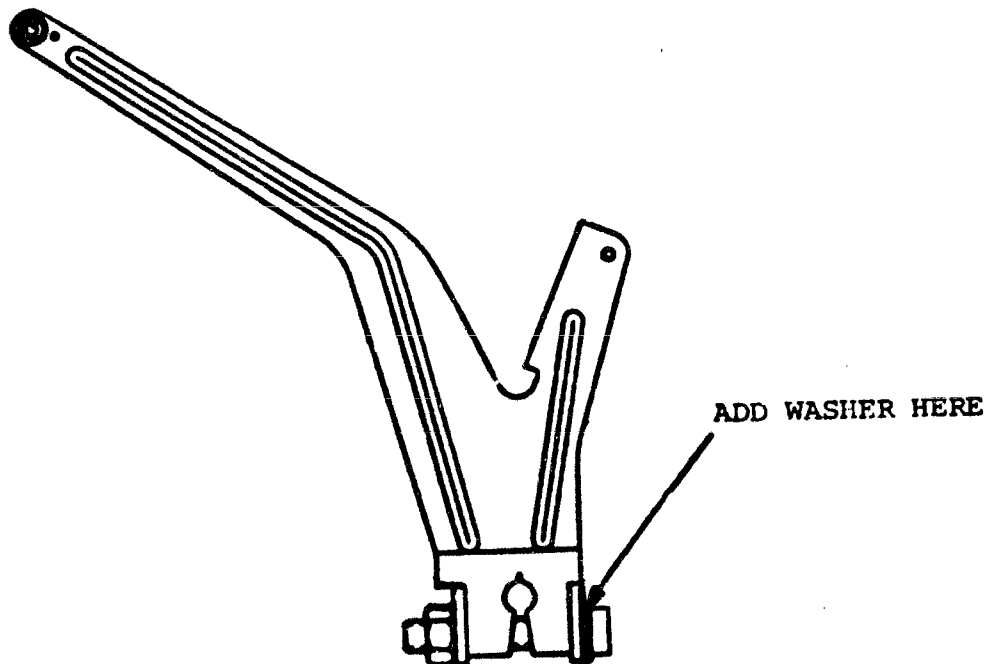
Governor instability may be caused by oil on the governor shaft which could cause the governor lever to slip on the governor shaft. Clean the governor shaft in the area where the governor lever attaches with choke cleaner, contact cleaner or equivalent. Add washer P/N 740-1006 under the head of the bolt which attaches the governor lever to the governor shaft. Torque bolt 8-10 ft.lbs. (11-14 Nm). Refer to Elite Service manual for adjustment procedures.

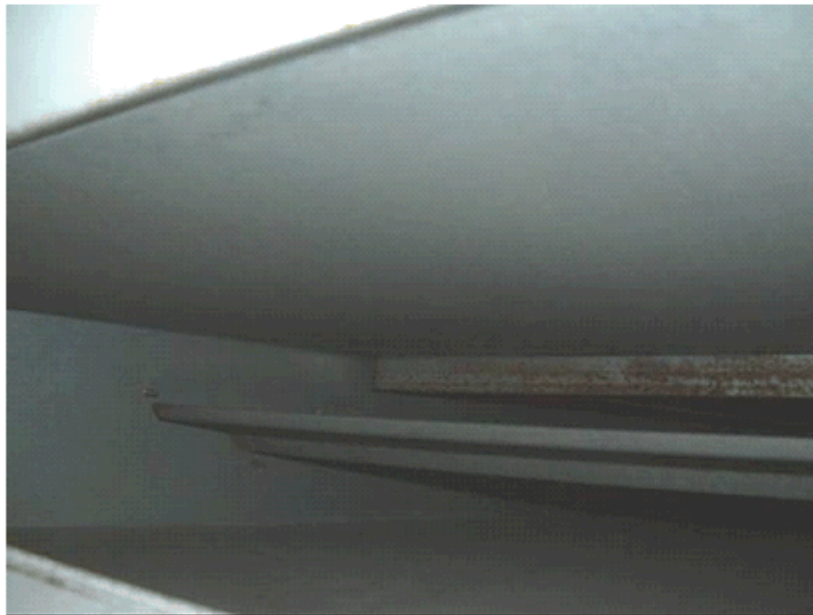
Figure 1: Indicates Open Damper

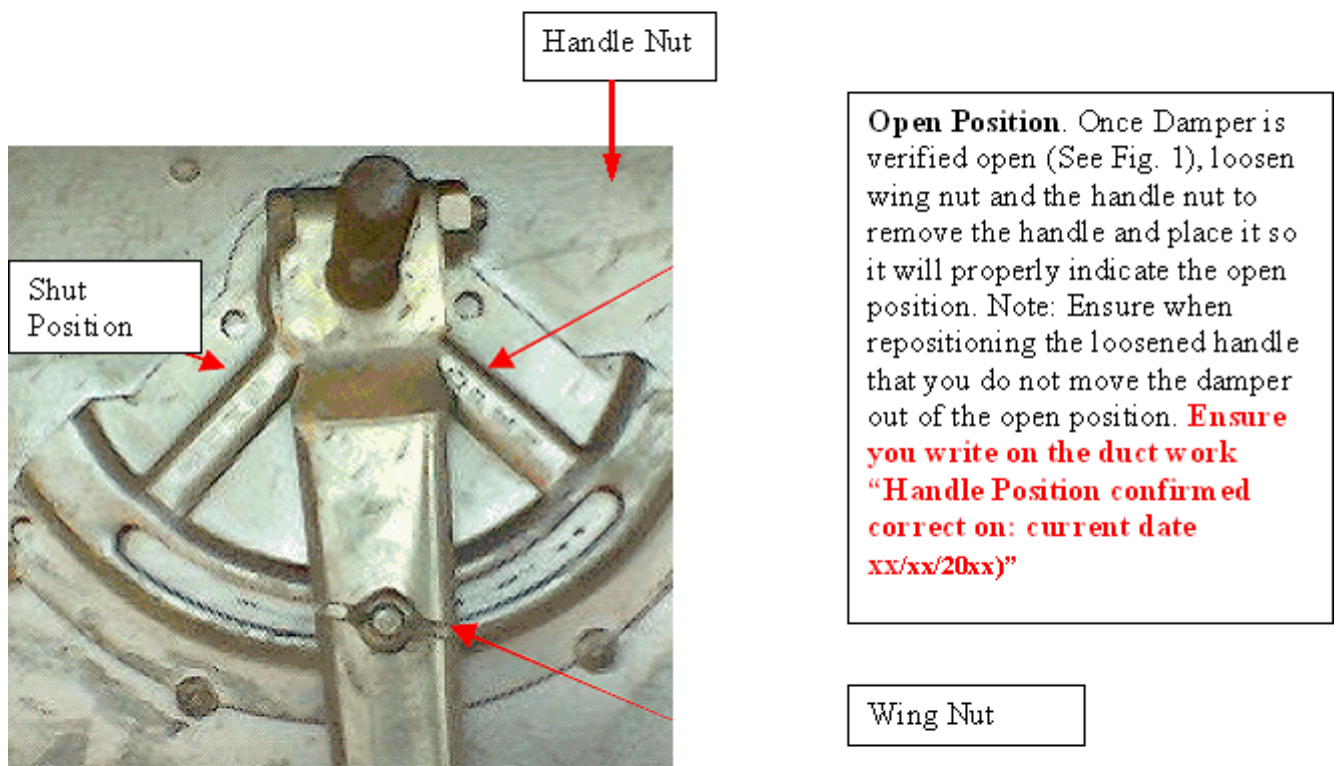
Figure 2 Shows a handle which does not indicate the Damper "open" position properly
