Product Support Bulletins

May 1974 to September 2000

MBB

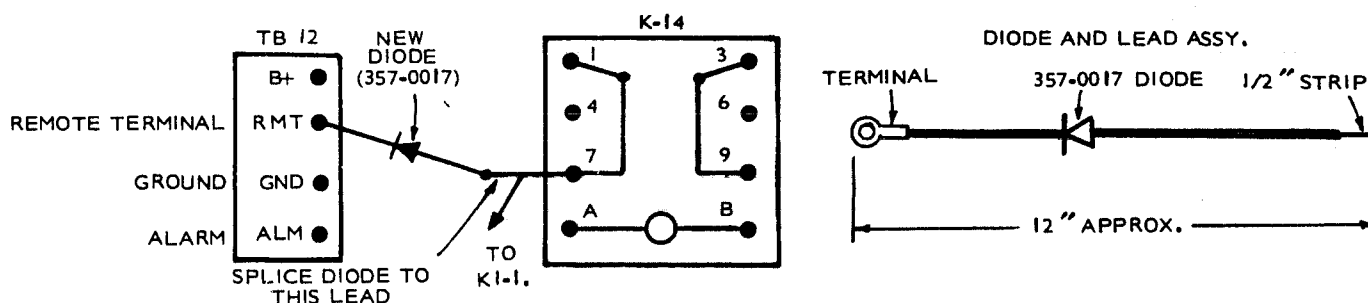
The solution to this problem is to install a diode (Part #357-0017) in the engine control between relay K14 pin 7 and terminal board TB12-remote terminal (RMT) connection point. See diagram below.

This diode and lead assembly will bypass the voltage drop of the time delay start-stop board when the starter is energized. This will provide enough voltage to the ignition relay (K-12) to keep it energized and preventing starter chatter.

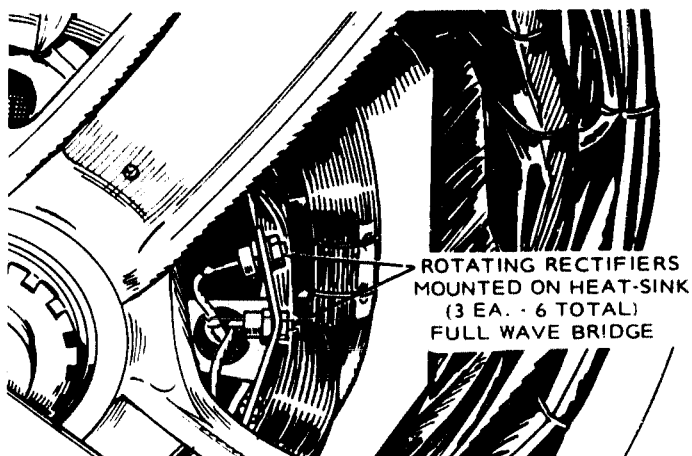
If the heat sink assemblies have SHARP bends instead of a smooth surface at the bends, they MUST be replaced. The condition of the bend can be determined by moving a pencil or small

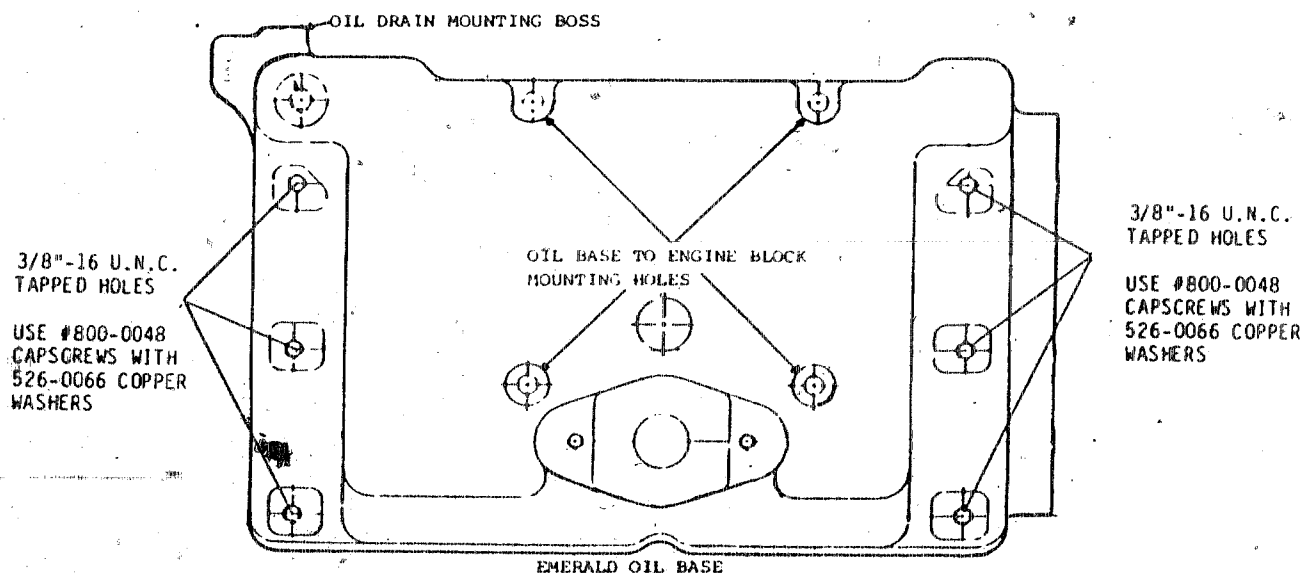
- 1) Oil leaking at (#504-0150) shutoff valve mounting boss. This valve may have been over-tightened at the factory causing oil base to crack. The only repair is to replace the (102-1242) oil base.
- 2) Oil leaking at oil base to engine block mounting holes. Check the base-to-block mounting gasket (102-1200). Replace gasket if damaged or not sealing properly. If no gasket or mounting surface damage is apparent, fill oil base with solvent and check for porosity. If oil base is porous, replace the oil base.
- 3) There are six 3/8" -16 U.N.C. tapped holes on the bottom of the oil base (3 on each side). If oil leaks occur at any one of these holes they can be repaired by installing a capscrew with copper washer, see figure. Apply Teflon pipe thread sealer to capscrew threads.
