Product Support Bulletins

May 1974 to September 2000

| | PSB INDEX | | |

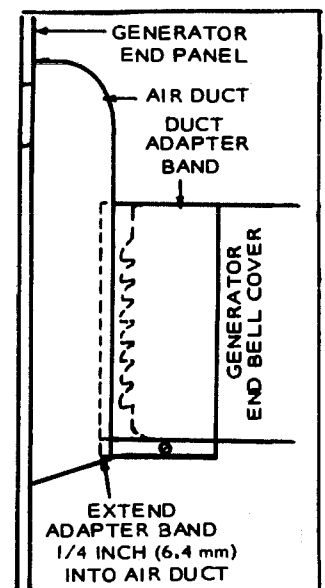
FIGURE 1.

Under extremely - abnormal operating conditions the emergency Relay (part #320-0104) being a thermo-activated device, can nuisance trip!

The addition of a new Duct Adapter Band (part #405-2209 for the MDJB and MDJE models and part #405-1536 for the MDJC and MDJF models) will lower the operating temperatures which caused nuisance tripping of the emergency relay.

Adjust the duct adapter band so it extends 1/4" (6.4 mm) into air duct. See Figure 1. Tighten adapter band.

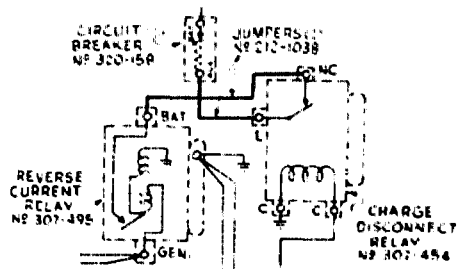
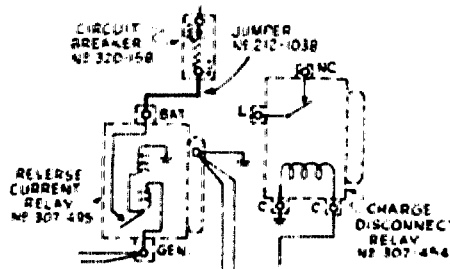
ORIGINAL CIRCUIT

BYPASSED CIRCUIT

To bypass the 307-0454 Charge Disconnect relay proceed as follows:

1. Completely remove the lead or jumper which runs from terminal L of the Charge Disconnect relay to the Auxiliary contact of the 320-0158 Circuit Breaker.
2. Next, MOVE the lead or jumper which runs from the NC (Normally Closed) contact of the 307-0454 Charge Disconnect relay to the Auxiliary Contact of 320-0158 Circuit Breaker. Refer to Wiring Diagram #610-0270. See Illustrations below also.

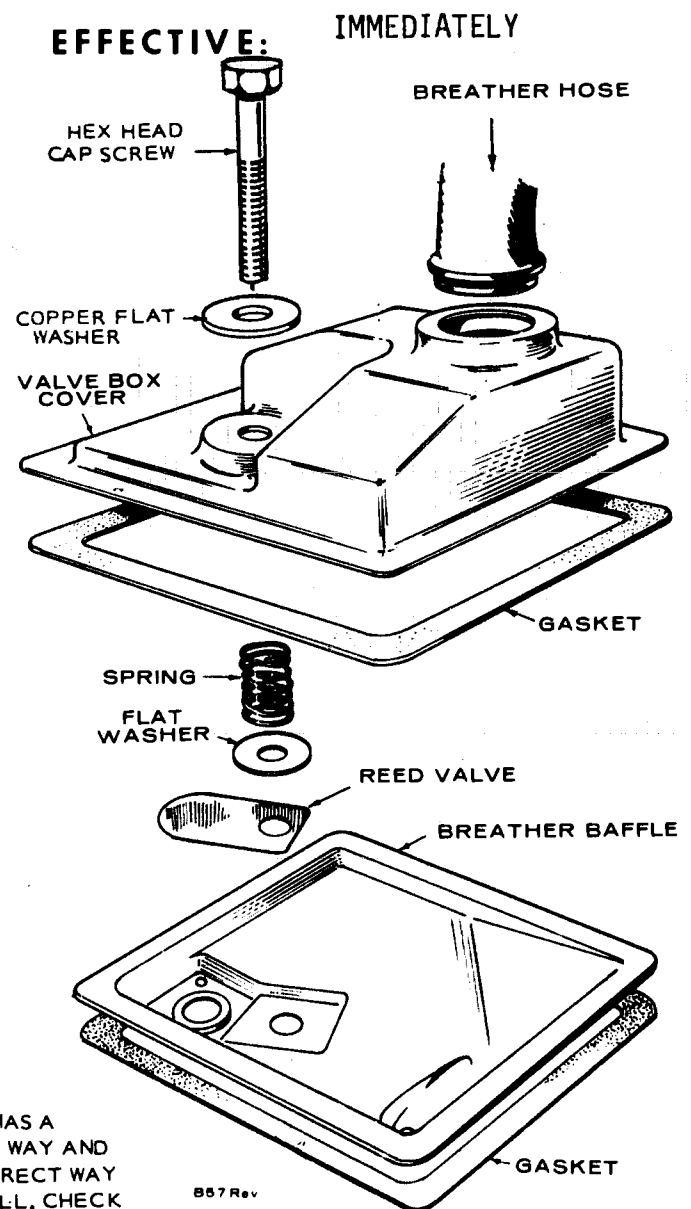
GASKET HAS A CORRECT WAY AND AN INCORRECT WAY TO INSTALL, CHECK CLOSELY FOR PROPER FIT!

The breather should be assembled as shown in illustration.

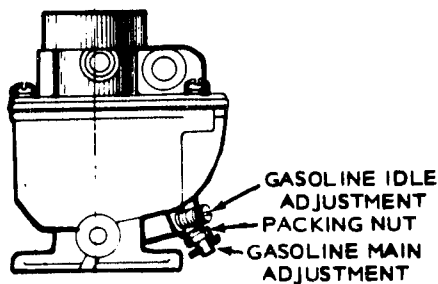
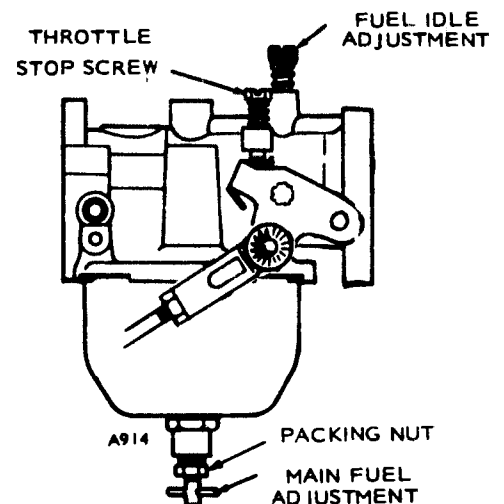
This packing nut should be tight enough so that main jet adjustment cannot be turned with adjustment tool. A loose packing nut may cause excessive air draw and rough engine operation. Fuel leakage may show up as a complaint that the unit is hard to start after not being operated for a number of hours.

CCK, CCKA, NHA, NHB and BF (RV)
Carburetor Adjustment

NH, NHC, NB, LKB, CCKB, MCCK and "J" Series
Carburetor Adjustment

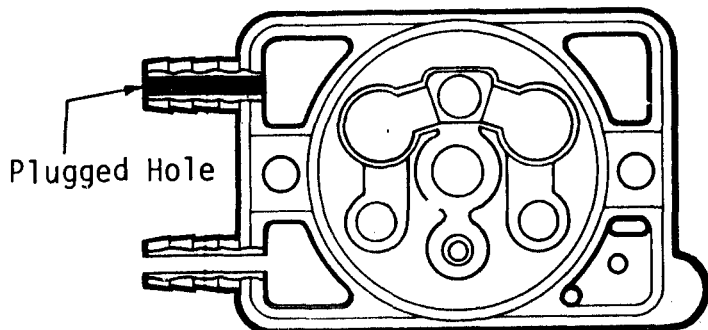
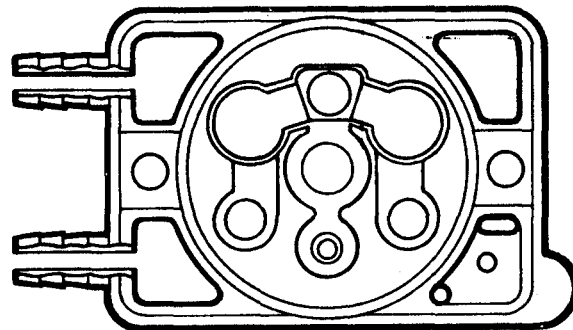
Green in Color
New Style Valve Plate

Black in Color
Old Style Valve Plate

A supply of caps (149-1321) and clamps (503-0301) should be kept in Distributor and Dealer stock to cover the 142-0537 valve plates presently in stock when used as a replacement part on the newer models with single fuel inlet nozzle,

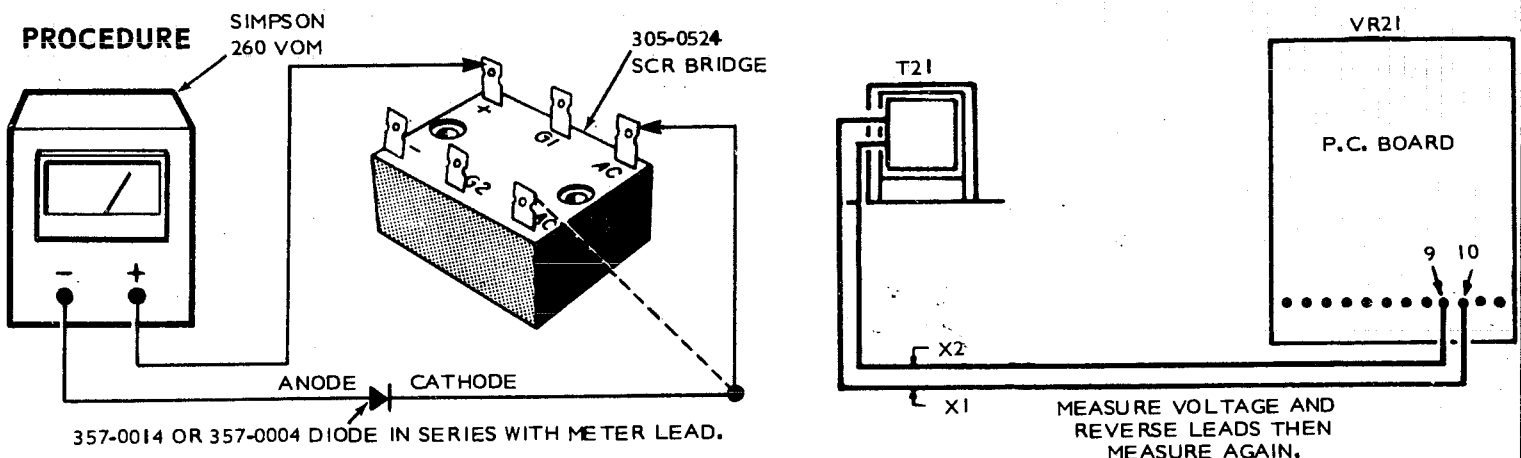
Non-symmetrical firing of the SCR's could result in premature bridge failure.

It is recommended that firing symmetry be established whenever servicing an applicable "UR" or "YB" type generator. Use the following procedure and refer to the illustration below:

Proceed as follows with the unit running at no load:

1. Use a Simpson 260 meter set on the 2.5 volt DC (+) positive scale. (If a different meter is used, start on a higher DC positive scale.)
2. Connect positive (+) meter lead to the plus (+) terminal on the 305-0524 module.
3. Connect negative (-) meter lead to the Anode of a diode. Onan Part #357-0014 or #357-0004.
4. Connect cathode end of diode to AC 1 terminal of SCR module. Record reading. (See illustration above.)
5. Connect cathode end of diode to AC 2 terminal of SCR module. Record reading again.
6. Stop engine. Reverse the secondary leads (X1 & X2) of the voltage reference transformer T21, (315-0342) at positions 9 & 10 on the voltage regulator board (332-1268) or (322-1704).

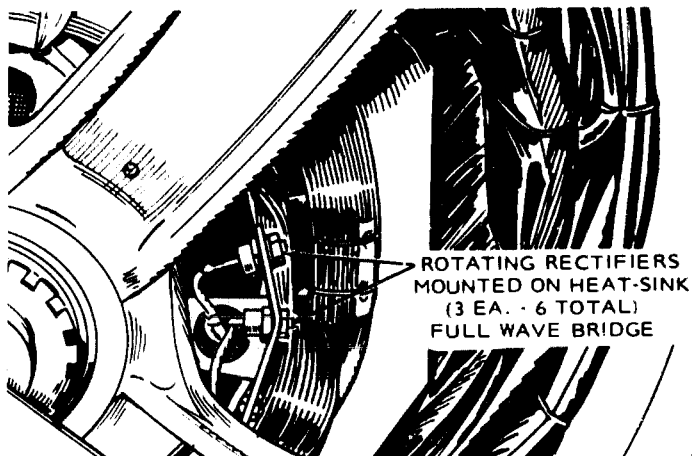
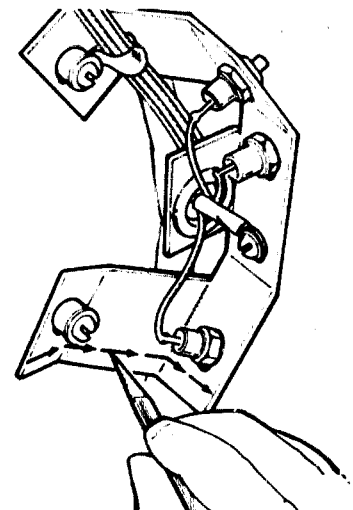
If the heat sink assemblies have SHARP bends instead of a smooth surface at the bends, they MUST be replaced. The condition of the bend can be determined by moving a pencil or small

screwdriver across the bends shown on the illustration. If movement ACROSS the bend is smooth, do not replace the heat sink. If the movement is not smooth, remove and replace the heat sink.

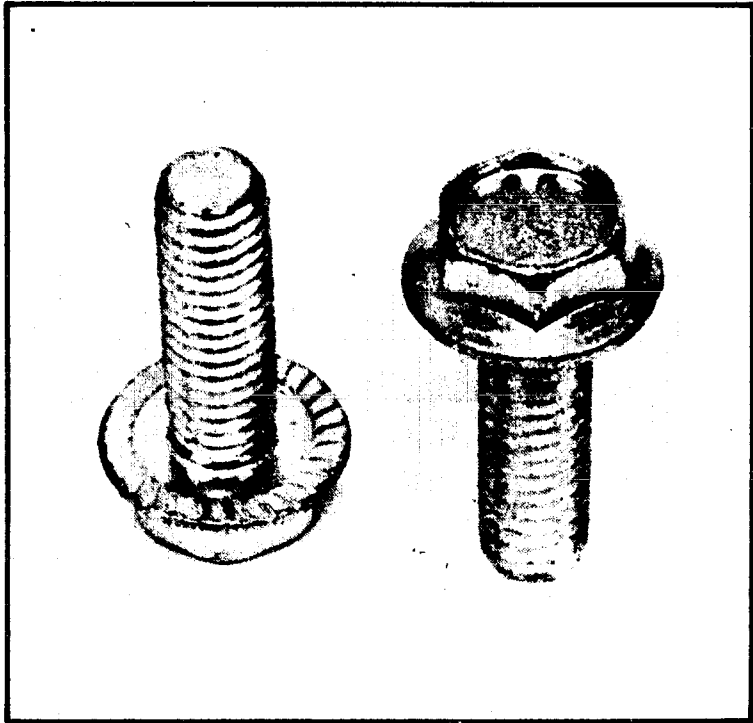
FIG. 1

On July 6, 1976, Onan initiated a field fix campaign on "MCCK" generator sets with certain engine exhaust manifold bolts that could, under certain conditions, shear, breaking the integrity of the exhaust system and allow carbon monoxide to be emitted into the living environment of the craft.

The illustrations on page 2 of this bulletin show the manifold bolts effected and the replacement manifold bolts required to correct any problem units.

**REMOVE THESE
SELF LOCKING
CAP SCREW**

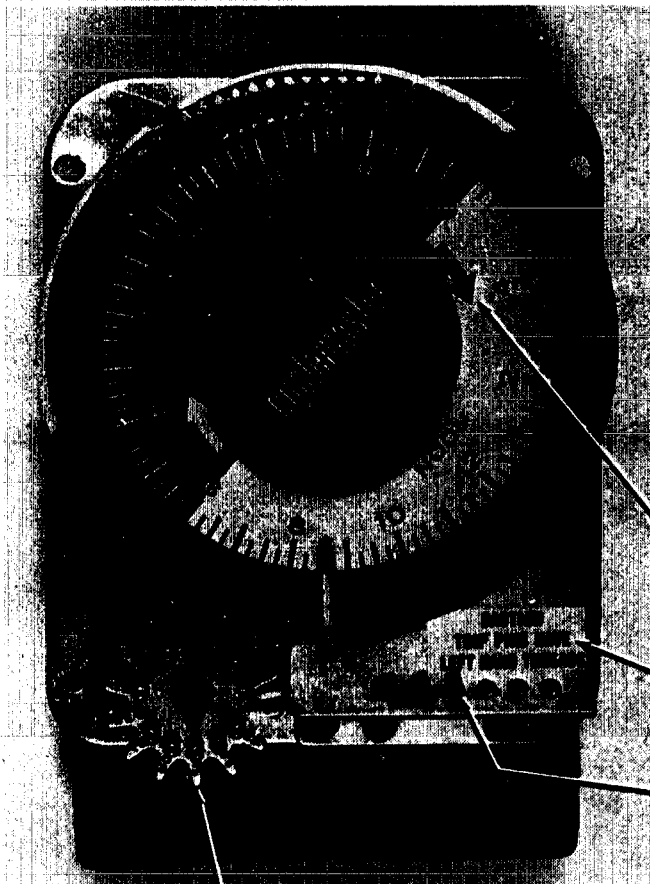
Warranty reports indicate these timers are being damaged (stripped gears) as a result of someone turning the small spoked wheel backwards (against direction of normal rotation.)

The trip pins for the timer are LEFT HAND THREAD and the timer rotation is CLOCKWISE ONLY. An arrow on the face of the exerciser clock indicates the direction of rotation.

Future production will have a new silk screen caution on the bottom of the exerciser timer pointer bracket -
CAUTION: LEFT HAND THREAD ONLY

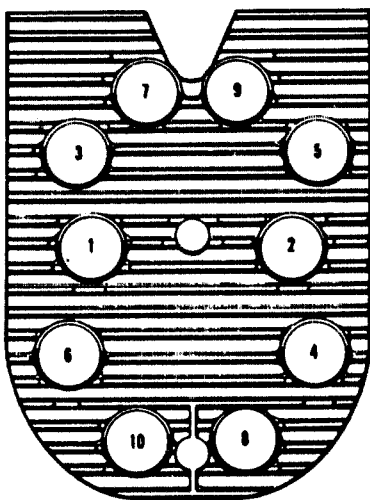
Figure 1. Head bolt Tightening Sequence.

Exercise caution to avoid over-torquing these cylinder head nuts as this can result in severe engine damage.

*All industrial N52M-GA019.9 engines are fitted with two compression washers on the upper 6 (#'s 9, 7, 5, 3, 2 and 1) cylinder head bolts. See illustrations below for clarification. These washers must be in place to maintain stud retention. When these washers are used, torque in three 5 ft. lb. (7 N•M) steps to 13-15 ft. lb. (18-20 N•M).

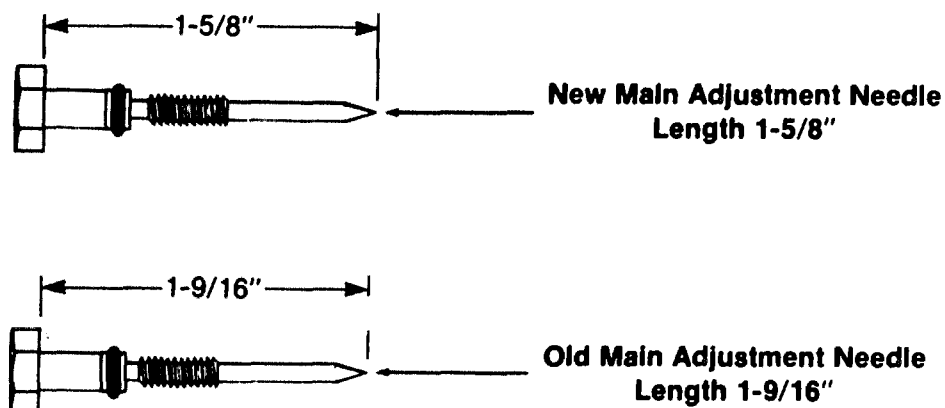
If you receive complaints on difficulty in getting proper adjustment of the main jet assembly, check the needle length dimension and replace it with the longer length new needle.

The old main adjustment needle length was 1-9/16". The new main adjustment needle length is 1-5/8". See ILLUSTRATION below.

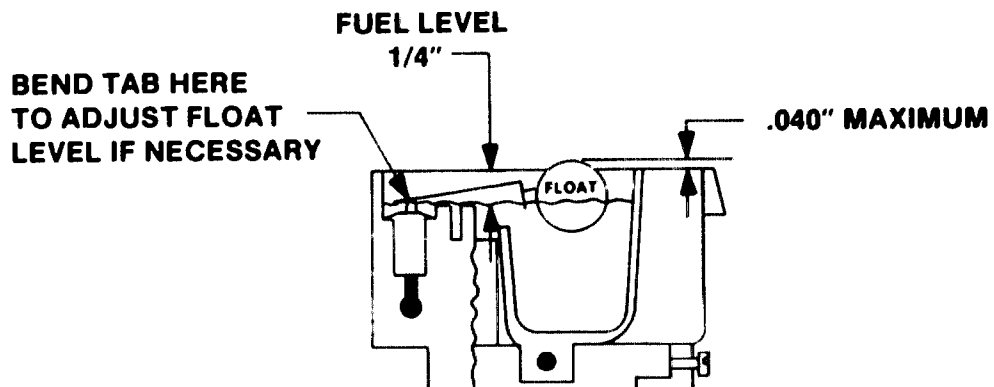
FIGURE D

NOTE: The floats should not protrude more than .040 inch out of the body after adjusting (see Figure D). If it is necessary to raise the floats higher than this to obtain .180 inch of travel the carburetor should be replaced.

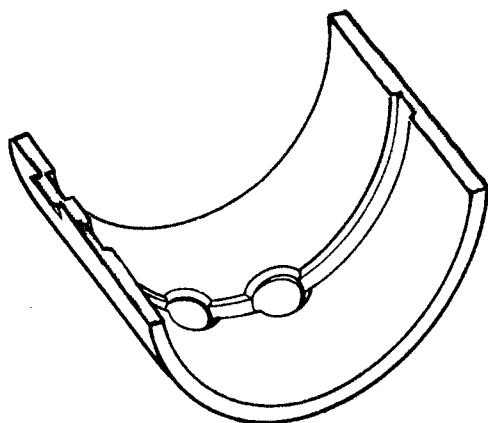
NON-MACHINED BEARING

INSPECT MATING SURFACE
FOR FLAT SMOOTH FINISH

Check your service parts stock and return any non-machined bearings to Onan for credit. Standard spare parts warranty will apply on defective bearings.

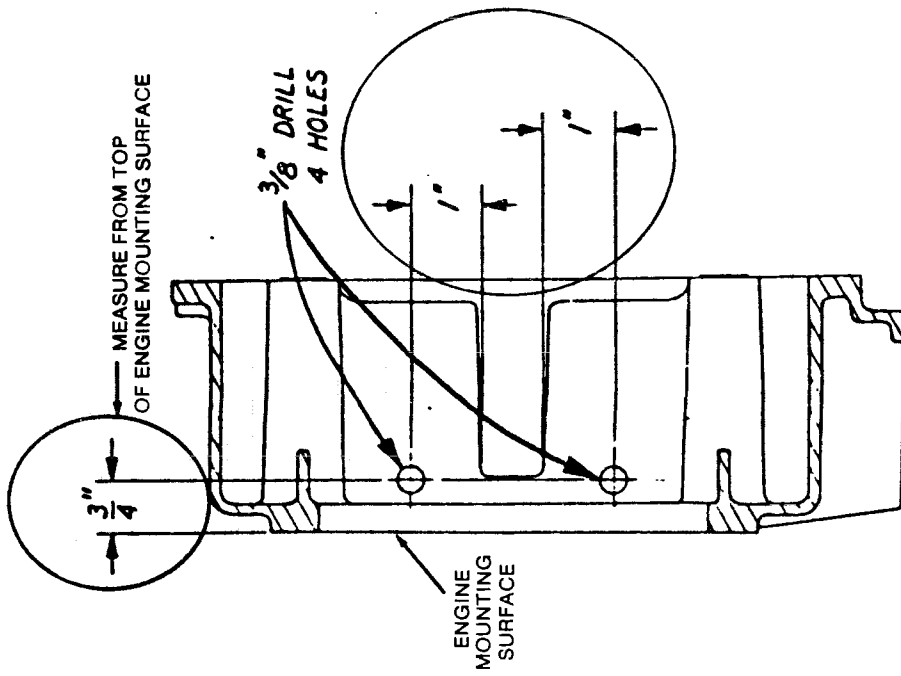
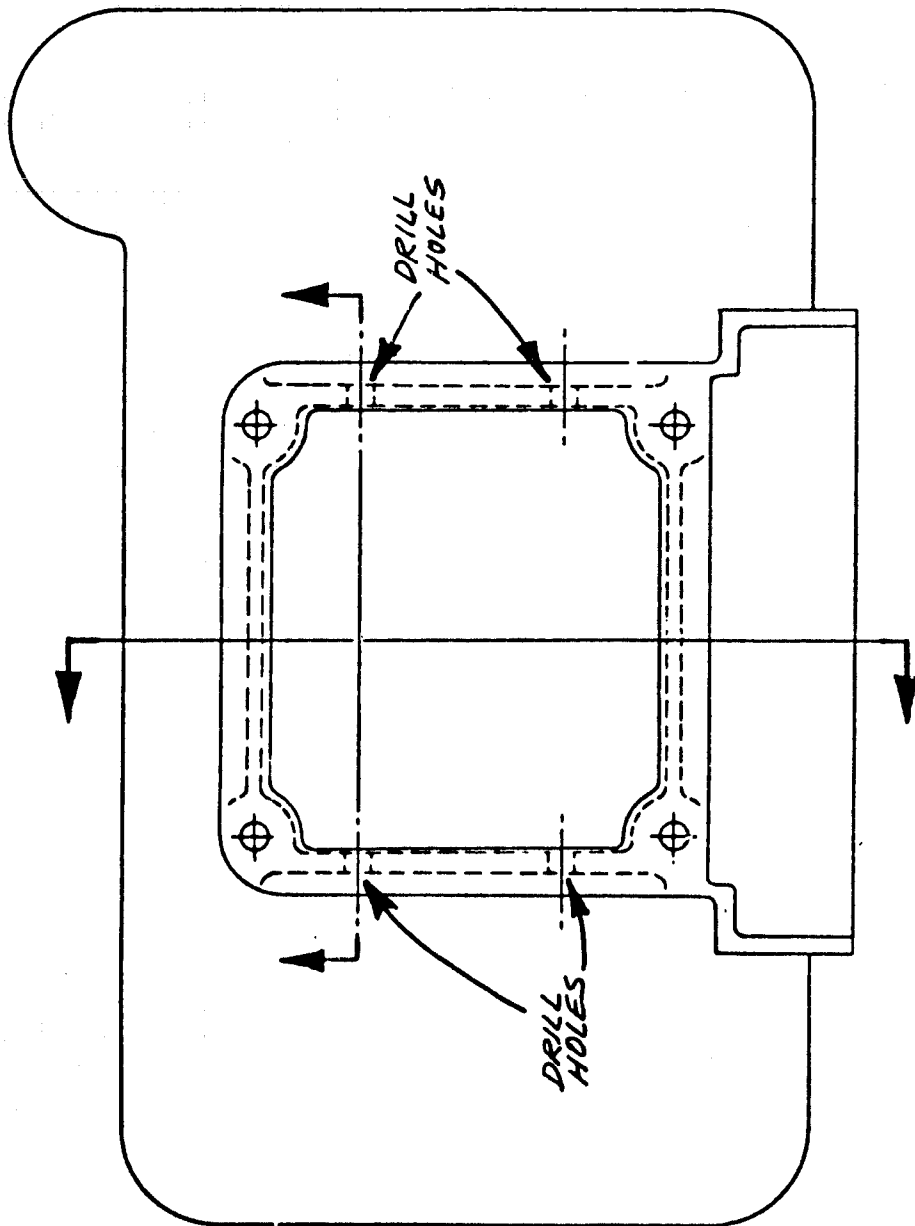
CAUSE: The sets shut down because the LOPKO (Low Oil Pressure Cut Out) opens due to a momentary loss of engine oil pressure. The reason for the momentary loss of oil pressure is that oil is NOT being returned to the center oil base cavity fast enough.

REPAIR: The oil base must be removed from the engine. Do NOT remove the sheet metal pan from the oil base. Drill four 3/8 inch diameter holes in the baffle plates per diagram shown on Page 2 of this Bulletin.

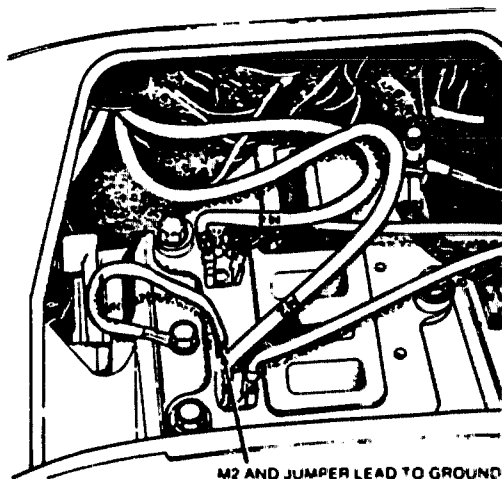
FIGURE 1. M2 PROPERLY GROUNDED

Whenever servicing any of the above models, check the AC brush block connections (M2 and M4) to be sure the ground lead jumper is on M2 and NOT M4.

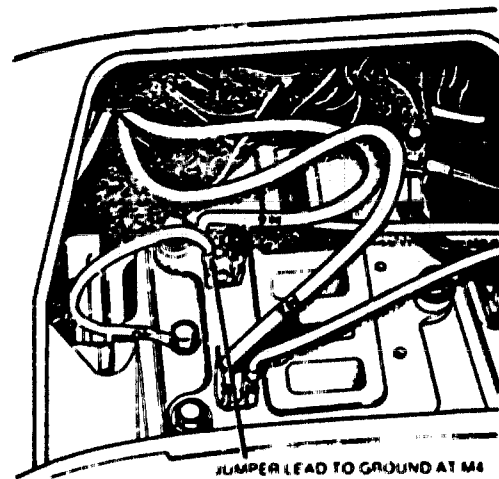
FIGURE 2. M4 IMPROPERLY GROUNDED

It is possible that the M4 generator lead may be grounded in addition to M2 if the jumper lead is connected as shown in Figure 2 (generator end top view). If M4 is grounded, this will cause a direct short in any 240 volt application. If only the 120 volt output is being used, the problem would not show up in normal operation of the generator set. M4 should NOT be grounded.

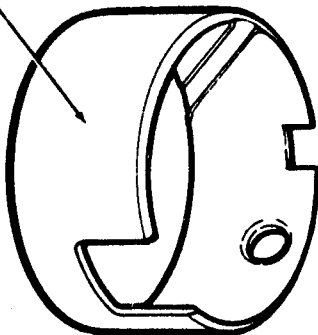
There is a noticeable difference in width between the 101-0391 production bearing and the 101-0405 replacement bearing. The 101-0405 bearing is about half as wide as the 101-0391 bearing but the actual bearing surface used by the camshaft is about the same.

The dimensional differences are illustrated and the bearings identified in the two figures below. Figure 1 is the 101-0391 production bearing which should NOT be used as a replacement part. Figure 2 is the 101-0405 replacement bearing.

The 101-0405 bearing must be used as a replacement part in above applications.

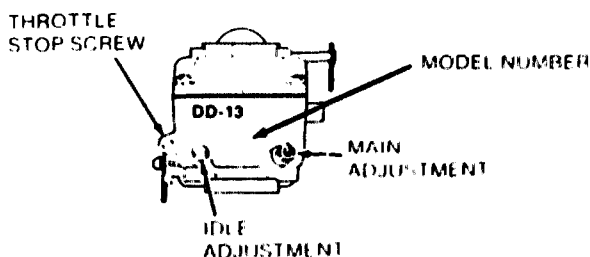
MARVEL SCHEBLER MODEL DD CARBURETOR

If your customer encounters a float swelling problem, refer to Product Support Bulletin #364(Dated 7/22/82)for testing procedures for contaminated fuels. If the 142-0547 float is swelling, replace this float with the 142-0652 float and have customer change fuel suppliers.

All Onan stock of the 142-0547 float has been removed from replacement parts stock and current production engines using any of the above model carburetors have the new 142-0652 high density float. All carburetors using the new float will have the suffix letter "A" stamped into the body of the carburetor after the model identification number. Example: DD-13A.

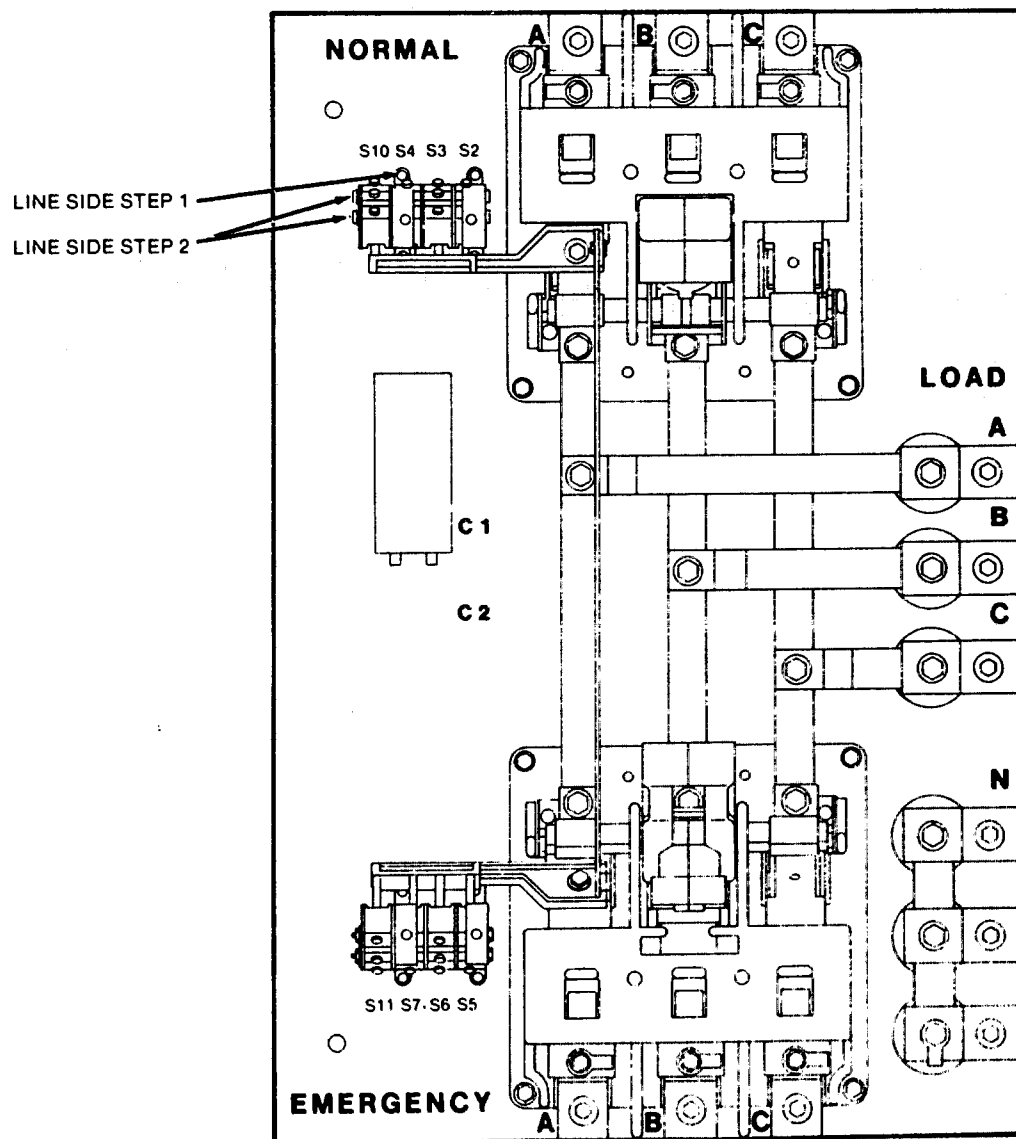
Because of the force required to actuate the microswitches in their present location, it is possible that the microswitch actuating arm can be flexed so that the switch will fail to actuate. If this occurs, the microswitch must be physically relocated from the outside position(i e S10)to the inside position(i e S2).

FIGURE 1. Original Transfer Switch Microswitch Configuration
Refer to Figure 2 on page 3 which shows the modified microswitch configuration.

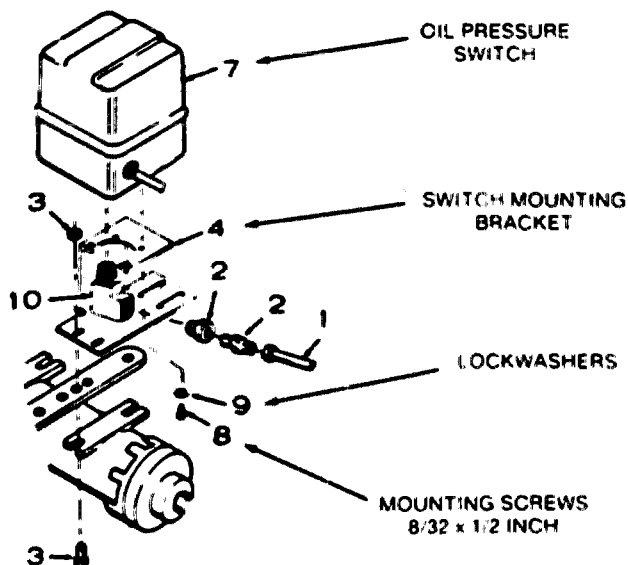
Some recent production sets with Kim tank heaters in the configuration shown below were built with improper hardware. The mounting screws shown below (Item 8) were inadvertently called out as an 8/32 x 5/8 inch screw. These screws were too long and will cause the oil pressure switch to remain open, leaving the heater in an "off" position.

If the tank heater fails to operate properly on any new installations during start-up, remove the screws (Item 8) and check for proper length. Replace as required.

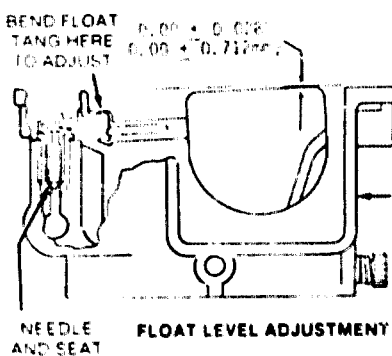
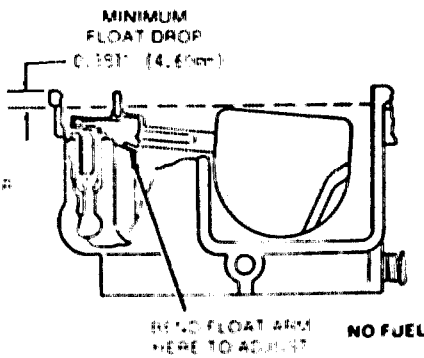
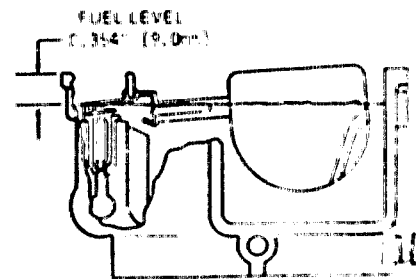
Field reports indicate that some engines may stumble or hesitate when operated at an angle or on an incline when equipped with a Nikki carburetor. This may be caused by an incorrect float level or float drop adjustment. Be sure carburetor linkages and governor speed are properly set prior to adjusting float level or float drop.

When checking float level and float drop, measure to float body, not seam.

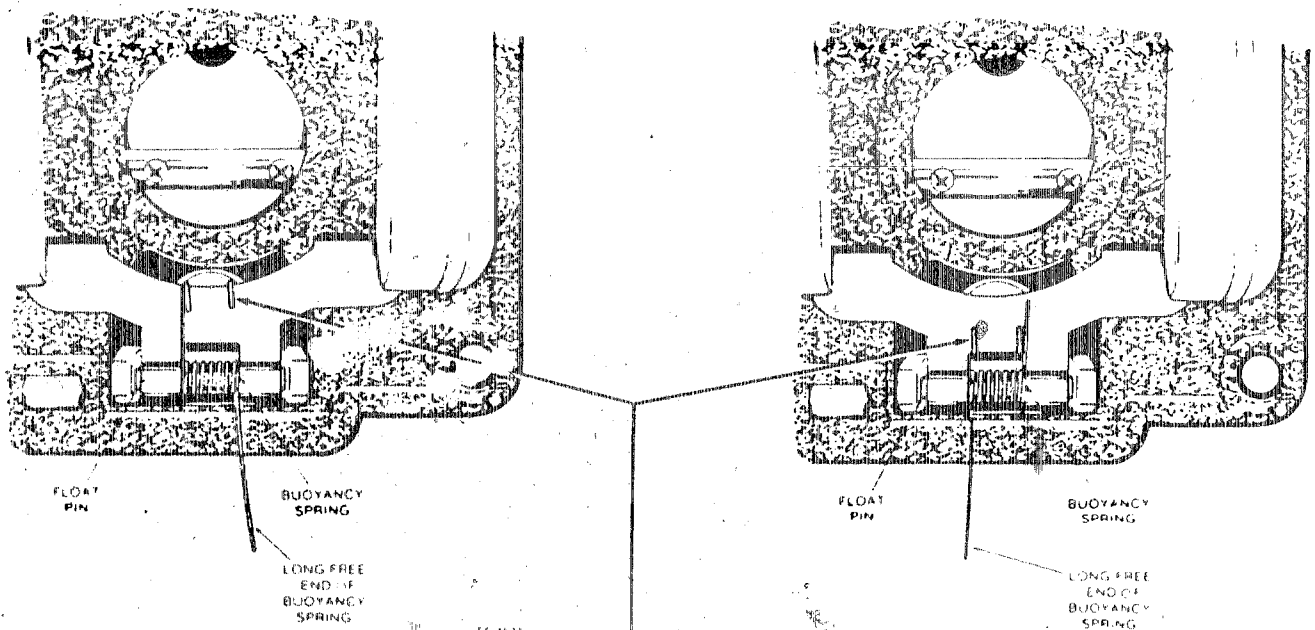
Fig 1
Incorrect

Instruction Sheet #292, Figure #1, has the float needle valve retaining clip illustrated incorrectly. Instruction Sheet #292a, Figure #2, has the needle valve retaining clip illustrated correctly.

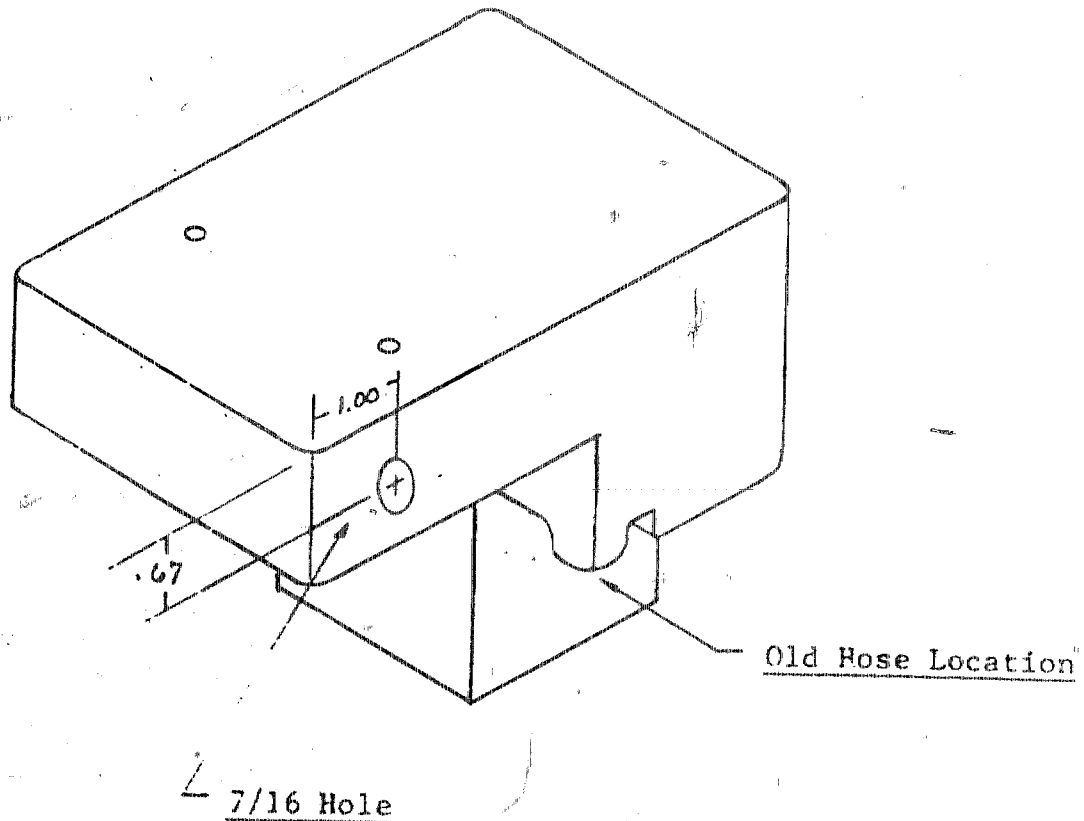
Recent reports of oil in the breaker box have been determined to be the result of a sharp bend in the breather hose. If you should experience this, check the breather hose for a sharp bend or kink.

The correction is to shorten the hose from 12" to 9-1/2" and relocating it as shown below. Insert approximately 1" of the hose into the new hole. It is not necessary to plug the old hole.

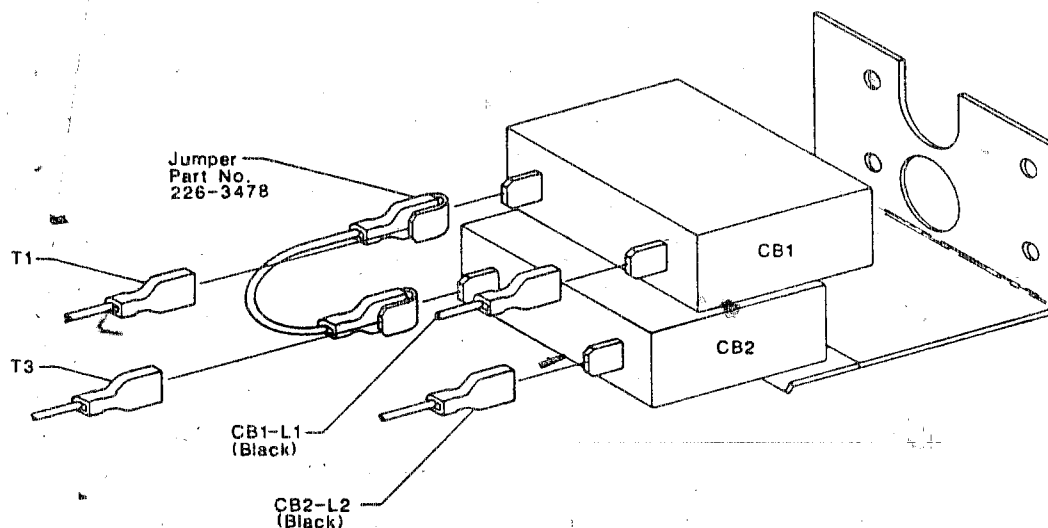
Onan has received complaints from the field that (Emerald III) gensets may have trouble starting air conditioners in hot weather. Symptoms include low voltage, air conditioners not operating properly, and tripping of load breakers.

This jumper lead should be connected across the input side of CB1 and CB2 (see Fig. 1).

This jumper will be added to factory built units starting with serial number 822017, in an effort to eliminate a potential problem.

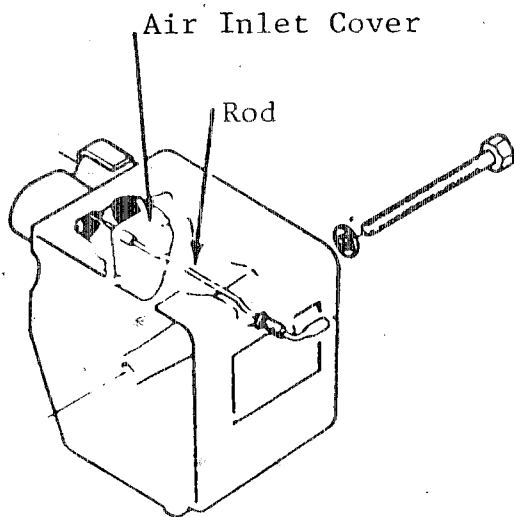
FIG. 1

Service Department has received complaints from the field of surging and overspeed conditions in Emerald RV gensets. These problems have been linked to carburetor icing which can occur under certain atmospheric conditions. To reduce the chances of carburetor icing, a change was made to the air inlet cover and rod, located in the air cleaner box (See Figure 1). The new style cover and rod can be identified by the revision letter (D) stamped on the inside of the inlet cover (See Figure 2).

When servicing an Emerald genset which exhibits the symptoms of surging or overspeeding, remove the air cleaner and check the revision letter on the inside of the air inlet cover. Any genset with revision (C) or earlier cover and rod, should be updated to revision (D) parts.

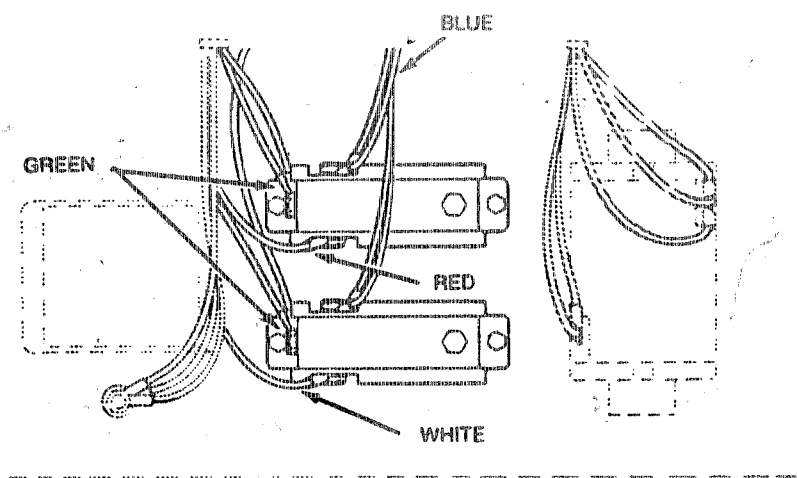
FIGURE 2. BEFORE

The possibility of electrical shock may exist from an improperly wired 120 V duplex receptacle on the side receptacle panel.

2. Remove the six faceplate mounting screws (Figure 1).
3. Gently pull the faceplate out from the control box taking care not to disconnect or strain the wires.
4. Remove the four mounting screws that hold the receptacles in place (Figure 1).
5. Disconnect the single wire (white on one receptacle and red on the other) and the two blue wires on the other receptacle. Do not disconnect the green (ground) wires (Figure 2).
6. Rotate each receptacle 180 degrees and connect the white, red, and blue wires in their original physical positions (Figure 3). With the receptacle rotated 180 degrees, the wires are now connected in opposite electrical polarity.
7. Re-install the receptacle mounting screws.
8. Position the faceplate on the control box and secure it, using the six mounting screws.
9. Test for correct receptacle polarity as described in the polarity testing procedure.

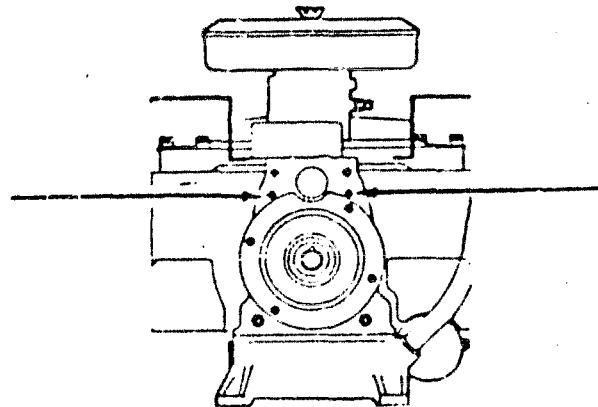
WARNING: Oil leakage causing permanent engine damage or personal injury may result from failure to appropriately plug these holes.

Use an appropriate Allen set screw, Onan part No. 803-00/1 or cap screw 3/8"-16 x 1/2" with 3/8" copper flat washer. Thread sealer must be used in both applications.

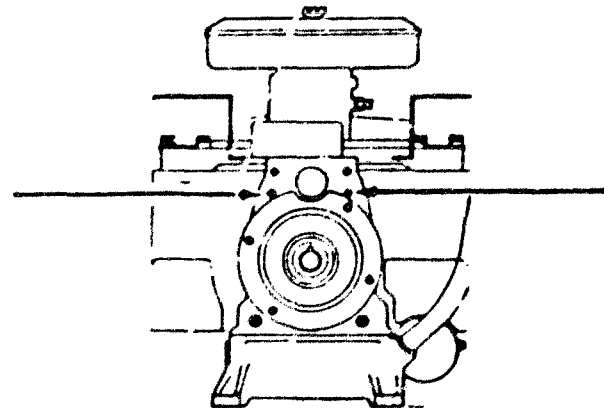
Whenever any of the above engine models are brought in for service with complaints of oil leaking near the rear main bearing plate or oil carryover into the air cleaner, look for plastic plugs in the block just above the rear main bearing plate. Remove the plastic plugs and reinstall an appropriate Allen set screw, Onan part No. 203-0071 or cap screw 3/8" - 16 x 1/2" with 3/8" copper flat washer. Thread sealer must be used in both applications.

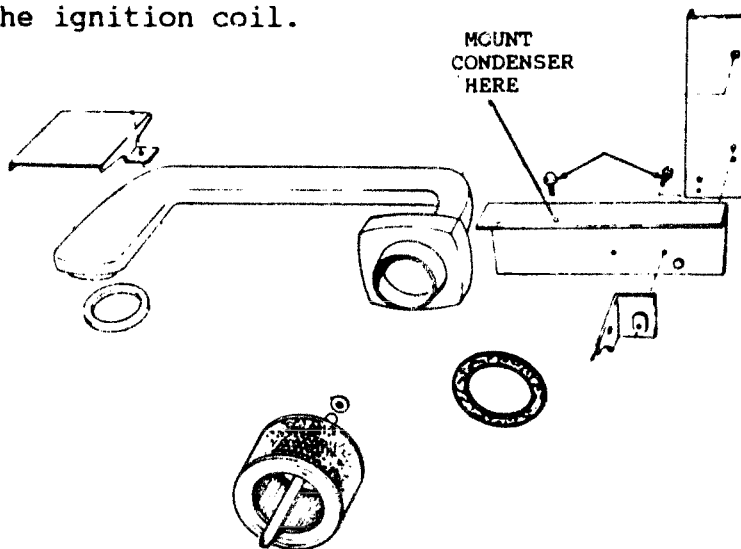
Locating the condenser outside the ignition points and condenser box eliminates the possibility of grounding the condenser lead to the ignition box cover or breaker assembly. Longer condenser life can also be expected because of better cooling.

Effective immediately, Onan is recommending relocation of the ignition condenser on all of its BFA, BGA, NH, and NHL gensets with top-mounted points and condenser boxes. The relocation will move the condenser from the ignition points and condenser box to the top side of the air duct bracket (P/N 140-1529).

Loosen and remove the bolt (P/N 821-0009) from the top side of the air duct bracket closest to the generator end-bell and install the condenser at this location, but reinstalling the (above) bolt to secure the condenser at this point. Be sure to remove enough paint to provide a good ground connection, and connect the condenser lead to the (-) negative side of the ignition coil.

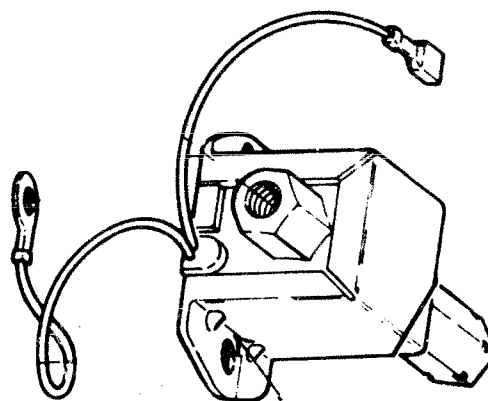
Figure 2

Failure to inspect and make necessary repairs to affected gensets could result in fuel line failure leading to a fire causing property damage with personal injury or death.

Inspect for cracks

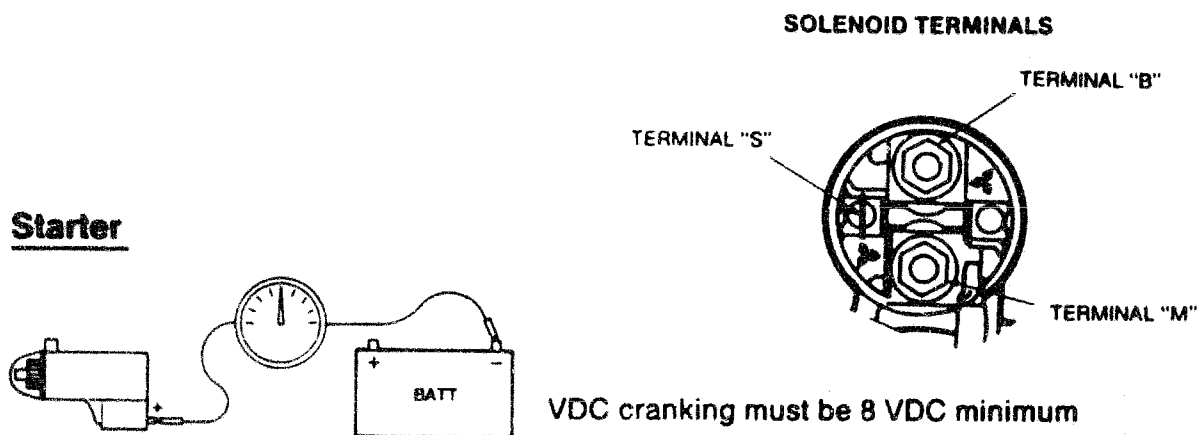
If the engine is experiencing excessive noise while cranking, binding, sticking or premature ring gear wear, this may be caused by several factors. When troubleshooting, check the following:

- * DC voltage at the starter solenoid terminal "S" when cranking. It must be a minimum of 8 volts.

- * Loose starter mounting bolts. Torque must be 19-21 Ft.Lbs. (25-2 N Loosen bolts. Push starter toward flywheel, torque bolt nearest flywheel first, then outboard bolt.
- * Pinion gear backlash to ring gear. Check at several places around ring gear. Backlash target is .008 - .050.

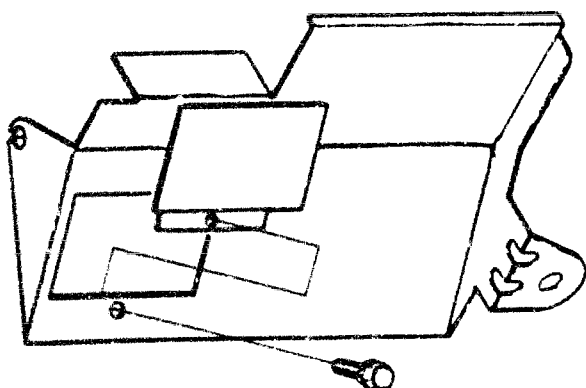
Date: Jan, '86 Page 1 of 1 Bulletin No. 435

Some E125V Spec B engines were built with Spec A cylinder air deflectors. This may cause the throttle linkage to bind or stick which can cause an overspeed condition. The illustration below shows the correct air deflector for Spec B Elite engines.

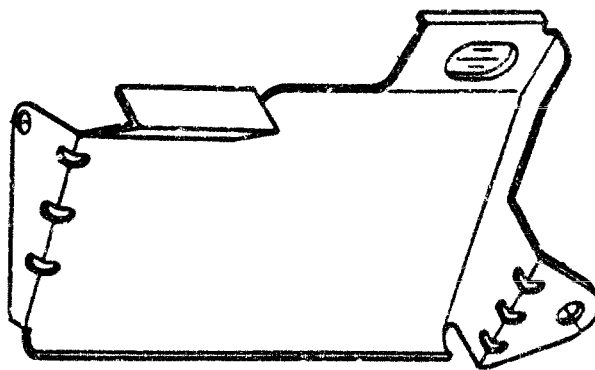
INCORRECT

CORRECT

If the correct air deflector is on the engine, adjust the governor per instructions in the Service manual. If the incorrect deflector is on the engine, order P/N 134-4743-50 and install per the following instructions

1. Slide new deflector under carburetor float assembly and install the two 13mm capscrews. Torque 8-15 Ft.-Lb (11-20 Nm).
2. Install the carburetor float bowl.
3. Remove clamp from fuel line and turn on fuel supply valve at bottom of fuel tank.
4. Check for fuel leaks and verify free movement of throttle linkage.

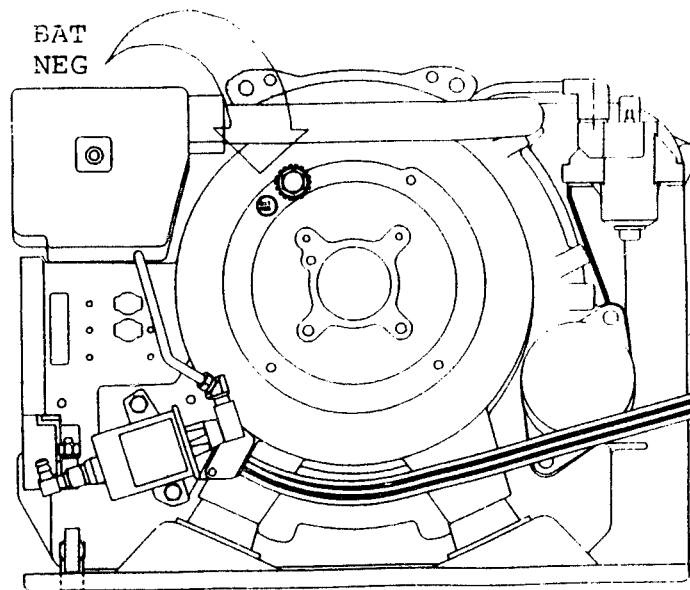
We are changing the recommended location for the battery negative connection on the Emerald and Marquis gensets. The recommended connection point was on the mounting tray at any mounting bolt location. We now supply a bolt and star washer, located on the endbell of the generator, to connect the battery negative cable. This change reduces the chance of poor engine ground connections caused by painted surfaces. We are clearly marking this connection point on all units with the words "Bat Neg" inside a circle.

This drawing depicts an Emerald, but change
is applicable to all listed gensets.

This change is recommended on new installations and where poor grounding is a problem. This change is being implemented now; therefore, all units with serial numbers starting with B92 will include this bolt and star washer.

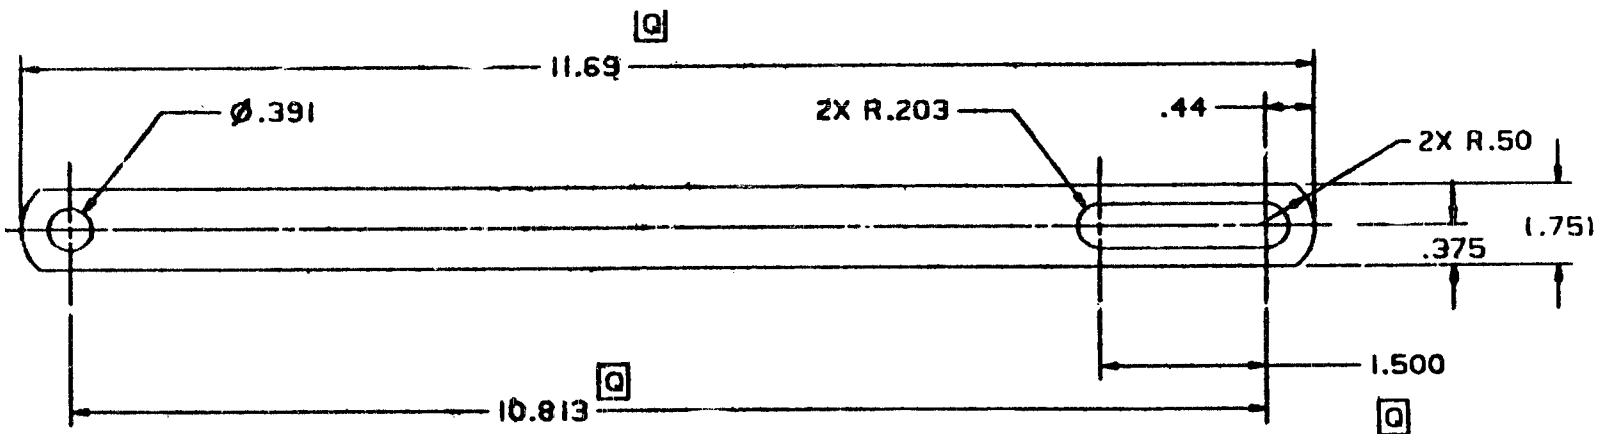
Some bars were found that had the slot on the one end too short. These were removed from production, but some may have gotten into the field. With the short slot, as the power contacts on line open, the interlock bar can hit the emergency side contacts, driving them closed. If you experience that condition, check the dimensions of the mechanical interlock bar against Figure 1 below.

If the slot is found to be too short, replace the bar. The part is 306-3482.

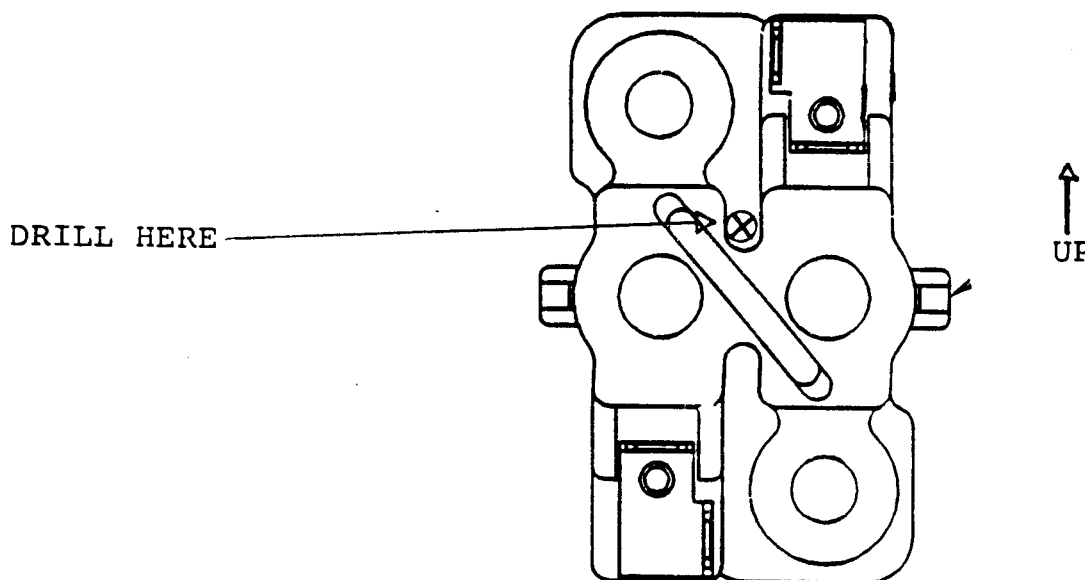
Service Department has received complaints of a lack of ac output in extremely wet conditions. Units experiencing this symptom will run, then die when the 'Start' switch is released, and fail to make AC output. Once the unit is dried out, all functions appear normal.

If you encounter these symptoms, disconnect the battery (negative [-] cable first) and remove the brush cover. Identify the uppermost side of the brush block, and mark it according to the diagram:

Remove the brush block, and drill a $\varnothing 1/8$ " hole through the block at the mark you made. This will allow water to drain, and prevent it from shorting the brush to the block retaining screw.

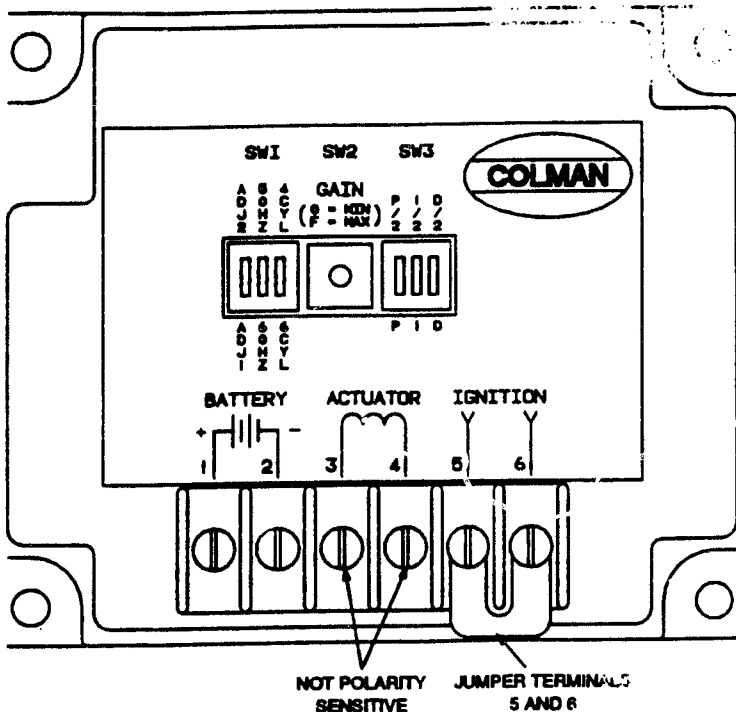
FIGURE 1 GOVERNOR CONTROLLER

If a model 20ES Spec E or beyond experiences an overspeed/overshoot shutdown on start, perform the following adjustments as necessary:

1. Place switch SW3 I in the upward position (Figure 1). This should reduce the level of overshoot on start to half of the original setting. If this does not help, return the switch to its original position and proceed to the following step.
2. Set the overspeed switch adjustment screw (Figure 2) for shutdown between 2500 and 2700 RPM's. If this does not prevent shutdown on start, it may be necessary to replace the governor controller.

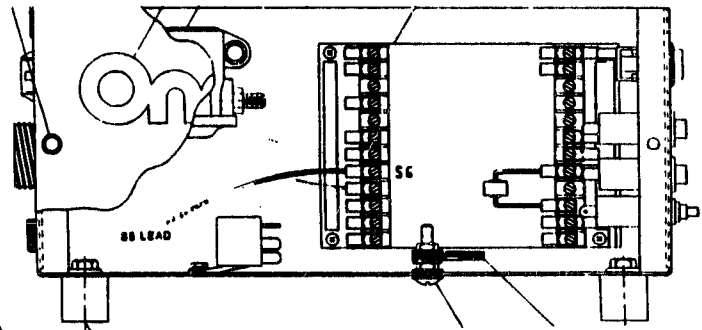
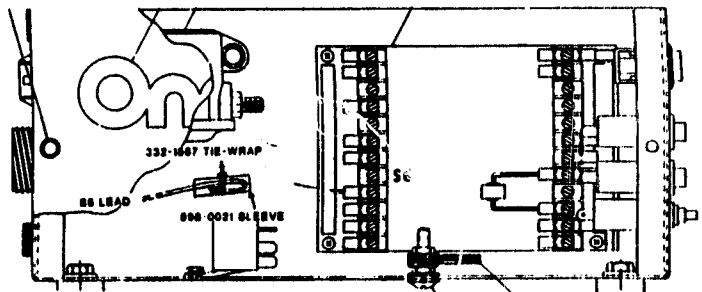
BEFORE

AFTER

- 1) Disconnect the set battery.
- 2) Remove the control cover and locate terminal board A11.
- 3) Loosen the terminal and remove the lead marked 'A11 S6 J2-3' (see drawing, below).
- 4) Insulate the lead using a tie-wrap and sleeving.
- 5) Replace the control cover and reconnect the set battery.
