Product Support Bulletins

May 1974 to September 2000

| | PSB INDEX | | |

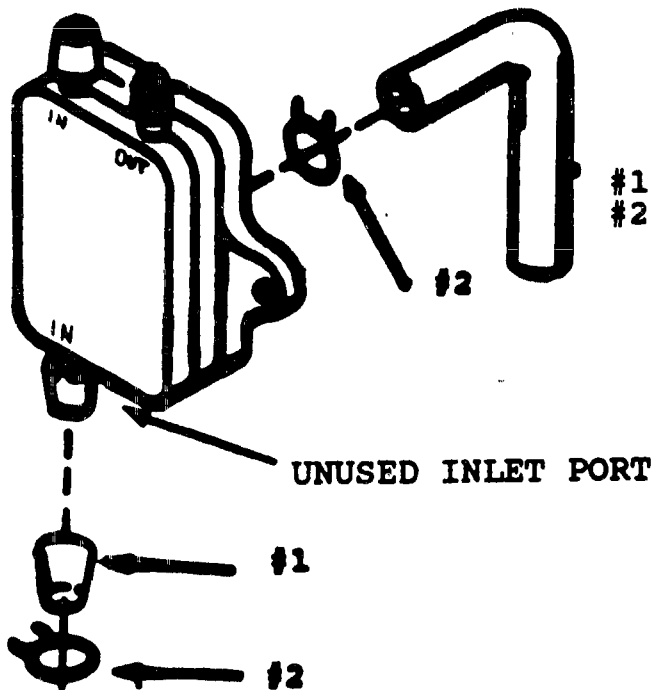
Some Performer P220 engines spec. 10808D installed in an application with the 3 port pulse fuel pump may have a temporary fuel cap installed on the permanently unused inlet port. The permanent fuel cap #149-1321 is heavy duty rubber cap with a clamp retaining it to the unused nipple of the fuel pump. If any equipment is found with the temporary cap still installed it is imperative that it be removed and the permanent cap and clamp be installed.

- #1 Permanent fuel cap # 149-1321
- #2 Hose clamp # 503-0301

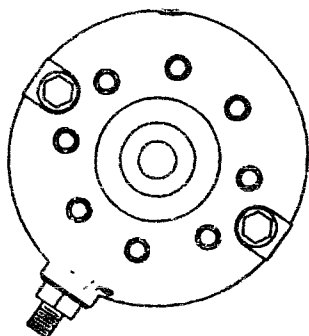
This bulletin is for information purposes only.
Standard warranty applies.

Starter P/N 191-1630 was replaced with 191-2132. This starter should have the four vent holes sealed.

The modified and unmodified starters can easily be distinguished, as seen below:

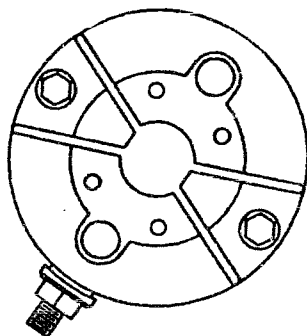
Figure A depicts starter motor (191-1630) and is the version that was used prior to January 1994. Note the design of the starter motor endcap. There is no need to replace this starter motor configuration.

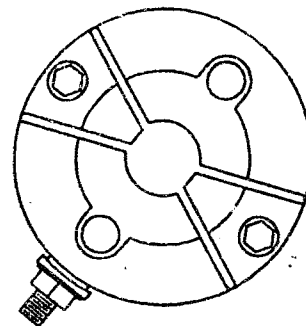
Figure B shows the starter motor (191-2132) which is the topic of this product improvement. Carefully view the starter motor end cap. Observe the four holes closest to the center. If each of these holes is filled with epoxy, no replacement action is necessary. If these four holes are open or filled with paint, then the starter motor should be replaced.

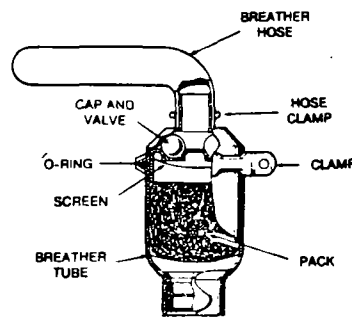
Figure A.

Check the breather system for the correct number of nylon balls (4) in the breather cap and valve assembly (See Figure A).

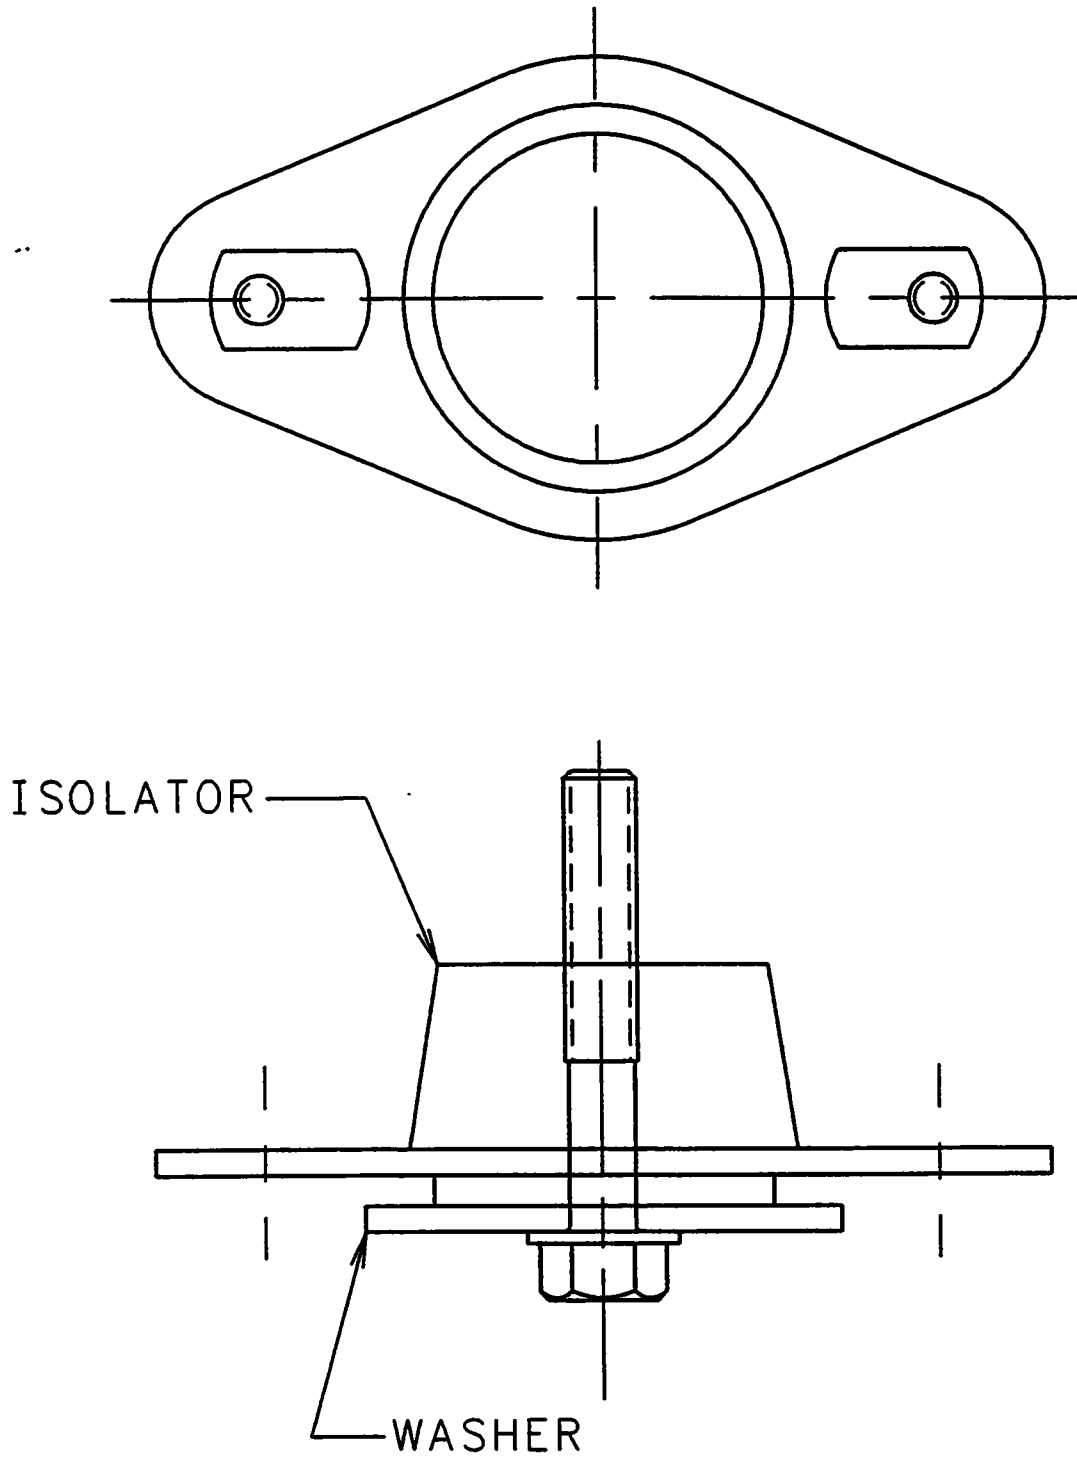
CORRECT CONFIGURATION

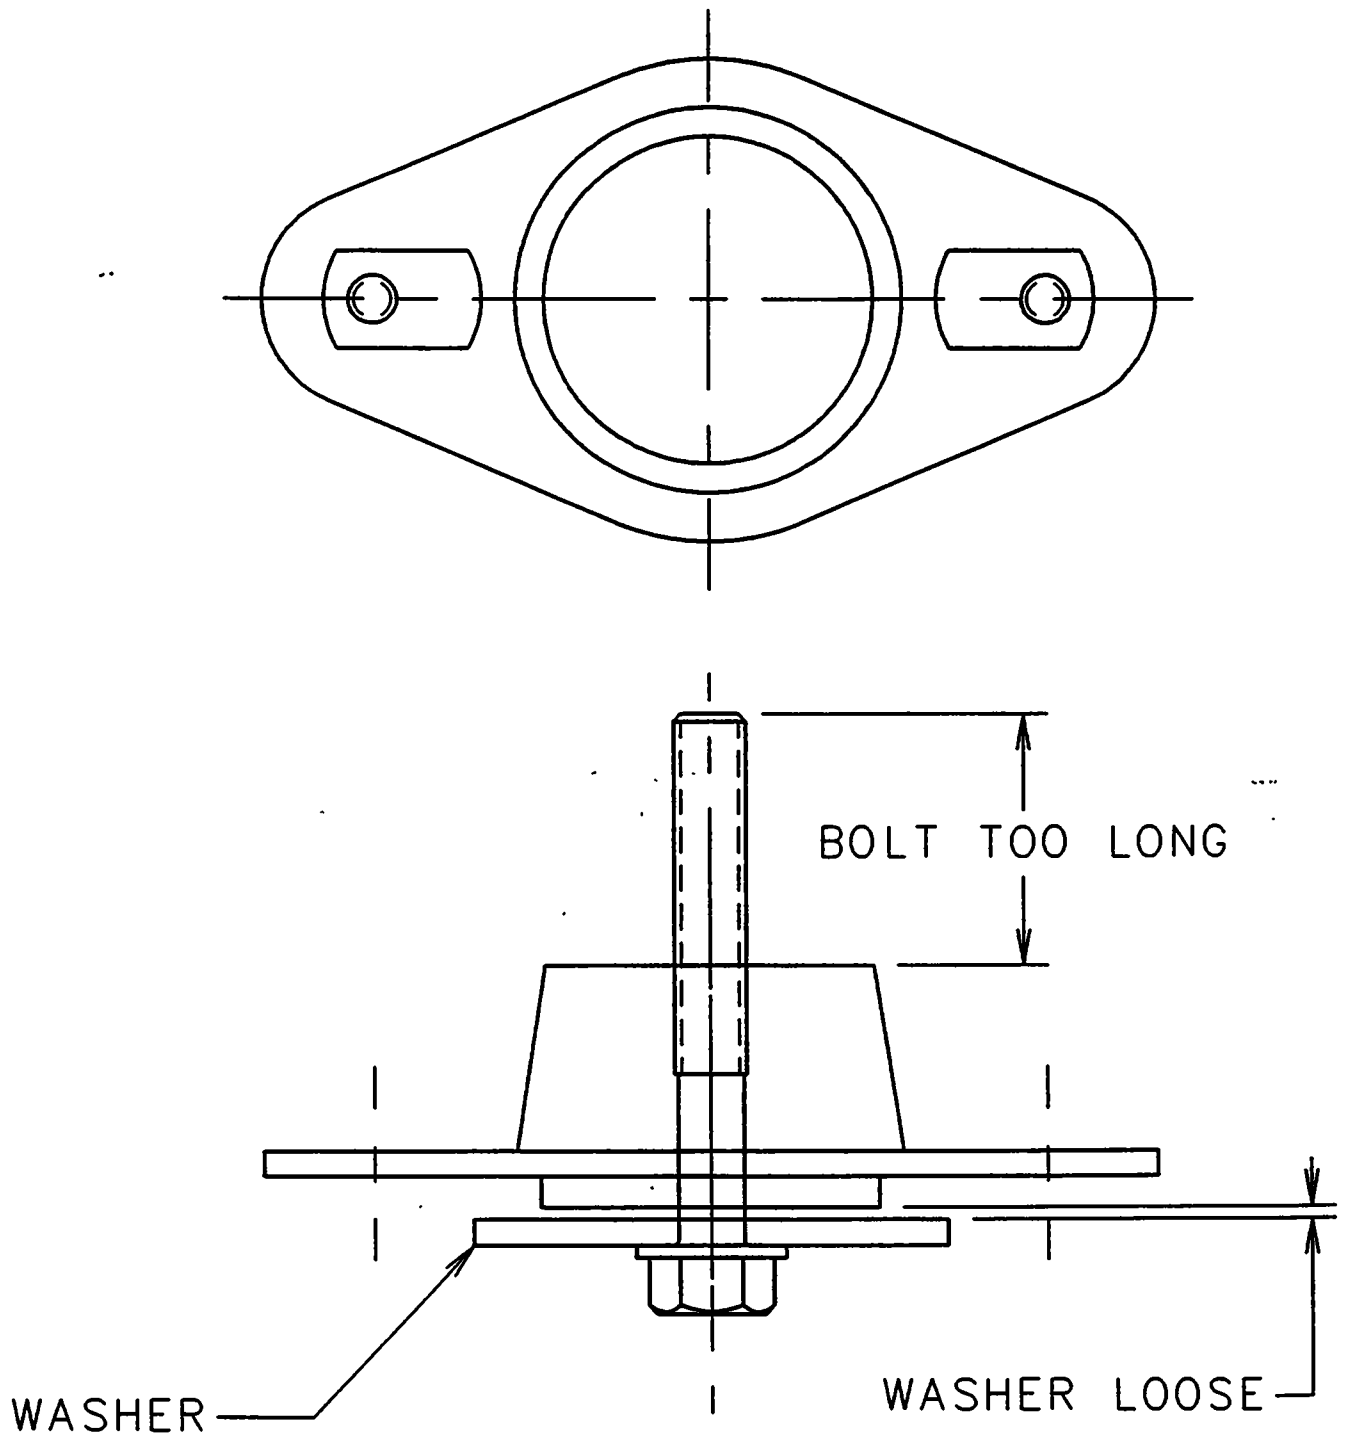
FIGURE 4

Figure 4 - The incorrect RV Emerald mounts with no snubber and the incorrect bolt are installed. This can be detected during inspection if there is a .25" empty gap between the bottom of the 526-0325 washer and the bottom of the generator tray.

INCORRECT CONFIGURATION

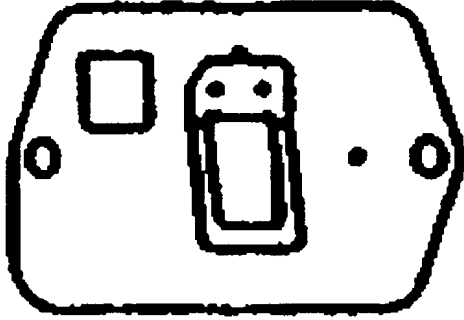
Correct Breather with Hole

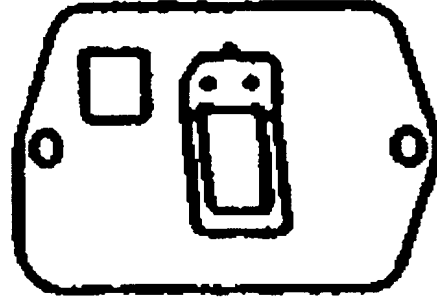
Incorrect Breather Missing Hole

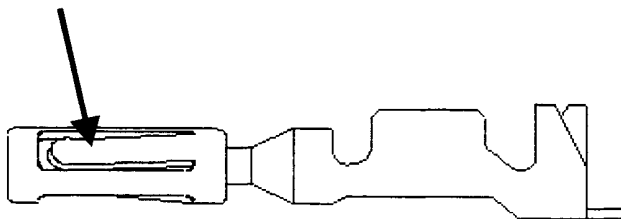
We have discovered that unintentional damage to the inner portion of the pin socket contact can create a secondary problem after the first failure is corrected, or worse, can mislead the technician in the troubleshooting process.

In the example below, a pin socket connector used in the KY and the HGJAA, HGJAB, and the HGJAC series generators, you can see how the wiper portion of the connector is designed to contact the mating pin below the end or entrance of the connector. The damage occurs when the sharp test probes dislodge or spread the wipers and they may not return to their original position. The result is a loss of proper contact which can cause an open or intermittent connection.

Possible solutions might include using the test points of the tester tool #420-0603, use mating pin connector, a pin gauge the same size .045" as the mating control connector pin, or any suitable device that will not damage the inside contact wipers of the pin socket.

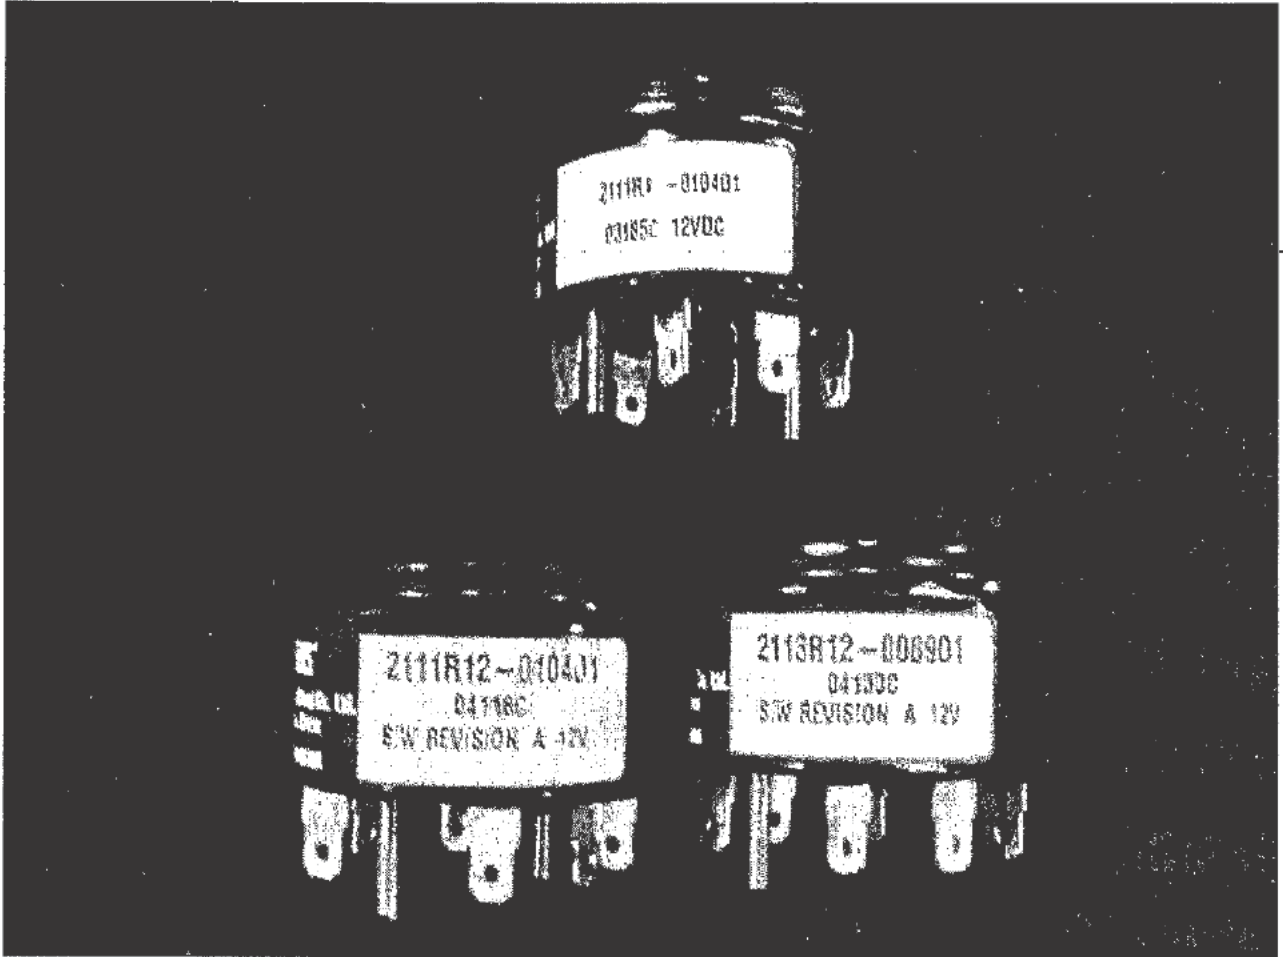
Gauge functionality effects operation of the microprocessor control. The gauges will function and read normally however the genset oil pressure and water temperature faults will not function as designed. If the incorrect gauges are connected to the circuit the genset will not shutdown if an oil pressure or water temperature fault condition should occur.

“Revision A” gauge identification versus original gauge identification

If the above incompatibility is identified you must replace the genset controller. Use the following controls for replacement.

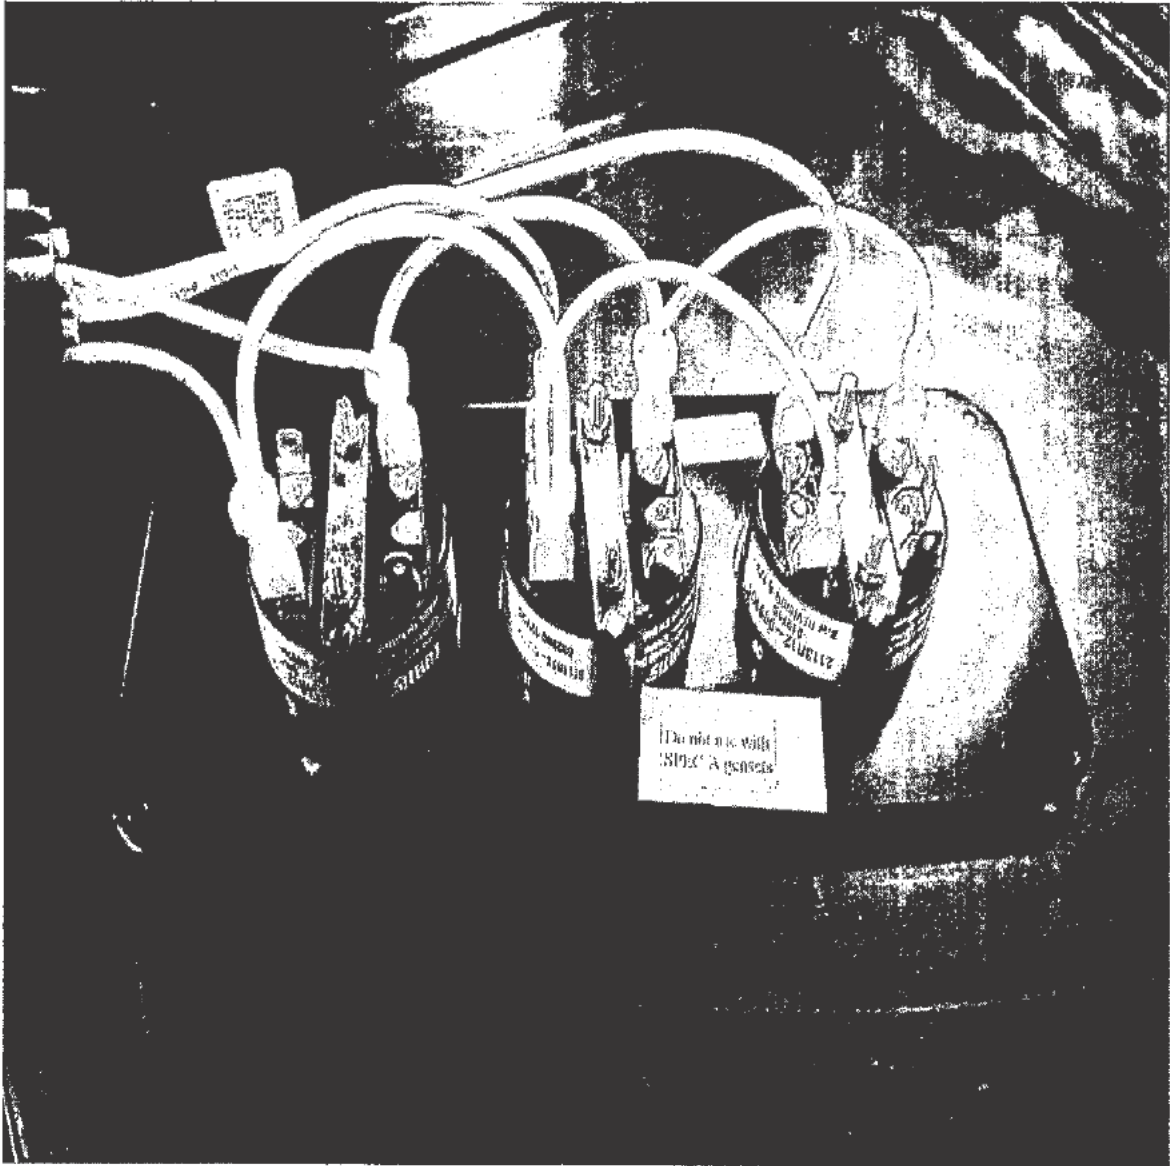
“Do not use with Spec A” label on remote panel accessory

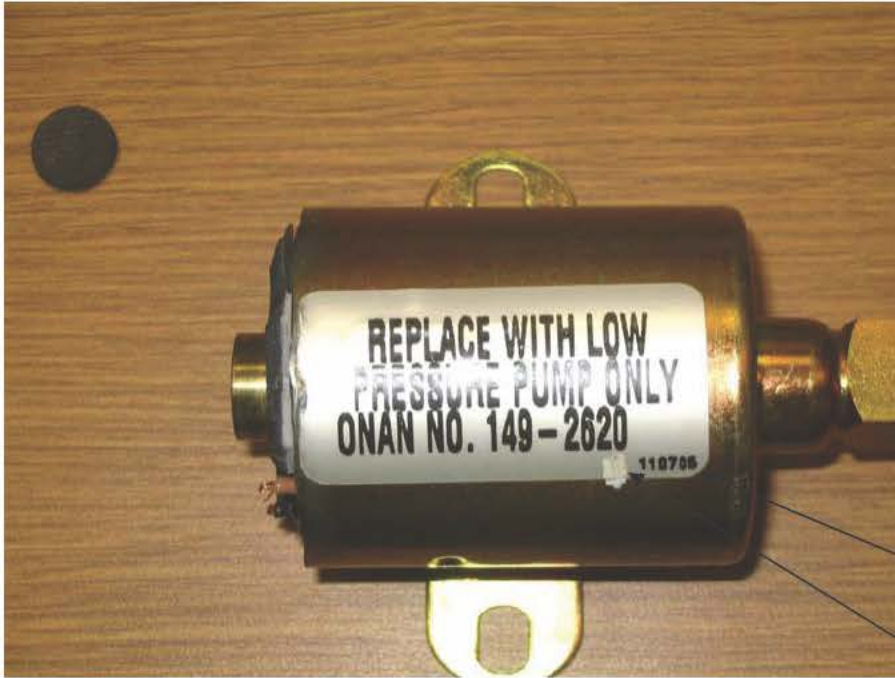
Date Code
DDMMYY

White Dot Location

- disconnect the fuel line at the carburetor
- remove fuel pump mounting hardware
- pull fuel pump with fuel lines attached down about 4in. for easy access to clamps
- remove old pump from fuel lines and install the new pump.
- Reattach fuel line to carburetor and reinstall pump mounting hardware.

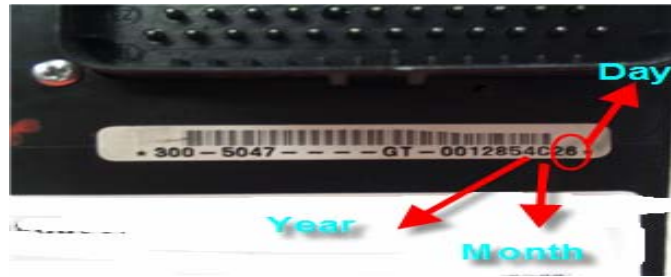
In the example above, the control board was manufactured on March 26, 2004 and would NOT be compatible with InPower Onan. (A generator built before January 2005 has a compatible control if the 4th character from the end has a digit that is 5 or higher. xxx – xxxx - - - - XX – xxxxxx7xxx. In this example the control was built in 2007)

c. DO NOT replace control boards just so it will operate with InPower Onan unless you are doing it at YOUR expense.
