Product Support Bulletins

May 1974 to September 2000

MBB

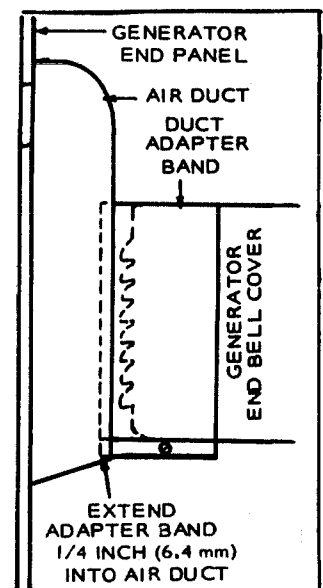
FIGURE 1.

Under extremely - abnormal operating conditions the emergency Relay (part #320-0104) being a thermo-activated device, can nuisance trip!

The addition of a new Duct Adapter Band (part #405-2209 for the MDJB and MDJE models and part #405-1536 for the MDJC and MDJF models) will lower the operating temperatures which caused nuisance tripping of the emergency relay.

Adjust the duct adapter band so it extends 1/4" (6.4 mm) into air duct. See Figure 1. Tighten adapter band.

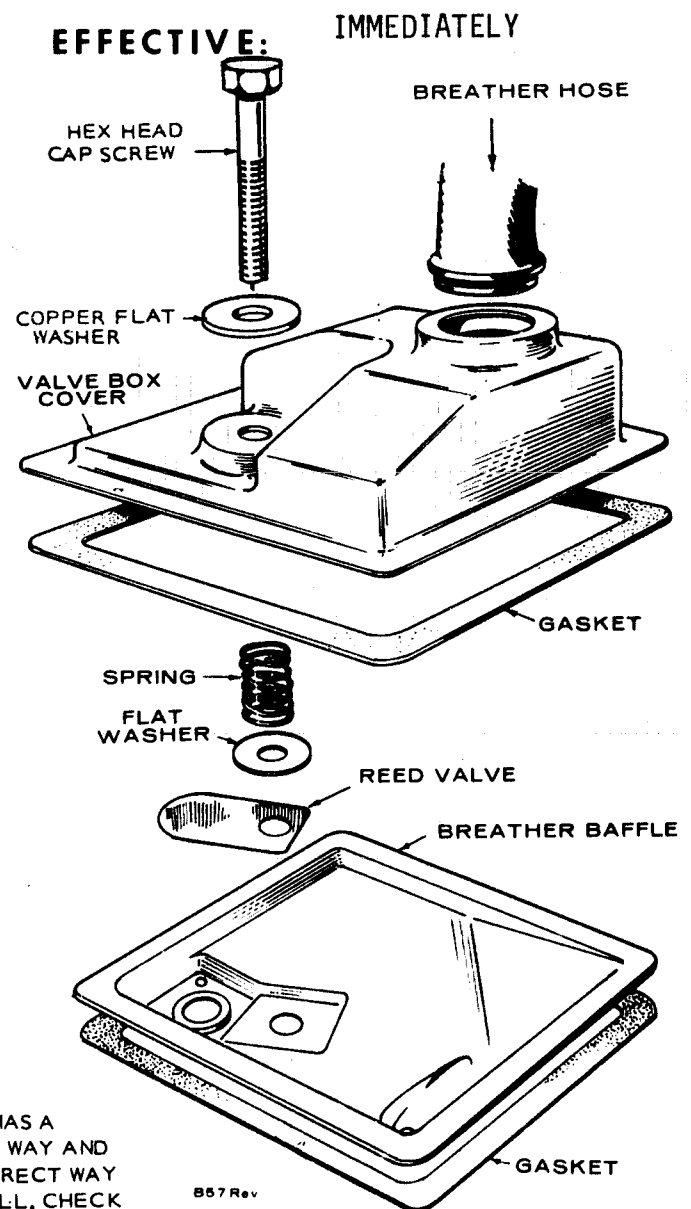
GASKET HAS A
CORRECT WAY AND
AN INCORRECT WAY
TO INSTALL, CHECK
CLOSELY FOR PROPER
FIT!

The breather should be assembled as shown in illustration.

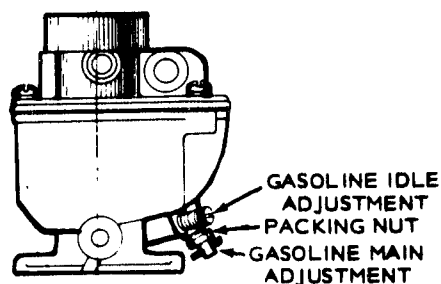
CCK, CCKA, NHA, NHB and BF (RV)
Carburetor Adjustment

This packing nut should be tight enough so that main jet adjustment cannot be turned with adjustment tool. A loose packing nut may cause excessive air draw and rough engine operation. Fuel leakage may show up as a complaint that the unit is hard to start after not being operated for a number of hours.

Refer to typical carburetor illustrations below. This bulletin is for informational purposes.

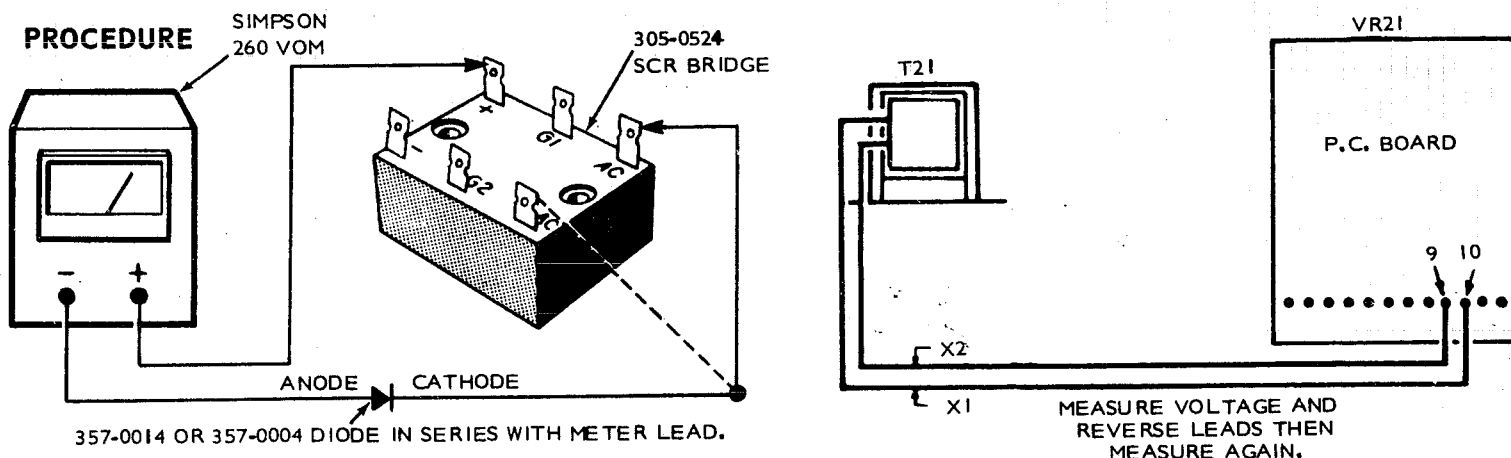
Non-symmetrical firing of the SCR's could result in premature bridge failure.

It is recommended that firing symmetry be established whenever servicing an applicable "UR" or "YB" type generator. Use the following procedure and refer to the illustration below:

1. Use a Simpson 260 meter set on the 2.5 volt DC (+) positive scale. (If a different meter is used, start on a higher DC positive scale.)
2. Connect positive (+) meter lead to the plus (+) terminal on the 305-0524 module.
3. Connect negative (-) meter lead to the Anode of a diode. Onan Part #357-0014 or #357-0004.
4. Connect cathode end of diode to AC 1 terminal of SCR module. Record reading. (See illustration above.)
5. Connect cathode end of diode to AC 2 terminal of SCR module. Record reading again.
6. Stop engine. Reverse the secondary leads (X1 & X2) of the voltage reference transformer T21, (315-0342) at positions 9 & 10 on the voltage regulator board (332-1268) or (322-1704).

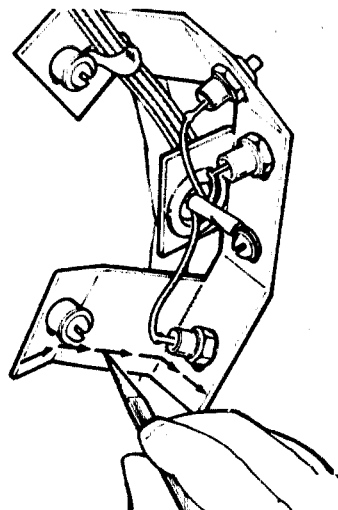
Whenever servicing any of the above models for any reason, check the rotating diode heat sinks for a structural condition. All parts stock must be checked and replacement heat sinks should be taken on service calls.

If the heat sink assemblies have SHARP bends instead of a smooth surface at the bends, they MUST be replaced. The condition of the bend can be determined by moving a pencil or small

screwdriver across the bends shown on the illustration. If movement ACROSS the bend is smooth, do not replace the heat sink. If the movement is not smooth, remove and replace the heat sink.

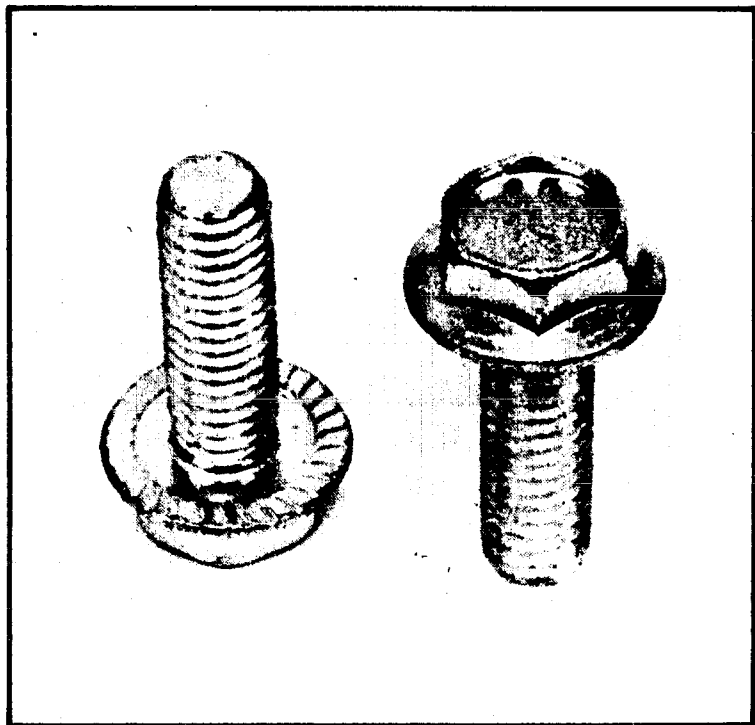
FIG. 1

On July 6, 1976, Onan initiated a field fix campaign on "MCCK" generator sets with certain engine exhaust manifold bolts that could, under certain conditions, shear, breaking the integrity of the exhaust system and allow carbon monoxide to be emitted into the living environment of the craft.

The illustrations on page 2 of this bulletin show the manifold bolts effected and the replacement manifold bolts required to correct any problem units.

**REMOVE THESE
SELF LOCKING
CAP SCREW**

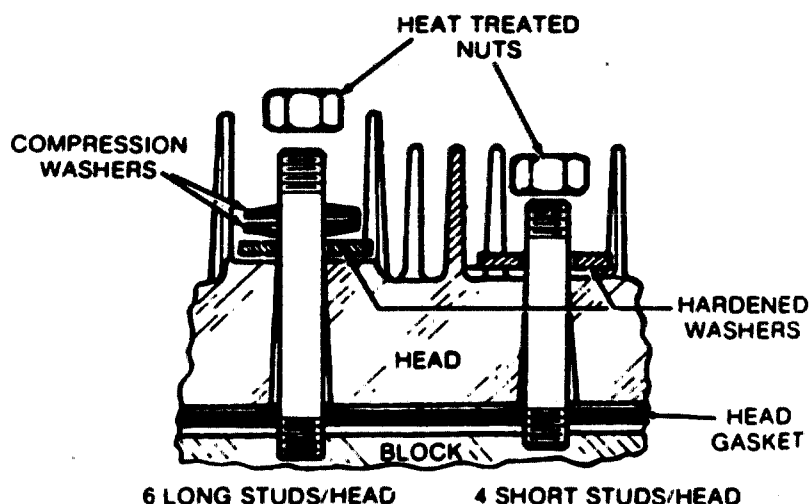
Figure 2. Cylinder Head with
Compression Washers.

*All industrial N52M-GA019.9 engines are fitted with two compression washers on the upper 6 (#'s 9, 7, 5, 3, 2 and 1) cylinder head bolts. See illustrations below for clarification. These washers must be in place to maintain stud retention. When these washers are used, torque in three 5 ft. lb. (7 N•M) steps to 13-15 ft. lb. (18-20 N•M).

Exercise caution to avoid over-torquing these cylinder head nuts as this can result in severe engine damage.

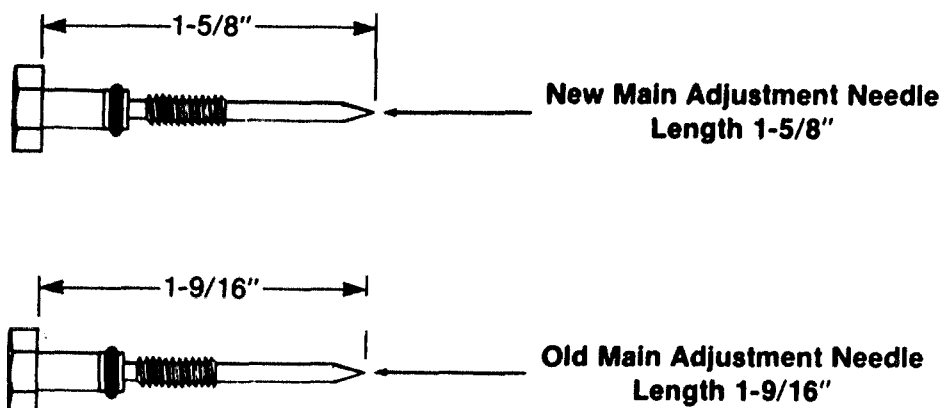
If you receive complaints on difficulty in getting proper adjustment of the main jet assembly, check the needle length dimension and replace it with the longer length new needle.

The old main adjustment needle length was 1-9/16". The new main adjustment needle length is 1-5/8". See ILLUSTRATION below.

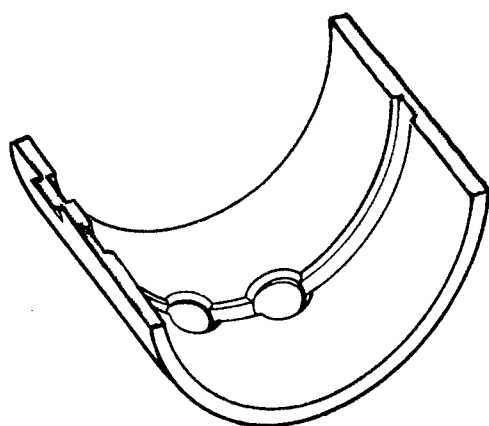
Product Support Bulletin

INSPECT MATING SURFACE
FOR FLAT SMOOTH FINISH

Check your service parts stock and return any non-machined bearings to Onan for credit. Standard spare parts warranty will apply on defective bearings.

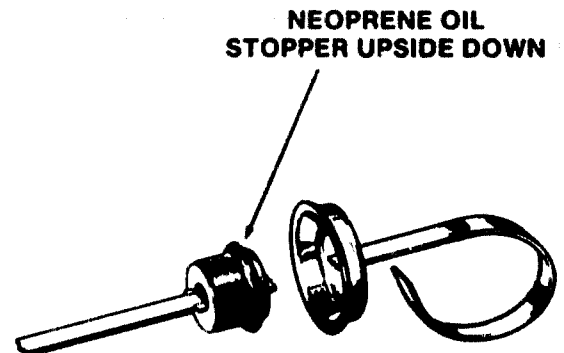
DEFECTIVE OIL LEVEL
INDICATOR

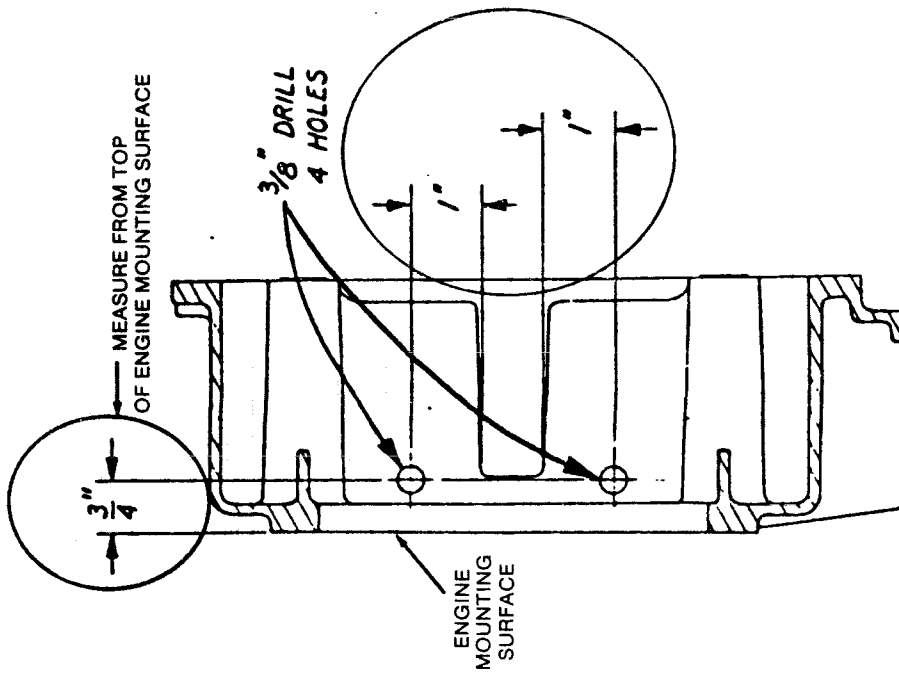
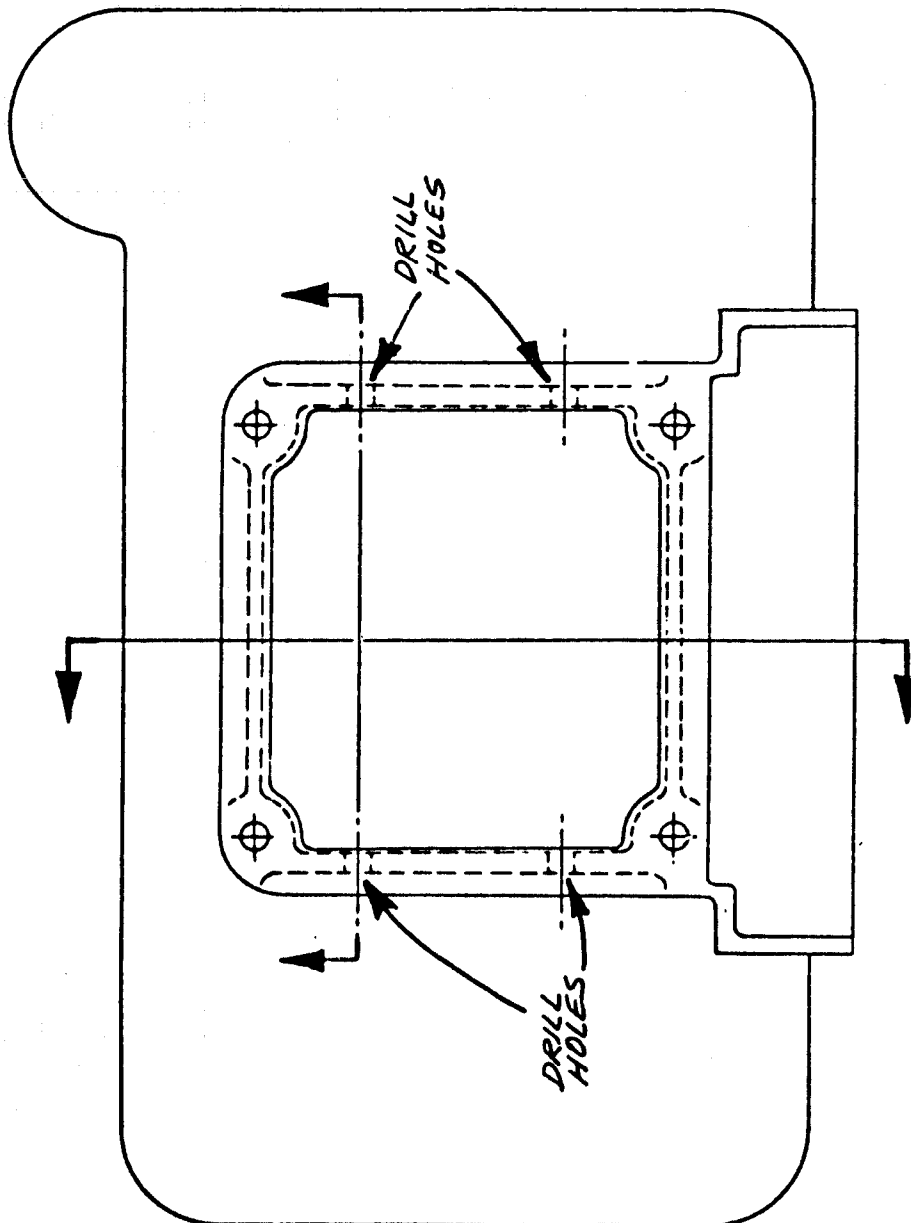
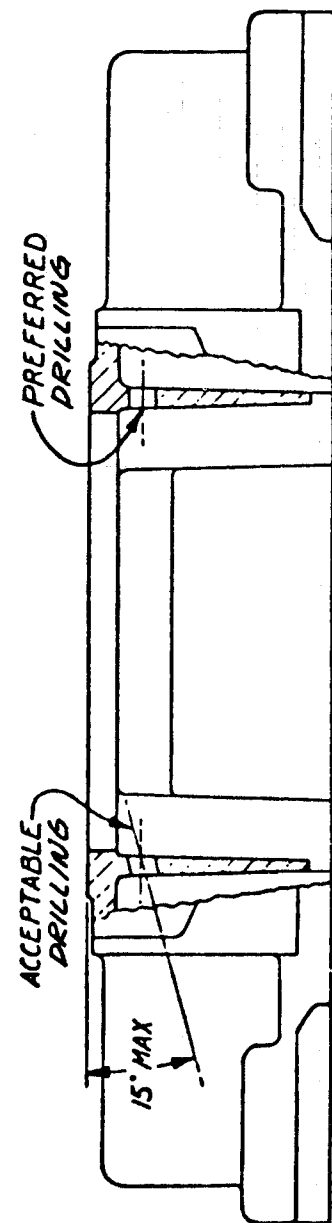
CAUSE: The sets shut down because the LOPKO (Low Oil Pressure Cut Out) opens due to a momentary loss of engine oil pressure. The reason for the momentary loss of oil pressure is that oil is NOT being returned to the center oil base cavity fast enough.

REPAIR: The oil base must be removed from the engine. Do NOT remove the sheet metal pan from the oil base. Drill four 3/8 inch diameter holes in the baffle plates per diagram shown on Page 2 of this Bulletin.

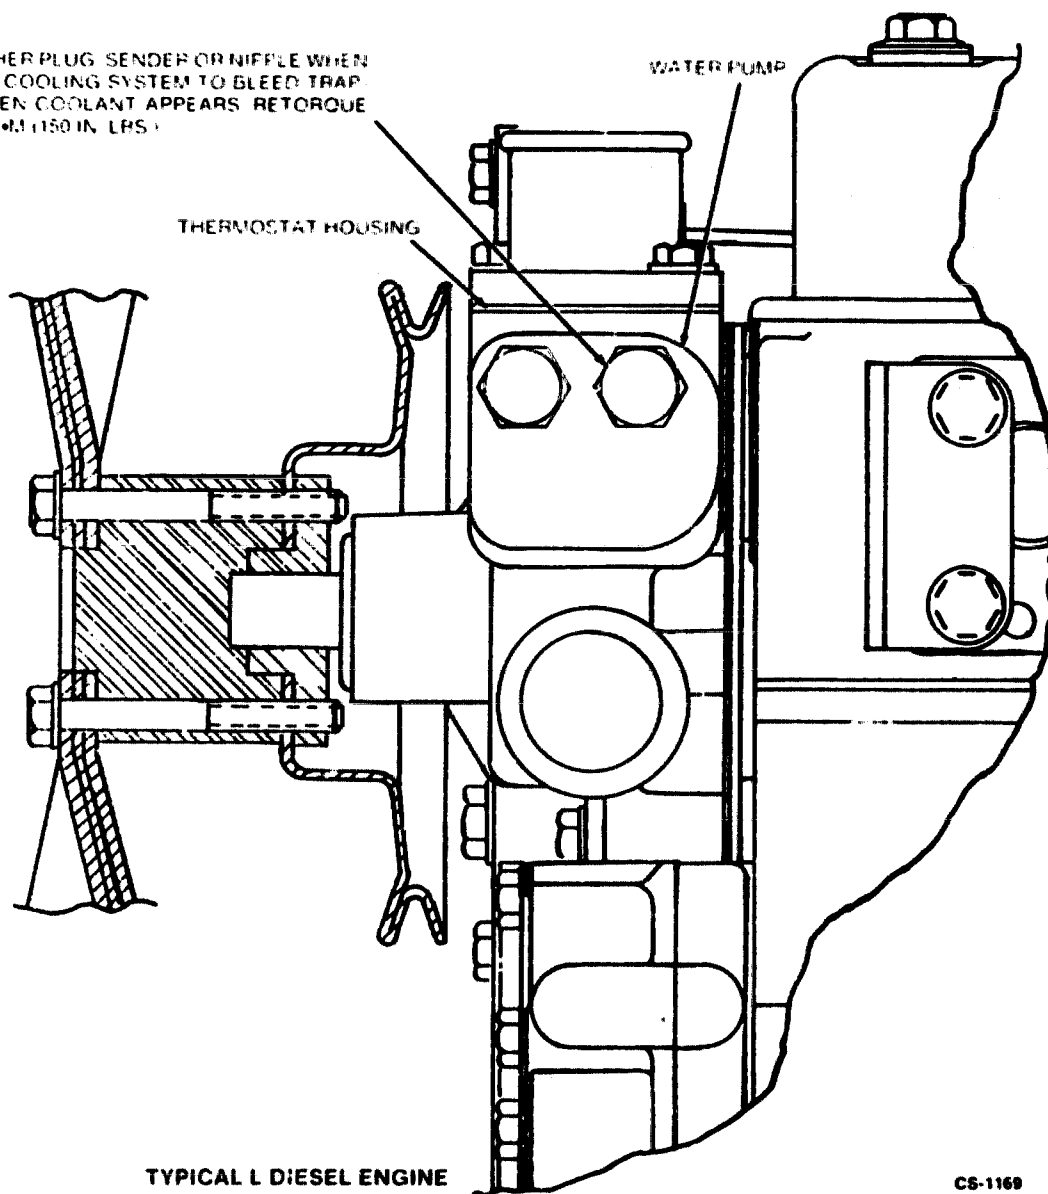
TYPICAL L DIESEL ENGINE

To bleed off any trapped air in the cylinder head and block, loosen either one of the plugs on the water pump located near the thermostat housing as shown in the illustration on page 2. Fill radiator with proper mixture of ethylene glycol anti-freeze and water (for protection at coldest expected ambient temperature) until coolant bubbles out at loose plug on water pump.

LOOSEN EITHER PLUG, SENDER OR NIPPLE WHEN
FILLING THE COOLING SYSTEM TO BLEED TRAP-
PED AIR. WHEN COOLANT APPEARS, RETORQUE
PLUG TO 17N•M (150 IN. LBS.)

Retorque plug on water pump to 17N·M (150 in. lbs.) Do NOT overtorque or pump housing may crack. Continue filling radiator until coolant level is approximately one inch below the bottom of the radiator filler neck.

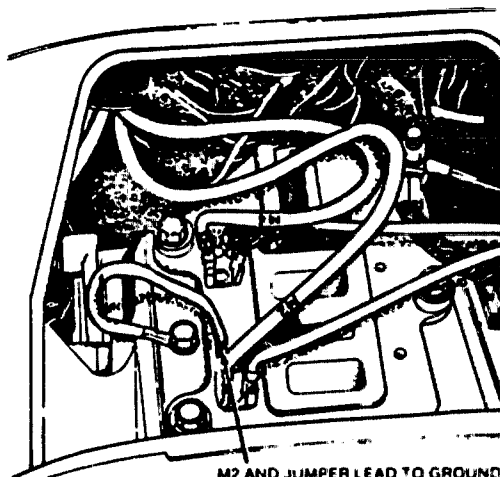
FIGURE 1. M2 PROPERLY GROUNDED

It is possible that the M4 generator lead may be grounded in addition to M2 if the jumper lead is connected as shown in Figure 2 (generator end top view). If M4 is grounded, this will cause a direct short in any 240 volt application. If only the 120 volt output is being used, the problem would not show up in normal operation of the generator set. M4 should NOT be grounded.

Whenever servicing any of the above models, check the AC brush block connections (M2 and M4) to be sure the ground lead jumper is on M2 and NOT M4.

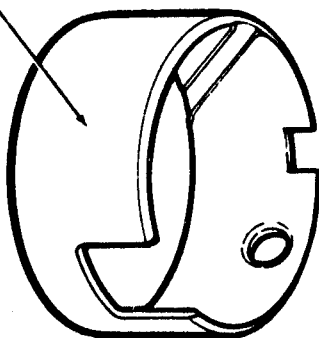
FIGURE 1. 101-0391 PRODUCTION BEARING

A few parts orders were received recently for the 101-0391 camshaft bearing. This bearing should NOT be used as a replacement part. It is a semi-finished bearing used by Onan manufacturing ONLY. It must be line reamed to the correct Inside Diameter for the application to be usable.

The dimensional differences are illustrated and the bearings identified in the two figures below. Figure 1 is the 101-0391 production bearing which should NOT be used as a replacement part. Figure 2 is the 101-0405 replacement bearing.

The 101-0405 bearing must be used as a replacement part in above applications.

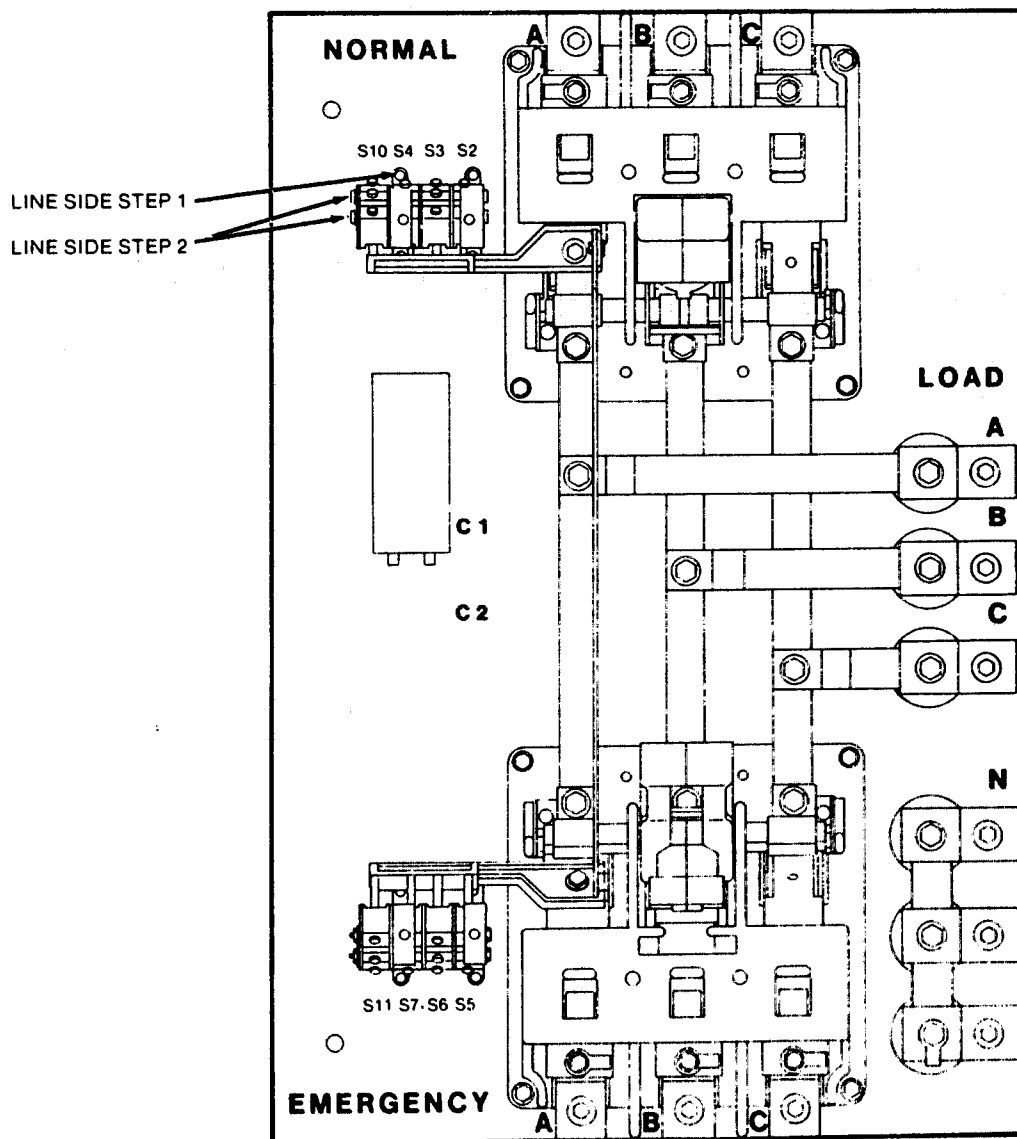
FIGURE 1. Original Transfer Switch Microswitch Configuration

Because of the force required to actuate the microswitches in their present location, it is possible that the microswitch actuating arm can be flexed so that the switch will fail to actuate. If this occurs, the microswitch must be physically relocated from the outside position(i e S10)to the inside position(i e S2).

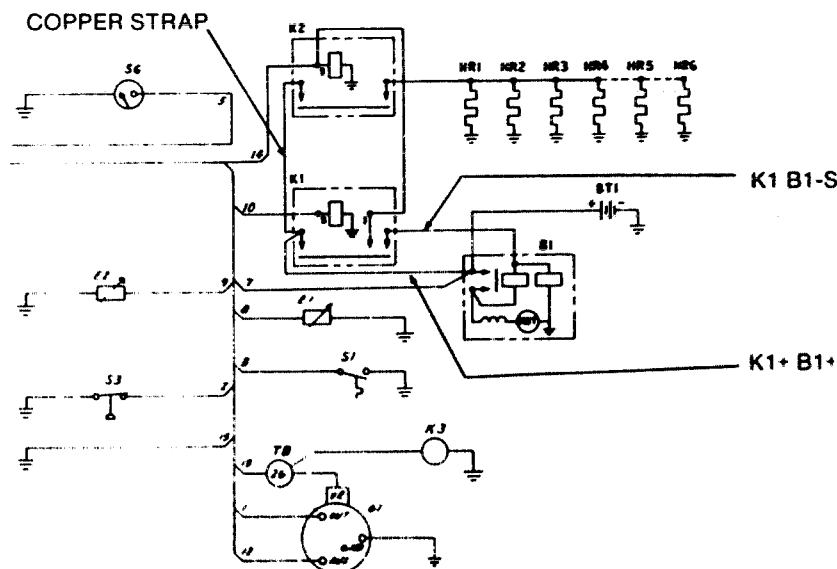
Correct Wiring Connections

When performing an initial start-up or if a customer complains about slow or erratic starting, check the wiring to the K1 starter pilot solenoid. The larger wire (K1+ to B1+) MUST go to the side of the solenoid that is common to the heater solenoid (side with the copper strap connecting K1 and K2 contacts together). The smaller gauge wire (K1 to B1-S) goes to the side of the solenoid without the copper strap. Refer to the wiring diagram below for proper connections.

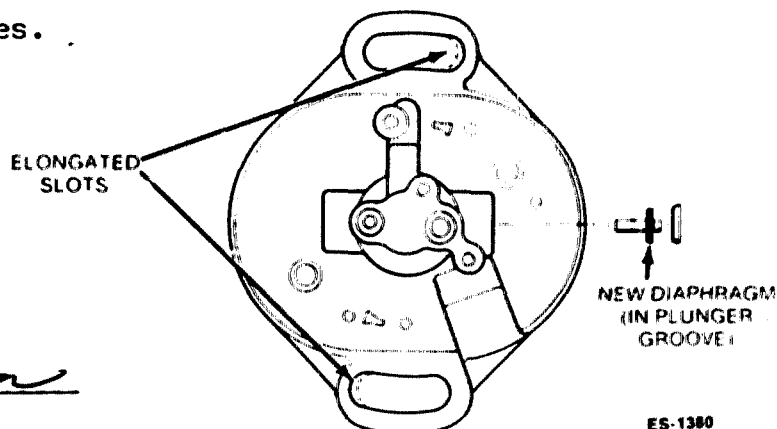
IGNITION BREAKER PLATE

Field reports indicate the possibility of ignition point diaphragm(160-0718) "stiffening" in colder ambients. This causes restricted ignition breaker plunger movement resulting in difficult or NO starting. This diaphragm may also deteriorate from exposure to heat and oil.

Diaphragm replacement requires removal of diaphragm cup, diaphragm and plunger. Use caution when removing diaphragm cup. If damaged, replace diaphragm cup(160-0717). During assembly of new diaphragm, place diaphragm over plunger before installing in breaker plate. Refer to Engine Master Service Manual(922-0501), Section 10, Page 10-33 for replacement illustration and procedures. The correct ignition point setting is .020 inch(0.51mm) on all models.

Production units are using the new RED plunger diaphragm and breaker plate with elongated timing adjustment slots. Onan Parts stock has been purged of the obsolete(black)plunger diaphragm.

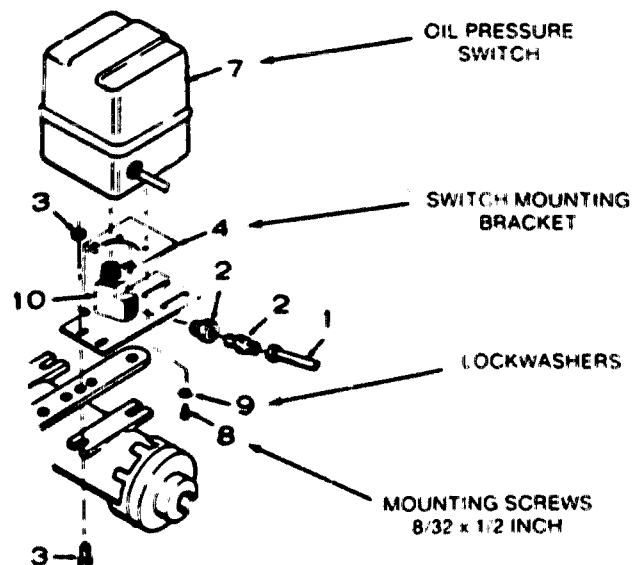
Some recent production sets with Kim tank heaters in the configuration shown below were built with improper hardware. The mounting screws shown below (Item 8) were inadvertently called out as an 8/32 x 5/8 inch screw. These screws were too long and will cause the oil pressure switch to remain open, leaving the heater in an "off" position.

If the tank heater fails to operate properly on any new installations during start-up, remove the screws (Item 8) and check for proper length. Replace as required.

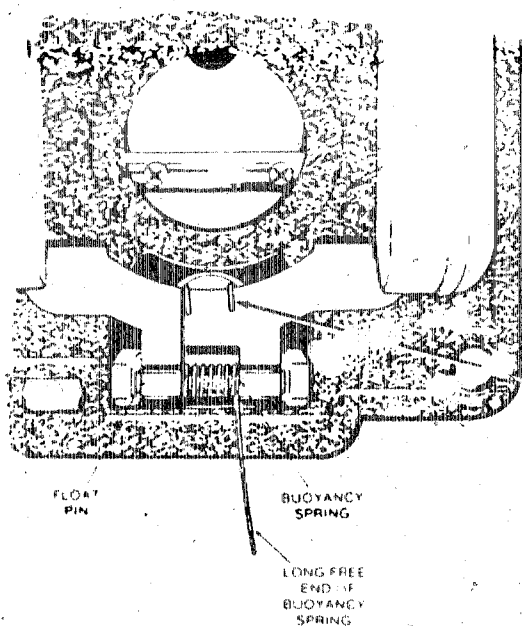
Fig. 1
Incorrect

Instruction Sheet #292, Figure #1, has the float needle valve retaining clip illustrated incorrectly. Instruction Sheet #292a, Figure #2, has the needle valve retaining clip illustrated correctly.

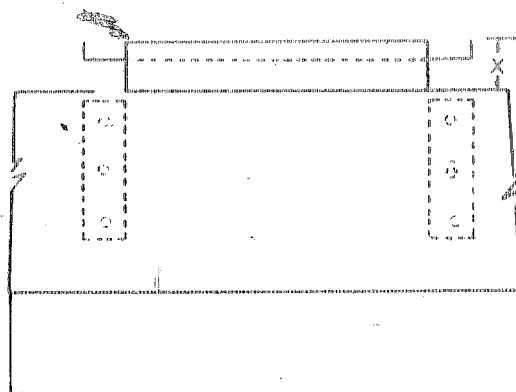
Early versions of the L powered TechStar generator sets equipped with a housing may have an interference problem between the housing door and the skid mounted battery rack. This interference makes it difficult to install the housing door.

X = 2 1/4" Old Style

X = 3 3/8" New Style

The battery rack 416-0847 has been increased in height to eliminate this interference and allow the door to be installed easier. The difference between the early version of the battery rack and the new battery rack is illustrated below.

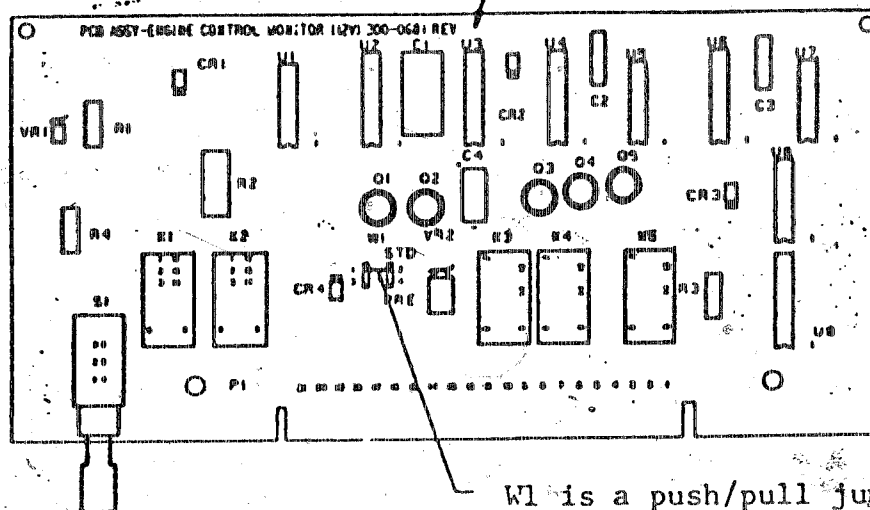
When installing new engine monitor boards with the above revision letters and later on units with pre-alarms, it will be necessary to move W1 from the STD position to the PRE position. (See figure). Failure to move W1 will result in an engine shut-down when a pre-alarm exists.

W1 is a push/pull jumper bar.

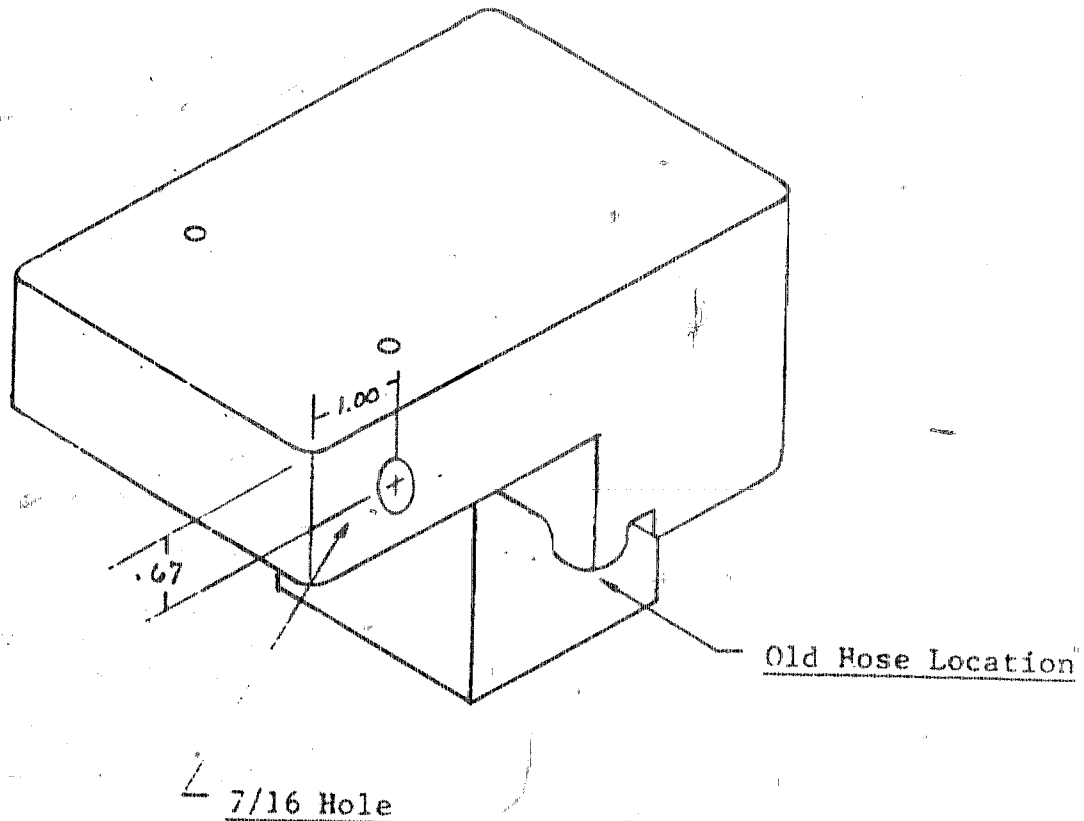
Recent reports of oil in the breaker box have been determined to be the result of a sharp bend in the breather hose. If you should experience this, check the breather hose for a sharp bend or kink.

The correction is to shorten the hose from 12" to 9-1/2" and relocating it as shown below. Insert approximately 1" of the hose into the new hole. It is not necessary to plug the old hole.

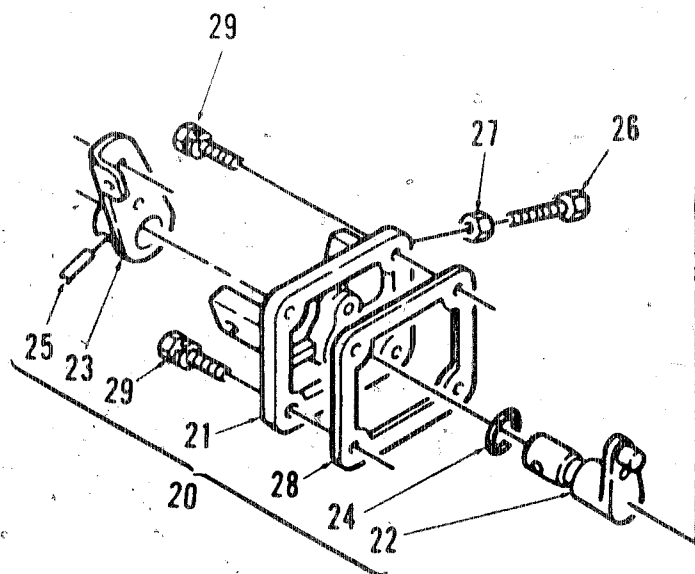
Fig. 1

Should corrosion be evident, replace the injection pump cover assembly (Item 20). New pump cover assemblies have a stainless steel shaft instead of cast iron shafts (Item 22). Consult the Parts Book for the correct part number.

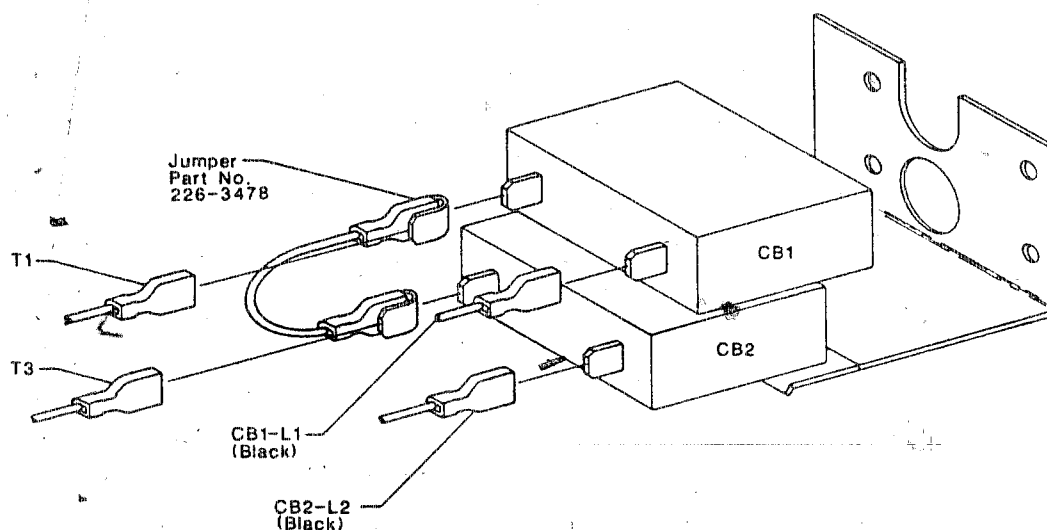
Onan has received complaints from the field that (Emerald III) gensets may have trouble starting air conditioners in hot weather. Symptoms include low voltage, air conditioners not operating properly, and tripping of load breakers.

This jumper lead should be connected across the input side of CB1 and CB2 (see Fig. 1).

This jumper will be added to factory built units starting with serial number 822017, in an effort to eliminate a potential problem.

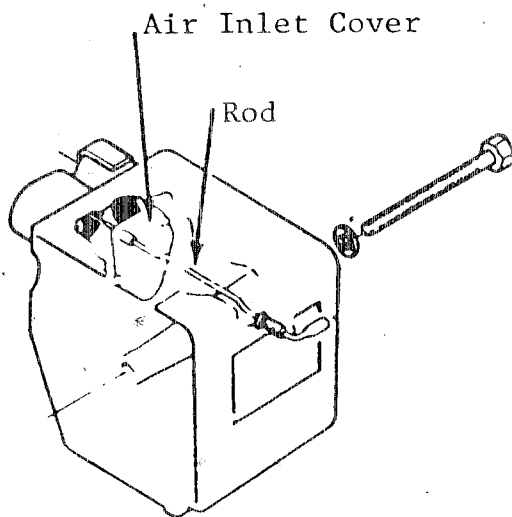
FIG. 1

Service Department has received complaints from the field of surging and overspeed conditions in Emerald RV gensets. These problems have been linked to carburetor icing which can occur under certain atmospheric conditions. To reduce the chances of carburetor icing, a change was made to the air inlet cover and rod, located in the air cleaner box (See Figure 1). The new style cover and rod can be identified by the revision letter (D) stamped on the inside of the inlet cover (See Figure 2).

When servicing an Emerald genset which exhibits the symptoms of surging or overspeeding, remove the air cleaner and check the revision letter on the inside of the air inlet cover. Any genset with revision (C) or earlier cover and rod, should be updated to revision (D) parts.

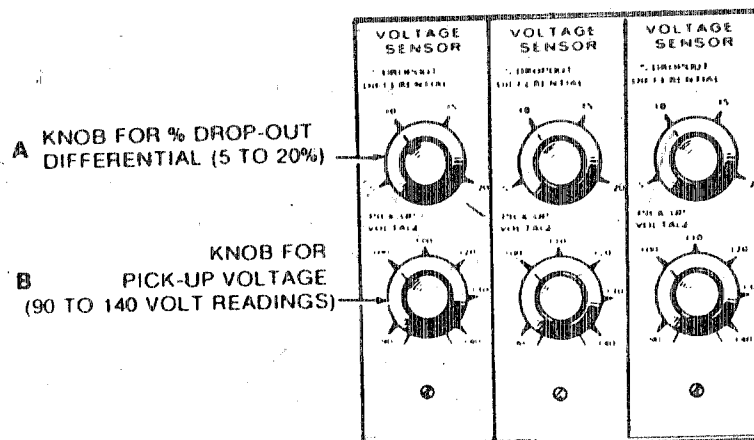
It was written due to the high percentage of relay-type voltage sensors being returned under warranty which operate properly. We believe the cause may be related to an improper calibration procedure/technique being used.

The board may not and was not designed to pickup and dropout by turning the calibration screw back and forth while at various % Dropout Differential Knob (A) settings. The proper method for distinguishing between pickup and dropout is to set the % Dropout Differential Knob (A) at 5% and then turn the Pickup Voltage Knob (B) back and forth while observing and hearing the difference.

When calibrating the Pickup Voltage (Knob B, see diagram), set the % Dropout Differential Knob (A) at 5%. Then turn the Pickup Voltage Knob (B) fully clockwise until the K-3 relay drops out (and/or the LED on the voltage sensor goes out). Continue the calibration procedure per the operator's manual by rotating the Pickup Voltage Knob (B) slowly counterclockwise and the calibration screw (if needed) slowly in the appropriate direction.

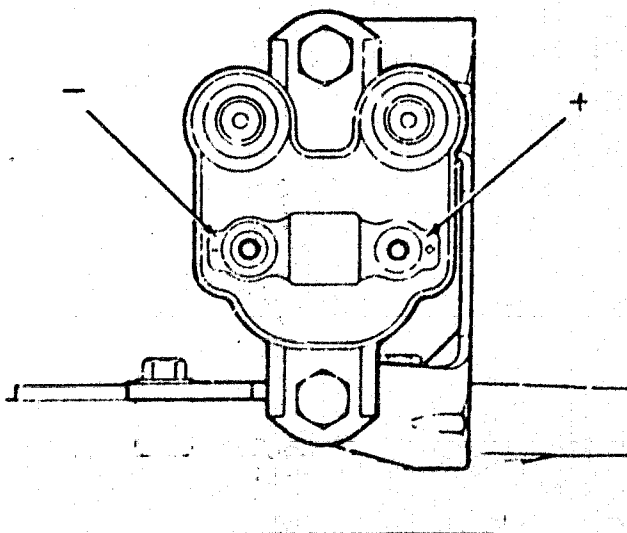
New Coil Assembly Orientation
Part #166-0787

CAUTION: Permanent Ignition Module damage could result if the Ignition Coil Terminals are reversed. Care should be taken when installing Ignition wires.

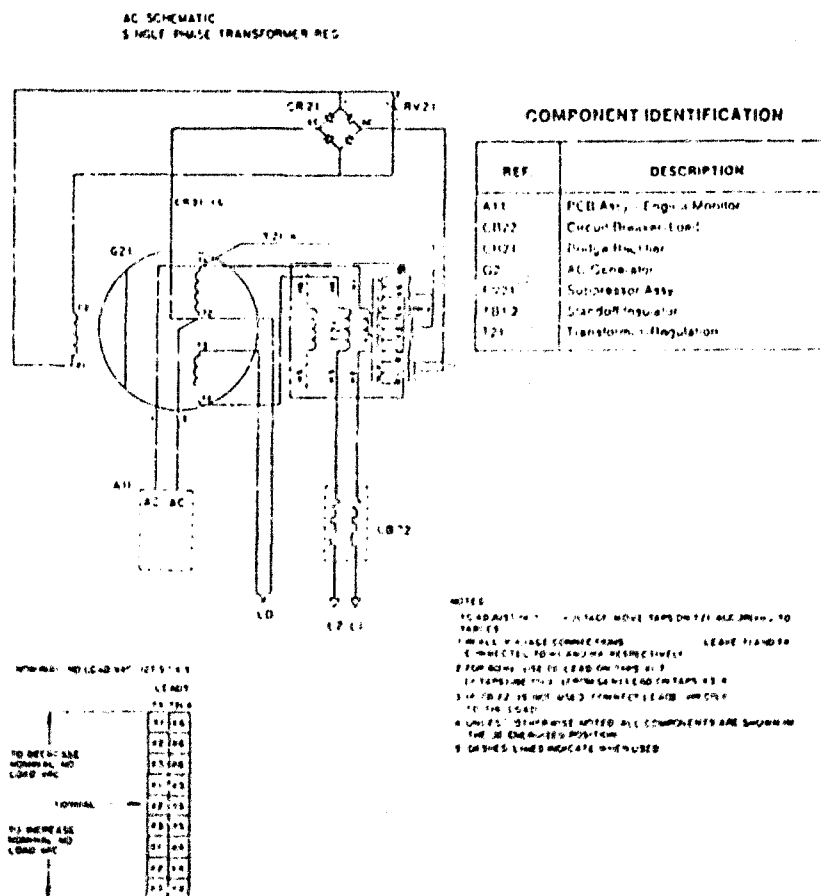
When changing voltage taps on T21, or if you experience a blown suppressor assembly and/or high output voltage, inspect the connections of leads T21-X and TX for proper placement on taps X1 through X6. The correct normal connection is TX to X2 and T21-X to X5. Refer to Wiring Diagram 612-6434 for additional information.

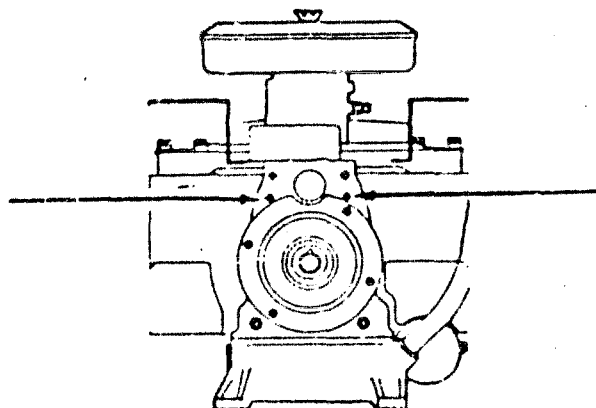
WARNING: Oil leakage causing permanent engine damage or personal injury may result from failure to appropriately plug these holes.

Use an appropriate Allen set screw, Onan part No. 803-00/1 or cap screw 3/8"-16 x 1/2" with 3/8" copper flat washer. Thread sealer must be used in both applications.

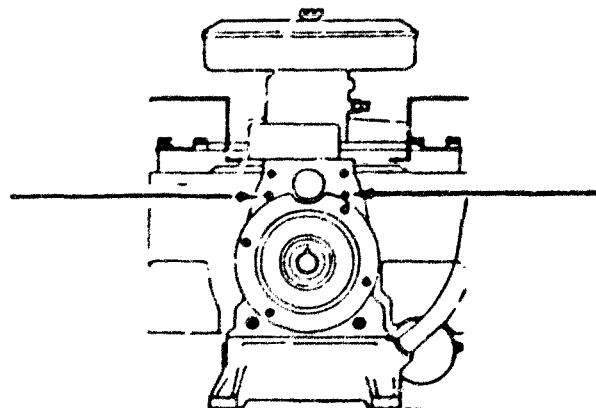
Whenever any of the above engine models are brought in for service with complaints of oil leaking near the rear main bearing plate or oil carryover into the air cleaner, look for plastic plugs in the block just above the rear main bearing plate. Remove the plastic plugs and reinstall an appropriate Allen set screw, Onan part No. 203-0071 or cap screw 3/8" - 16 x 1/2" with 3/8" copper flat washer. Thread sealer must be used in both applications.

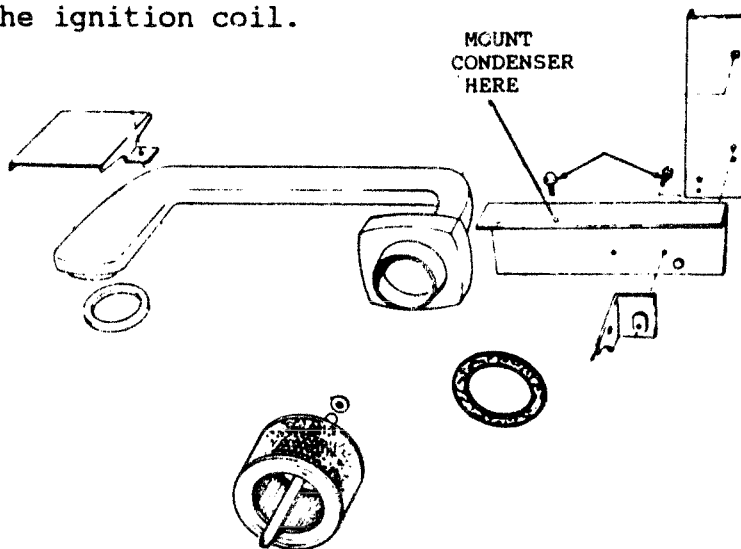
Locating the condenser outside the ignition points and condenser box eliminates the possibility of grounding the condenser lead to the ignition box cover or breaker assembly. Longer condenser life can also be expected because of better cooling.

Effective immediately, Onan is recommending relocation of the ignition condenser on all of its BFA, BGA, NH, and NHL gensets with top-mounted points and condenser boxes. The relocation will move the condenser from the ignition points and condenser box to the top side of the air duct bracket (P/N 140-1529).

Loosen and remove the bolt (P/N 821-0009) from the top side of the air duct bracket closest to the generator end-bell and install the condenser at this location, but reinstalling the (above) bolt to secure the condenser at this point. Be sure to remove enough paint to provide a good ground connection, and connect the condenser lead to the (-) negative side of the ignition coil.

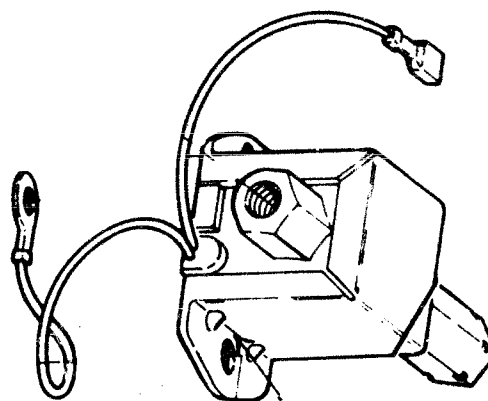
Figure 2

Failure to inspect and make necessary repairs to affected gensets could result in fuel line failure leading to a fire causing property damage with personal injury or death.

Inspect for cracks

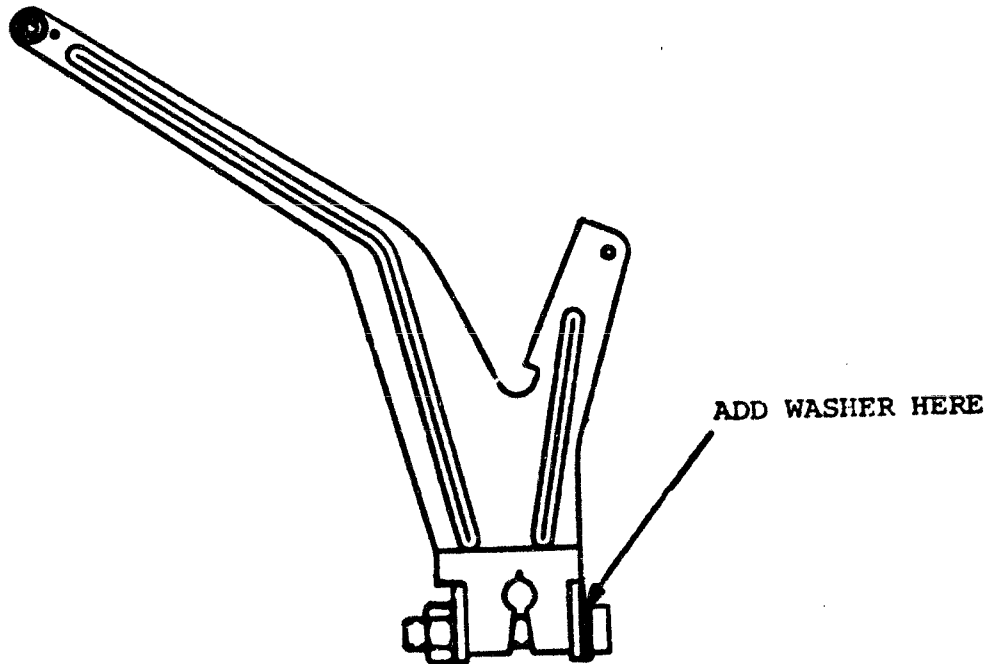
Governor instability may be caused by oil on the governor shaft which could cause the governor lever to slip on the governor shaft. Clean the governor shaft in the area where the governor lever attaches with choke cleaner, contact cleaner or equivalent. Add washer P/N 740-1006 under the head of the bolt which attaches the governor lever to the governor shaft. Torque bolt 8-10 ft.lbs. (11-14 Nm). Refer to Elite Service manual for adjustment procedures.

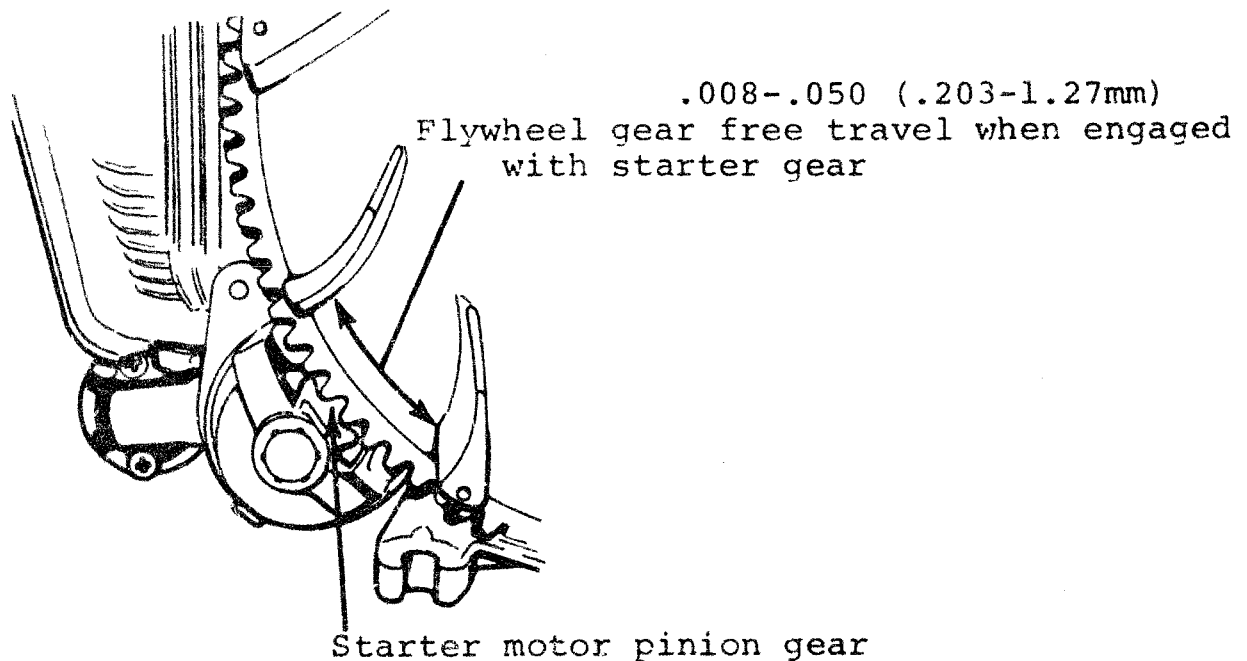
4. Measure gear backlash with narrow auto ignition type feeler gauge, round wire feeler gauge or small drill bit. Position flywheel so that only one tooth of pinion gear engages ring gear. Measure on back side of tooth engagement.

5. Measure backlash measurements at two other locations around the ring gear. If the backlash exceeds .050, examine the starter for bushing wear or a bent armature shaft. If these are okay, check the starter mounting boss area on the block for damage, wear or cracking. Loosen mounting bolts and adjust starter toward flywheel. Torque inboard bolt first, then outboard bolt. Repeat backlash test. If starter checks okay and cannot be reinstalled and adjusted to maintain backlash of .050 or less, replace the block. (and ring gear if damaged).
6. Remove jumper wire, install blower housing, replace battery cable to starter and install spark plugs and spark plug wires.

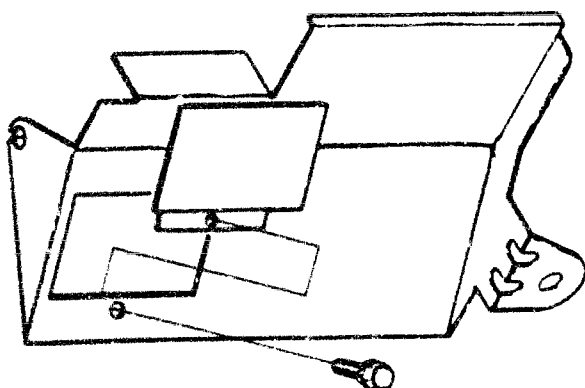
INCORRECT

Some E125V Spec B engines were built with Spec A cylinder air deflectors. This may cause the throttle linkage to bind or stick which can cause an overspeed condition. The illustration below shows the correct air deflector for Spec B Elite engines.

If the correct air deflector is on the engine, adjust the governor per instructions in the Service manual. If the incorrect deflector is on the engine, order P/N 134-4743-50 and install per the following instructions

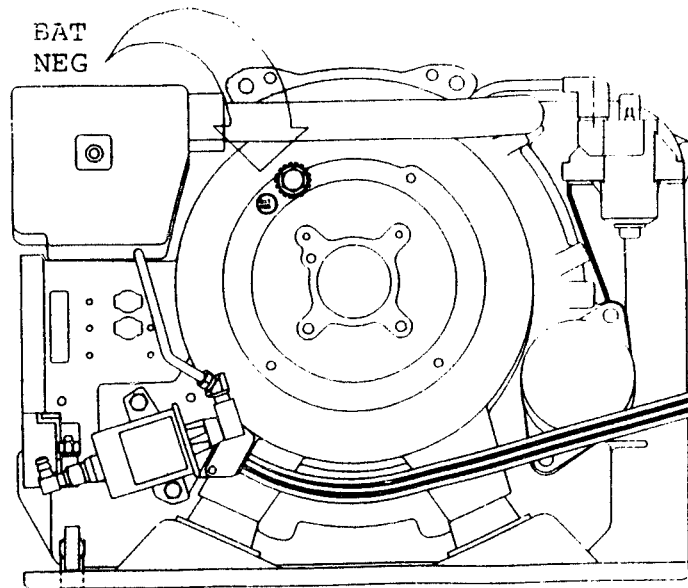
We are changing the recommended location for the battery negative connection on the Emerald and Marquis gensets. The recommended connection point was on the mounting tray at any mounting bolt location. We now supply a bolt and star washer, located on the endbell of the generator, to connect the battery negative cable. This change reduces the chance of poor engine ground connections caused by painted surfaces. We are clearly marking this connection point on all units with the words "Bat Neg" inside a circle.

This drawing depicts an Emerald, but change
is applicable to all listed gensets.

This change is recommended on new installations and where poor grounding is a problem. This change is being implemented now; therefore, all units with serial numbers starting with B92 will include this bolt and star washer.

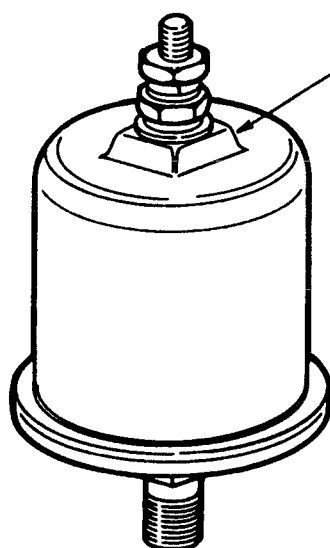
FIGURE "A"

OLD

Submit a standard spare parts warranty claim for any of the old style senders that you may have in stock. Order replacements from Onan Service Parts Department.
