Product Support Bulletins

May 1974 to September 2000

MBB

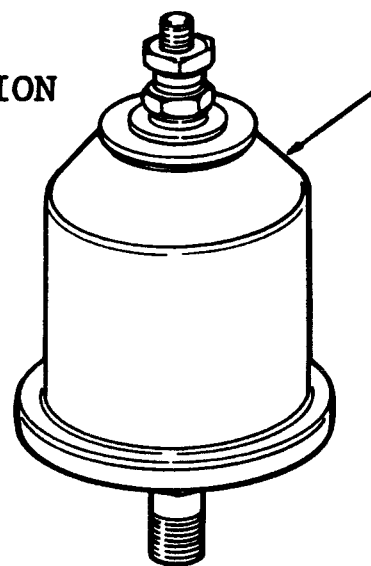
FIGURE "B"

NEW

Submit a standard spare parts warranty claim for any of the old style senders that you may have in stock. Order replacements from Onan Service Parts Department.

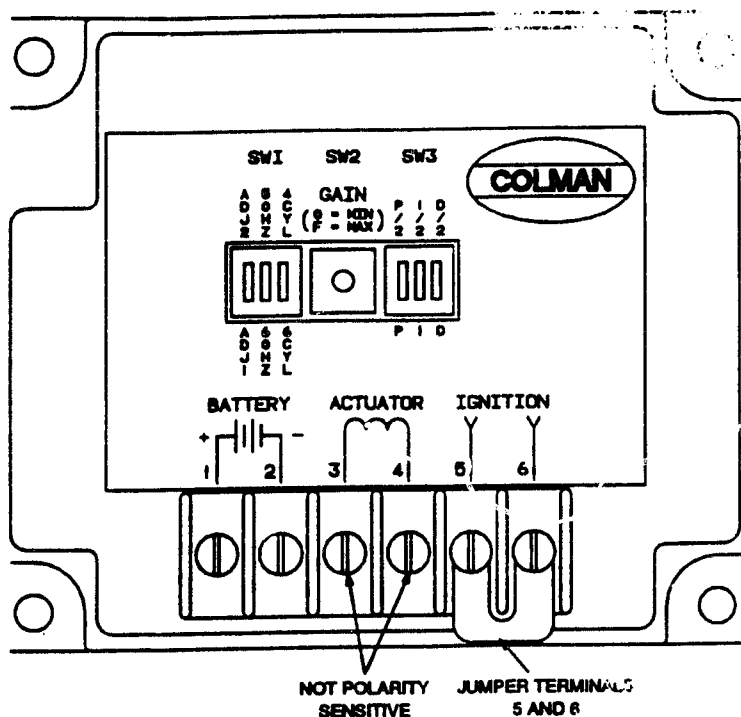
FIGURE 1 GOVERNOR CONTROLLER

If a model 20ES Spec E or beyond experiences an overspeed/overshoot shutdown on start, perform the following adjustments as necessary:

1. Place switch SW3 I in the upward position (Figure 1). This should reduce the level of overshoot on start to half of the original setting. If this does not help, return the switch to its original position and proceed to the following step.
2. Set the overspeed switch adjustment screw (Figure 2) for shutdown between 2500 and 2700 RPM's. If this does not prevent shutdown on start, it may be necessary to replace the governor controller.

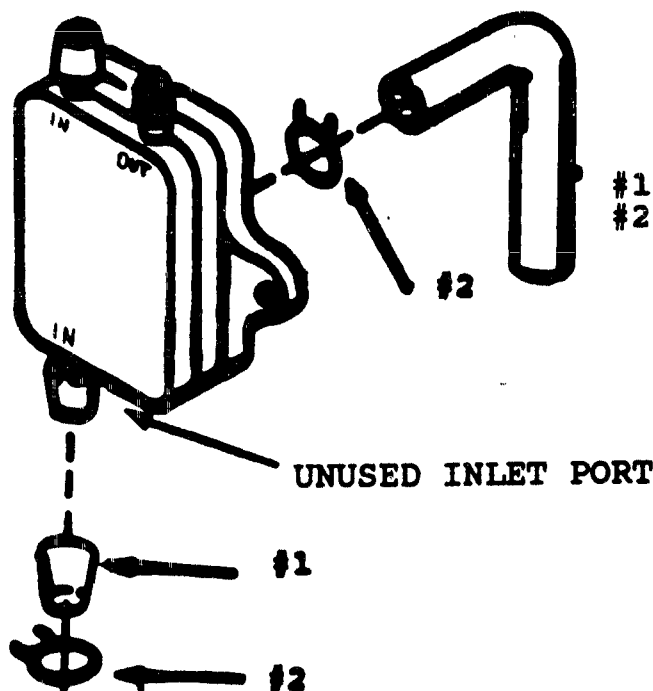
ACTUAL SIZE

Some Performer P220 engines spec. 10808D installed in an application with the 3 port pulse fuel pump may have a temporary fuel cap installed on the permanently unused inlet port. The permanent fuel cap #149-1321 is heavy duty rubber cap with a clamp retaining it to the unused nipple of the fuel pump. If any equipment is found with the temporary cap still installed it is imperative that it be removed and the permanent cap and clamp be installed.

- #1 Permanent fuel cap # 149-1321
- #2 Hose clamp # 503-0301

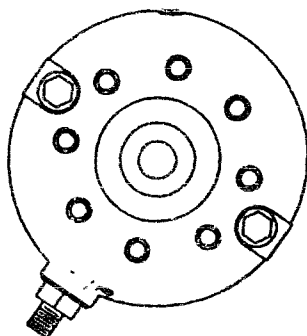
Figure A

Starter P/N 191-1630 was replaced with 191-2132. This starter should have the four vent holes sealed.

The modified and unmodified starters can easily be distinguished, as seen below:

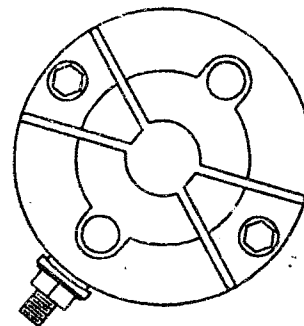
Figure B shows the starter motor (191-2132) which is the topic of this product improvement. Carefully view the starter motor end cap. Observe the four holes closest to the center. If each of these holes is filled with epoxy, no replacement action is necessary. If these four holes are open or filled with paint, then the starter motor should be replaced.

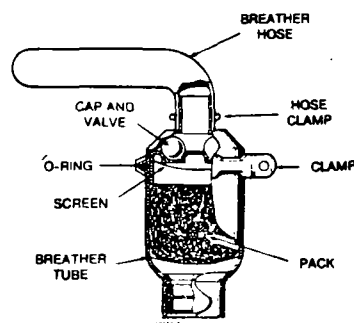
Figure A.

Check the breather system for the correct number of nylon balls (4) in the breather cap and valve assembly (See Figure A).

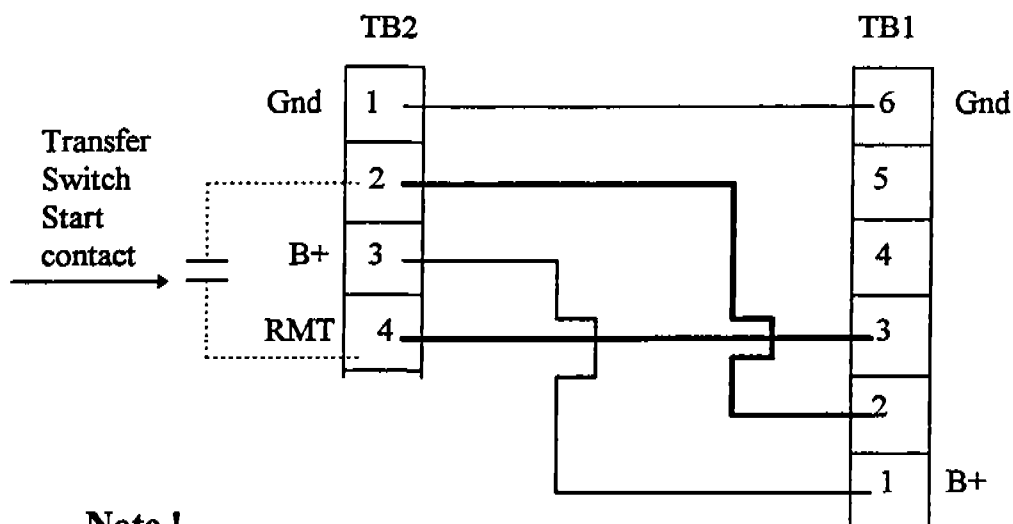
Gen Set with 612-6719 Control

There must not be a jumper,
on TB2 position 2 to 1 or 2 to 3
If one is there it must be removed.

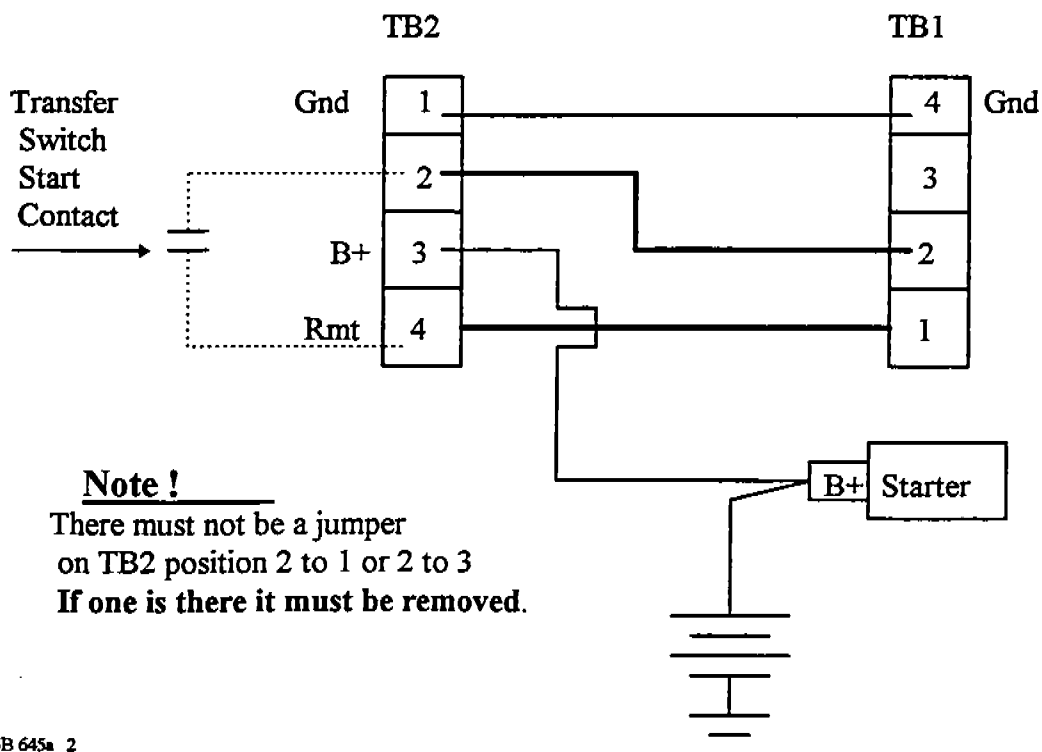
Gen Set with 612-6708 Control

There must not be a jumper
on TB2 position 2 to 1 or 2 to 3
If one is there it must be removed.

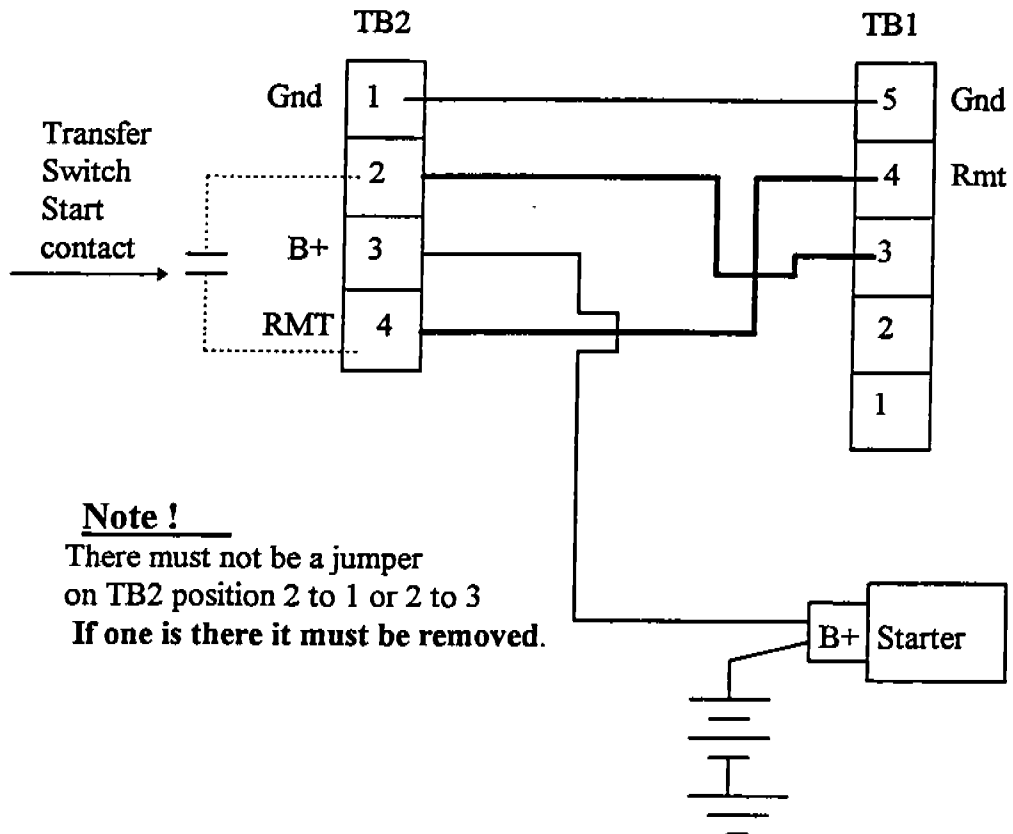
**Gen Set with
612-6697 Control**

There must not be a jumper
on TB2 position 2 to 1 or 2 to 3
If one is there it must be removed.

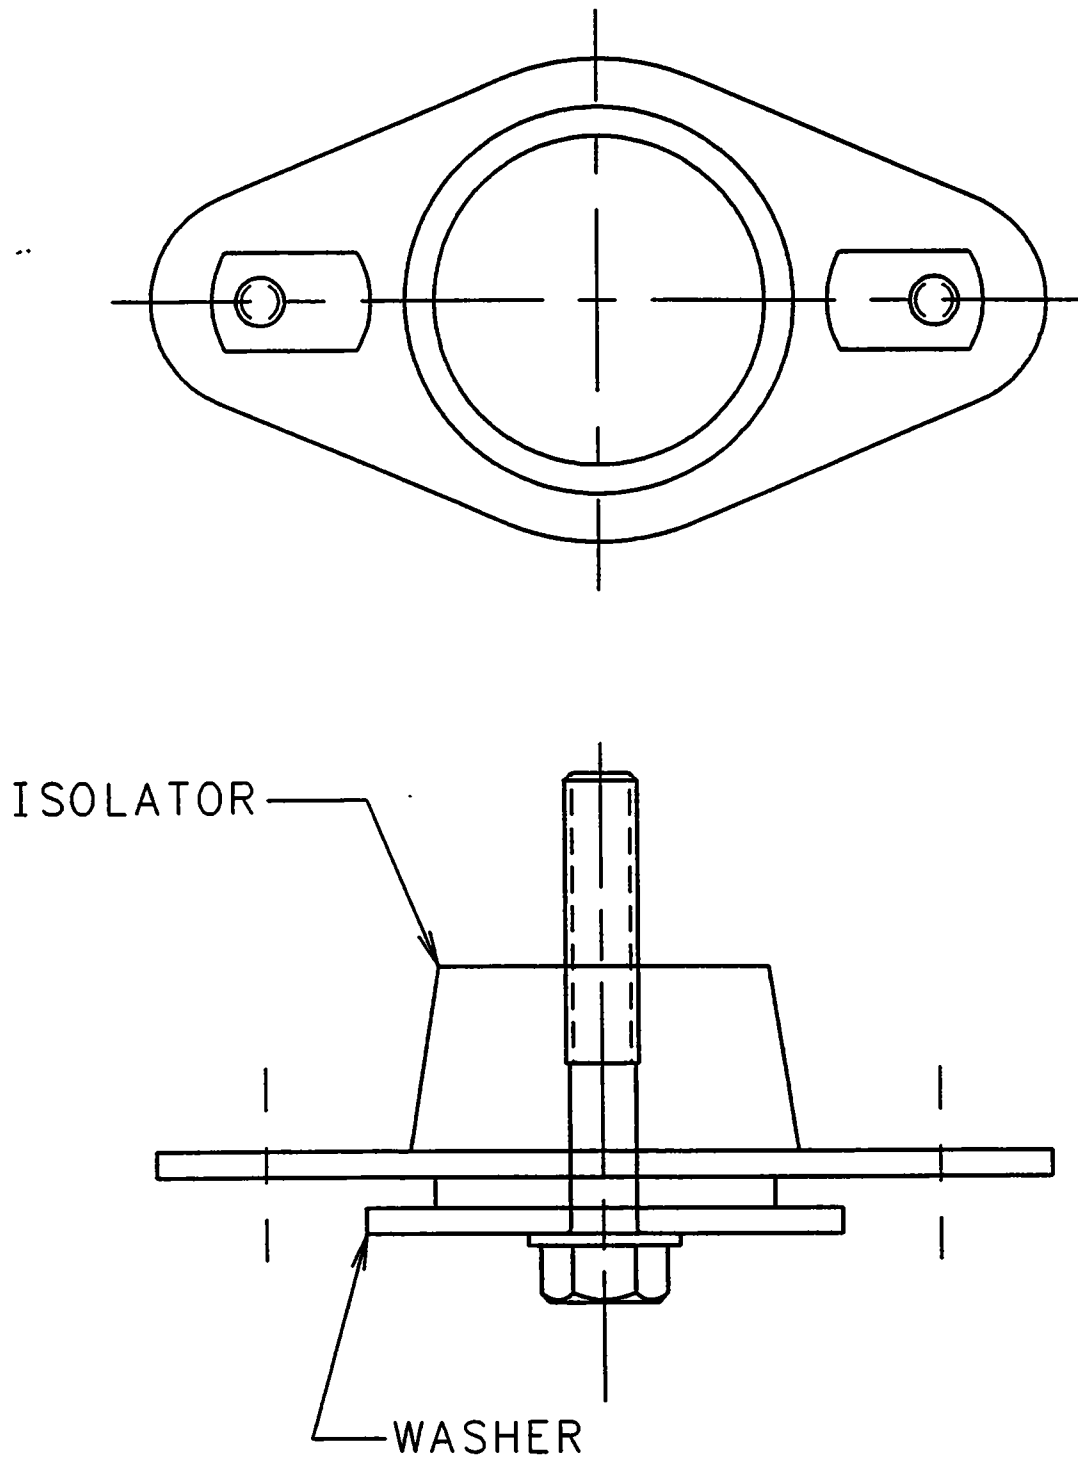
FIGURE 1

CORRECT CONFIGURATION

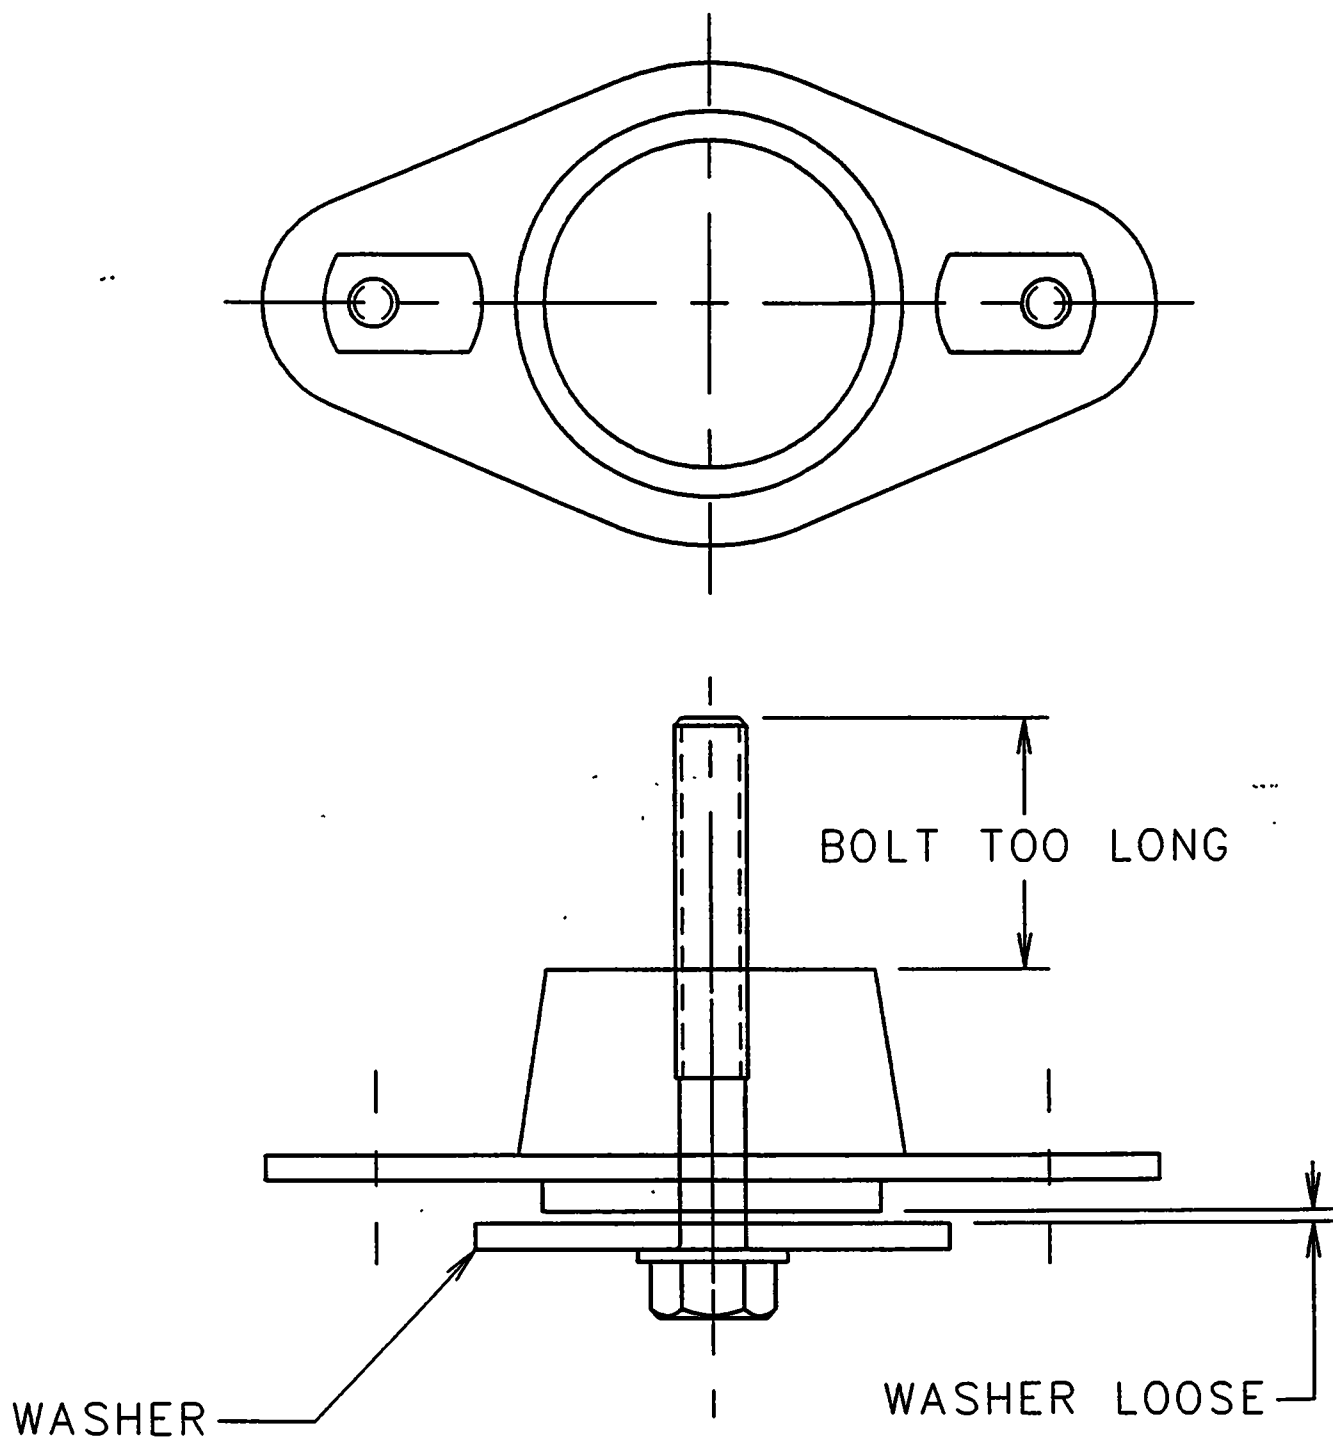
INCORRECT CONFIGURATION

Figure 4 - The incorrect RV Emerald mounts with no snubber and the incorrect bolt are installed. This can be detected during inspection if there is a .25" empty gap between the bottom of the 526-0325 washer and the bottom of the generator tray.

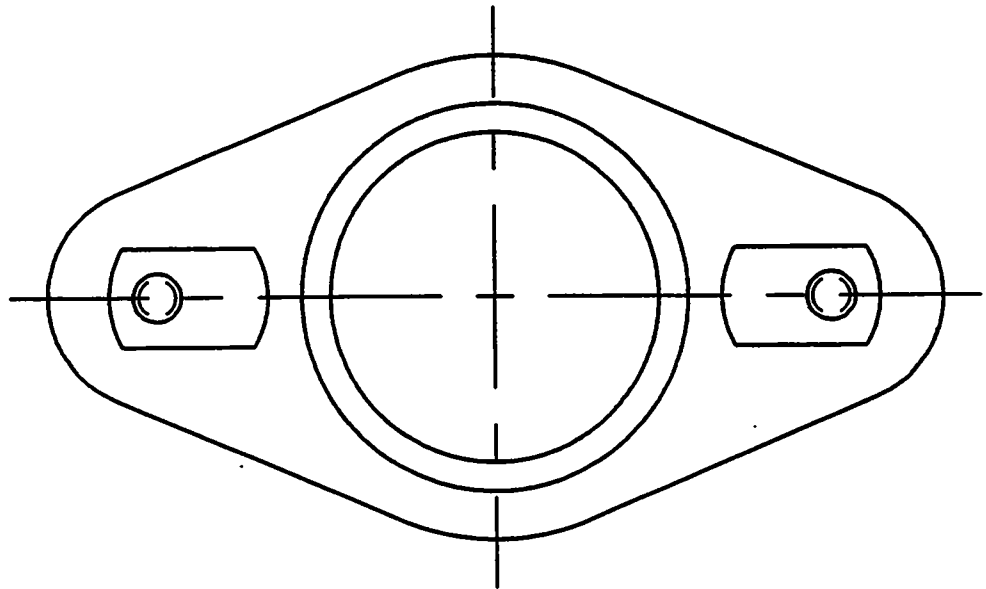
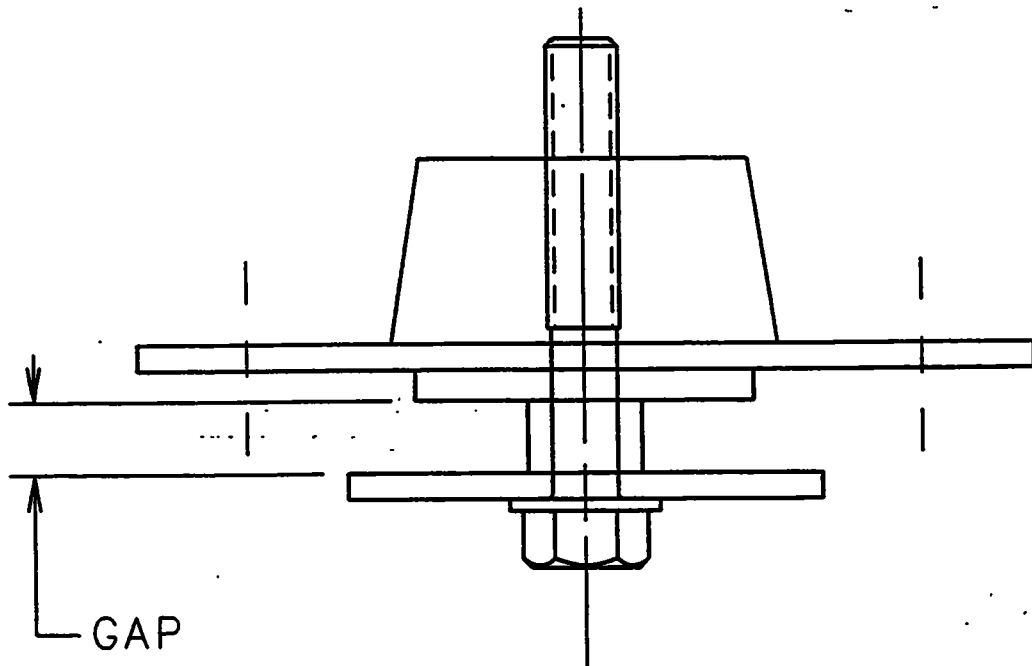
FIGURE 4

INCORRECT CONFIGURATION
